Spotlight

Dec 2023

FOREWORD

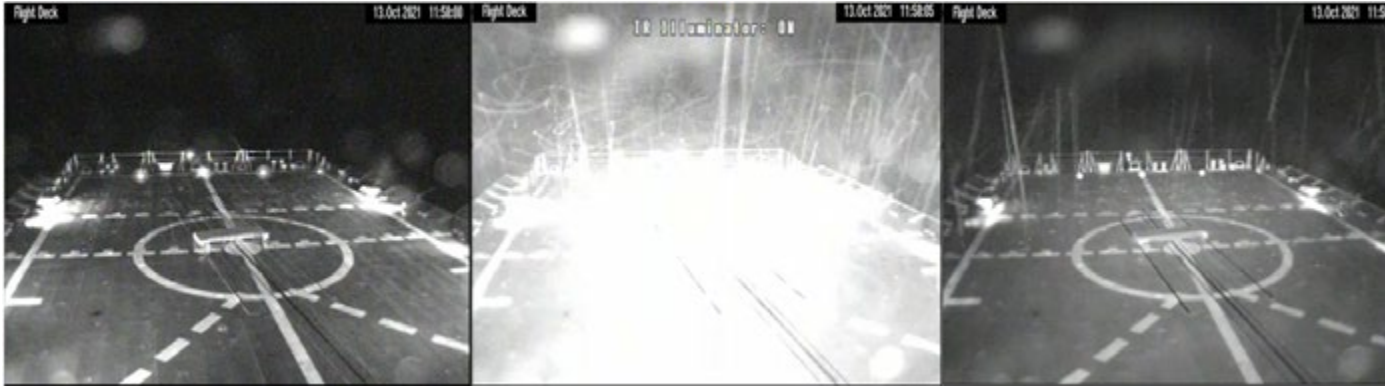
While on the final approach to *Brisbane*, the aircrew again experienced an IR illumination from the same CCTV camera. This caused a significant distraction for aircrew members in flight, removing their primary visual reference with the ship through NVG.

The ASIT found that both activations of the IR illuminator (pre- and post-aircraft launch) were initiated by a member in the ship’s platform control room.

CCTV screenshot before, during and after activation of IR illuminator pre-accident

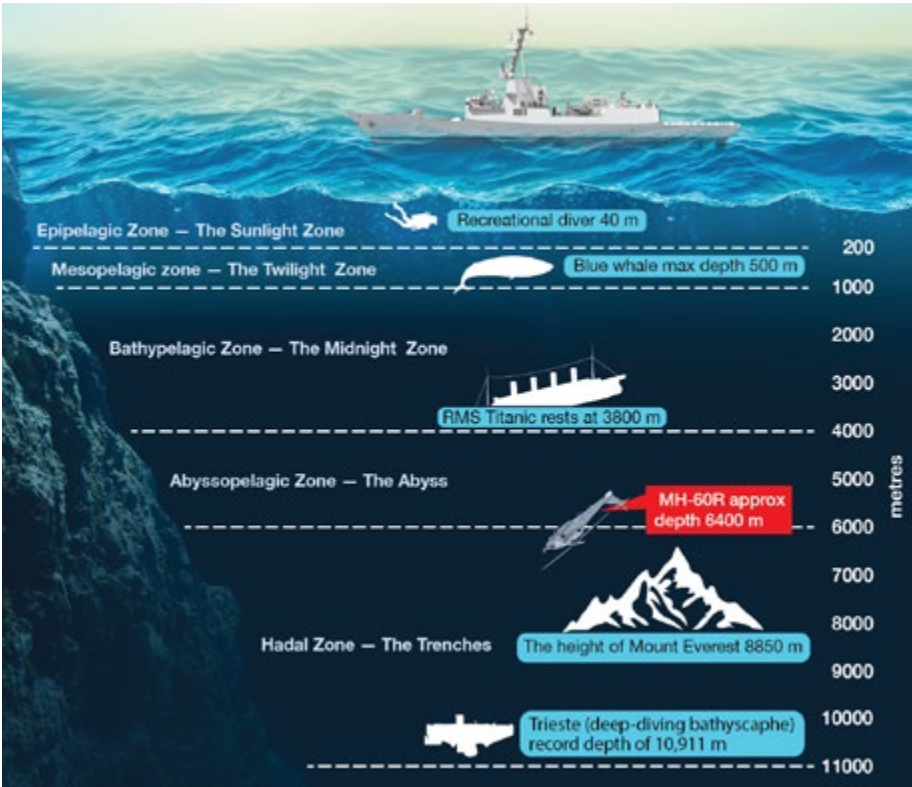
Depth of wreckage

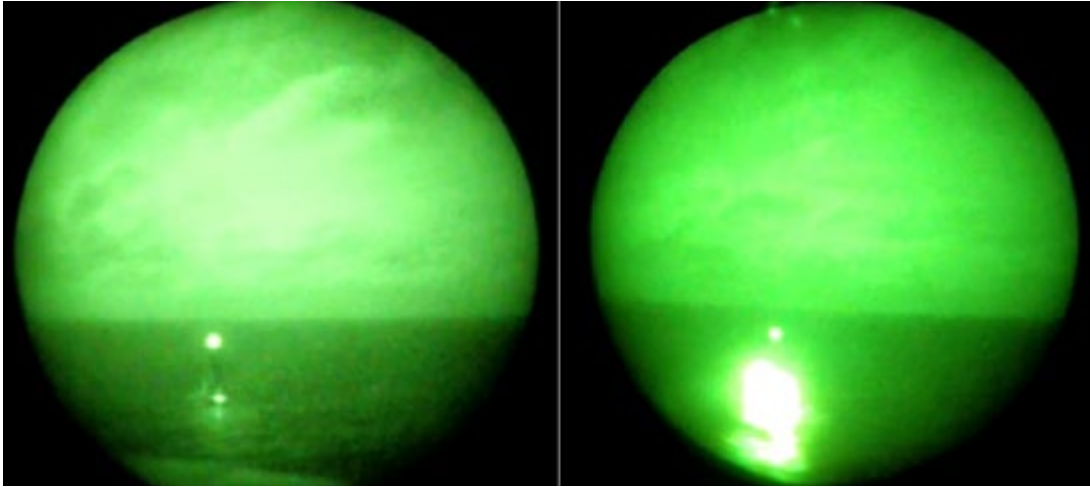
Effect of IR illuminator on NVGs

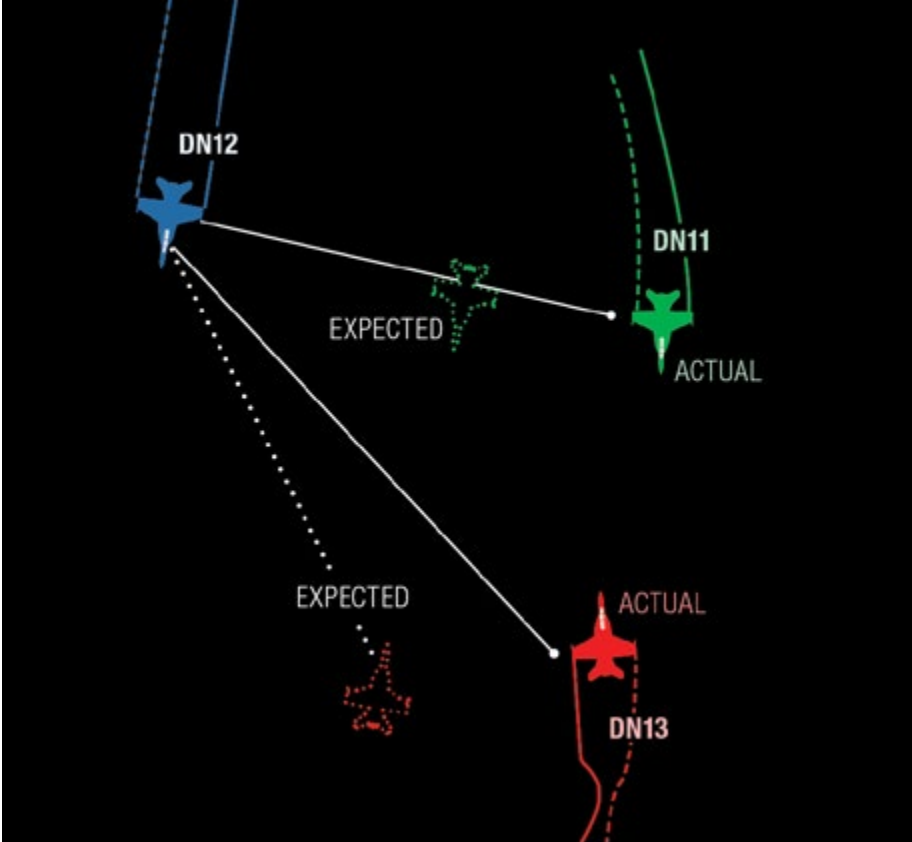
DN11 and 13 actual vs expcted positioning

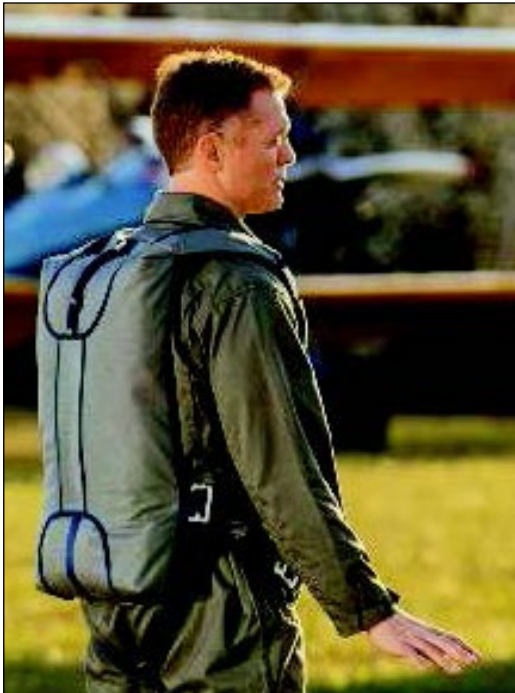
Slim-back type emergency parachute

The pilot carried out wearer trials of a slim-back emergency parachute similar to the type depicted above, with the assistance of engineering staff at Temora, in an attempt to mitigate the level of risk if required to bail out from the aircraft.

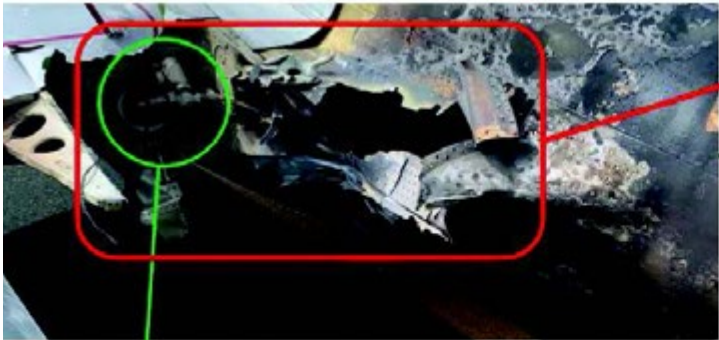
Further inspection revealed that the fire extinguisher, normally located beneath the port-side wing-flap cavity, had separated from its manifold as did the flap itself, with both components departing the aircraft. Considering the substantial level of damage sustained by the aircraft and engine within the turbine plane of rotation, the ASIT noted the fire extinguisher’s vulnerability to damage from an uncontained engine failure.

A combination of the exit of engine debris and heat escaping from the exhaust area under the wing-flap very likely caused an over-pressurisation and rupture of the fire extinguisher. Although the loss of the fire extinguisher was extremely likely not causal to the event it was considered to be a secondary effect.

Damaged fire-extinguisher manifold

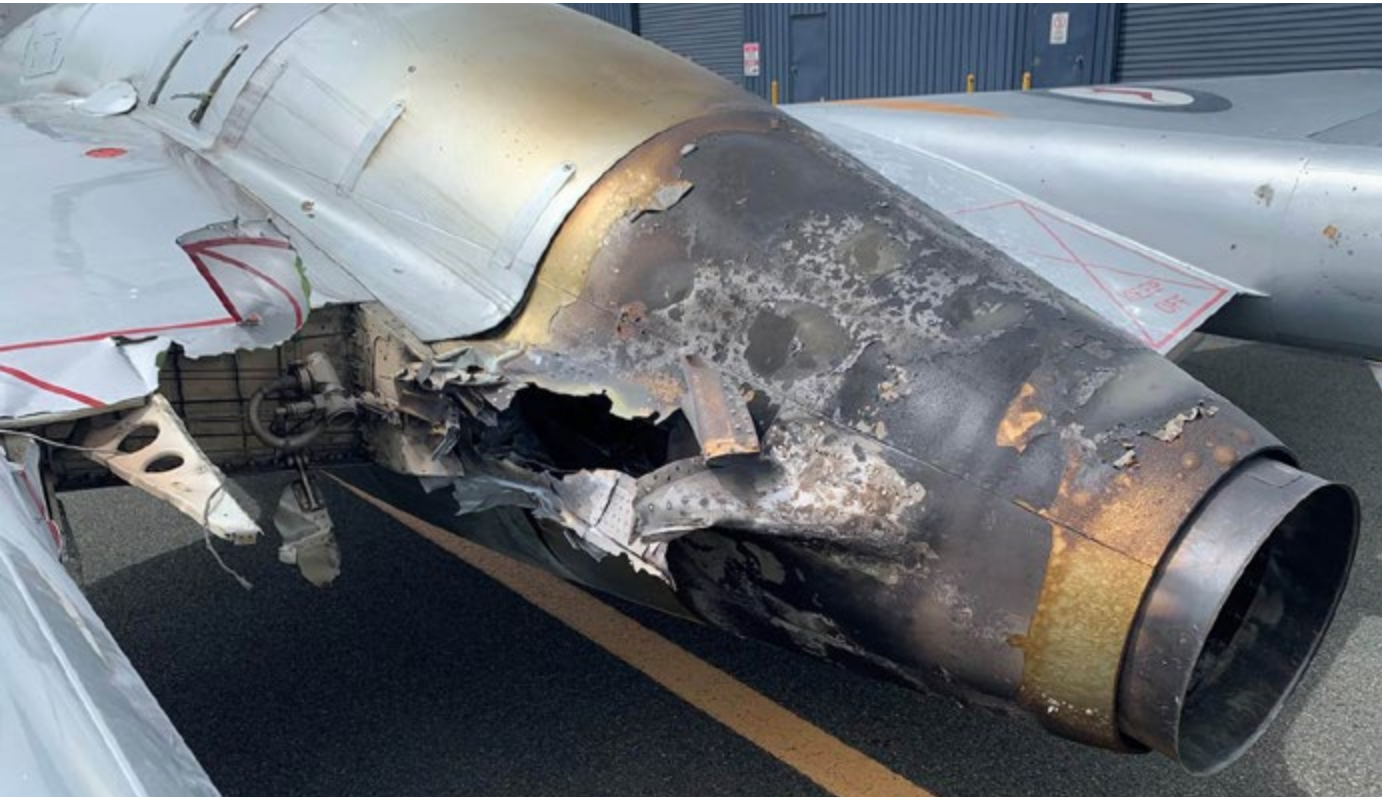
The ASIT’s preliminary inspection of the aircraft revealed extensive fire damage to the external engine cowlings, heat shields and upper and lower sections of the port-side wing. Significant damage was also evident on the outer port-side of the engine casing indicating the potential exit of engine components up and away from within the turbine plane of rotation.

Gaping hole adjacent to fire extinguisher with deformation of material directed from the engine

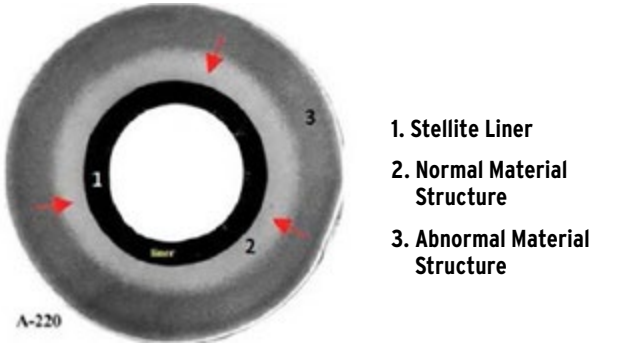
due to the excessive heat, leading to external bulging and erosion to the bore and rifling. The incident barrel was compared to one that had reached its service life, which was found not to have the same abnormalities.

Figure 1: Barrel cross section 200 mm from chamber end.

Analysis of the barrel showed that the material properties of the barrel had changed due to the excessive heat.

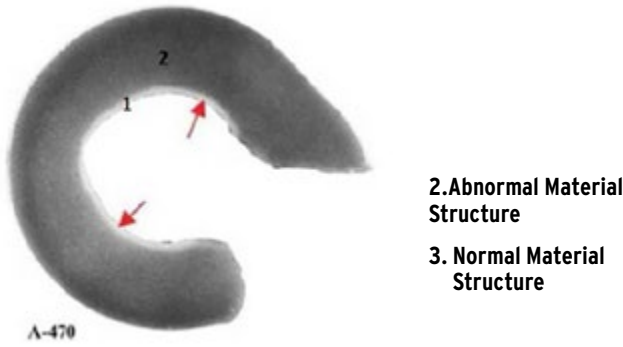
Figure 2: Barrel cross section 470 mm from chamber end.

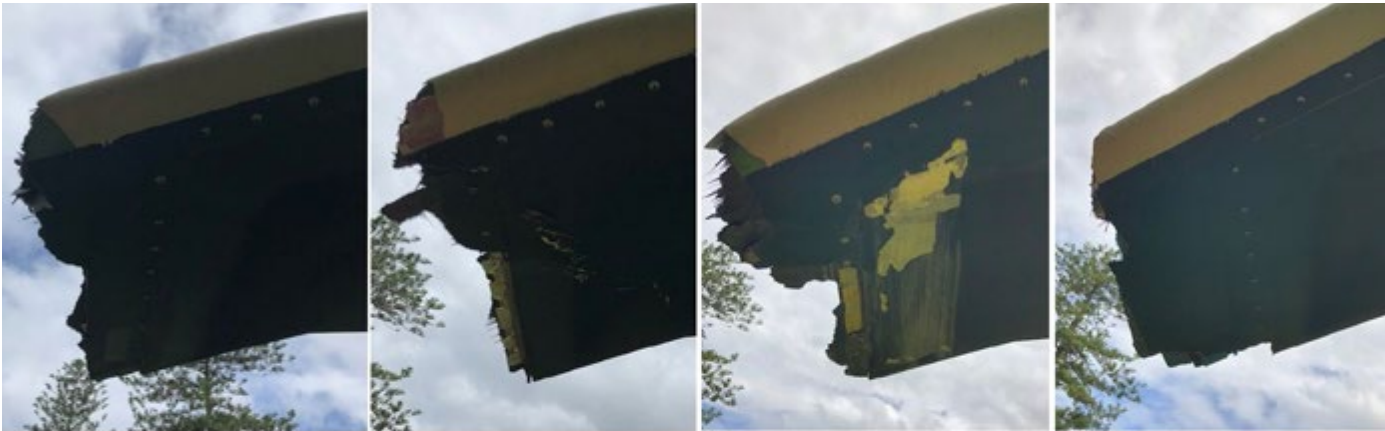
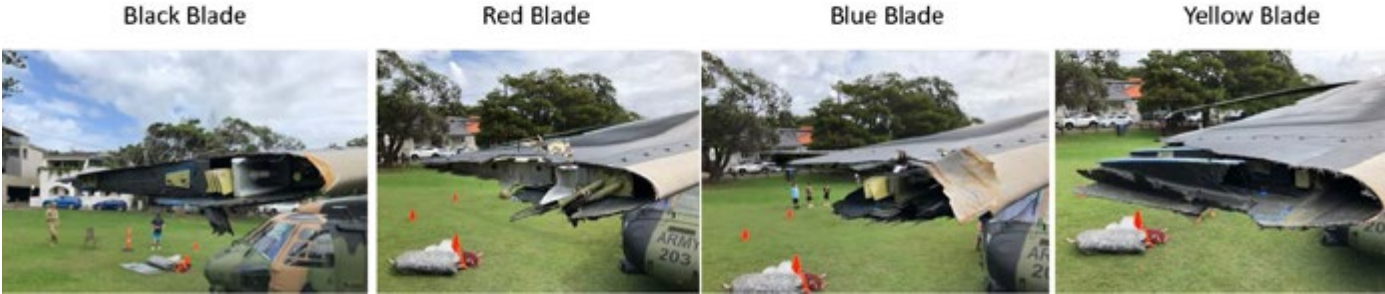
Blade tip damage

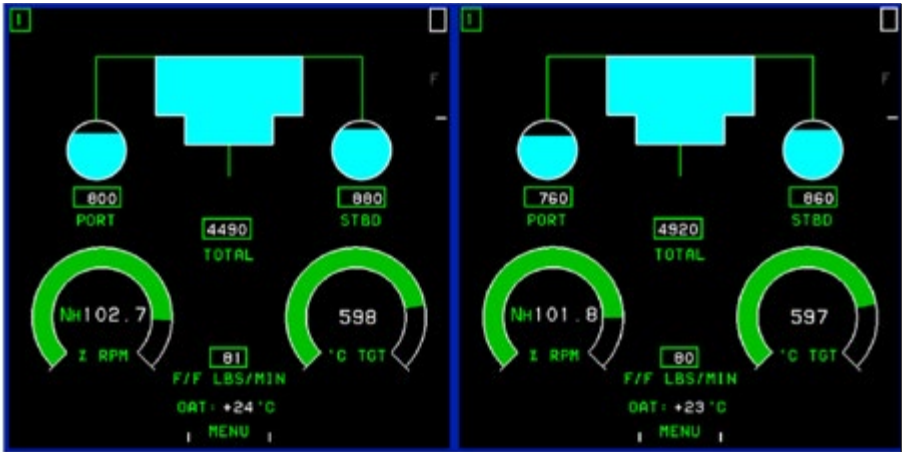
Fuel reading at take-off (left) and fuel reading after take-off (right)

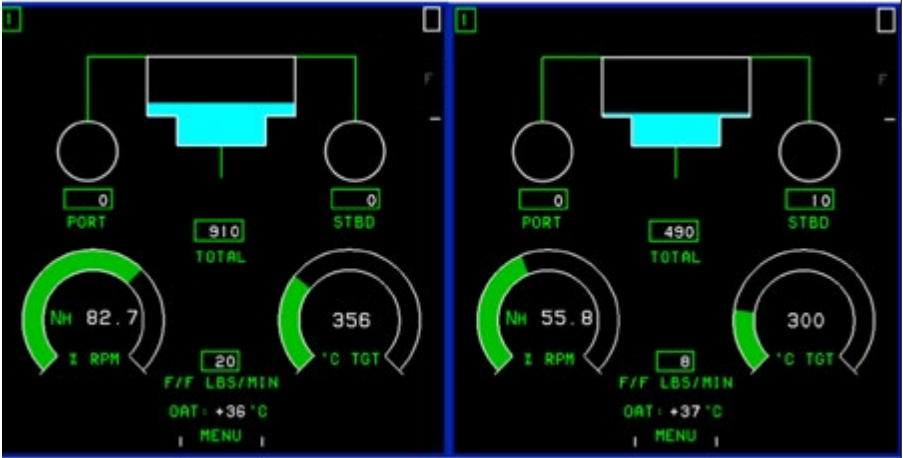
16 March fuel reading prior to landing (left) and during landing roll (right)
