AVIATION SAFETY INVESTIGATION REPORT

6th Aviation Regiment – NHIndustries MRH-90 Taipan
A40-040, Spatial Disorientation leading to Controlled Flight
Into Terrain (CFIT), Whitsunday Islands, QLD, 28 July 2023.

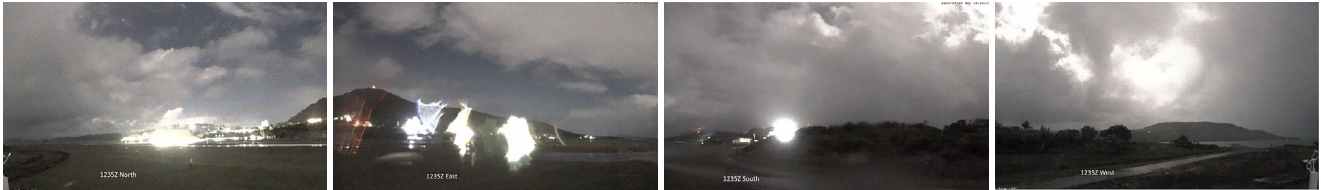
Figure 12: Hamilton Island Weather Camera at 2235K

- 1.8.6 A weather camera located at Hamilton Island captured the weather conditions in the vicinity of Hamilton Island at 2235K, approximately one minute before the accident (shown at Figure 12). Showers can be observed towards the south-west of Hamilton Island, with areas of clear sky visible to the east and north-east, matching the description of the weather provided by the crews of BSMN.

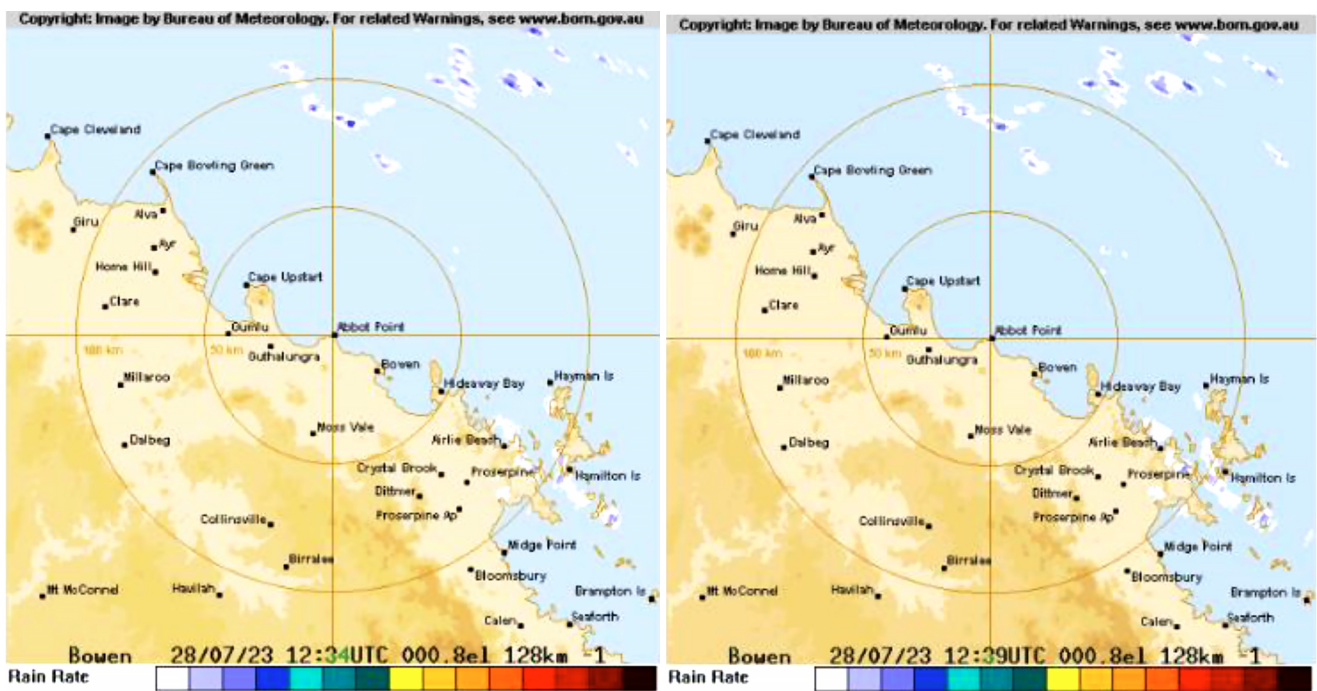
Figure 13: Bowen Weather RADAR, 128 km scale at 2234K and 2239K

- 1.8.7 The Bowen weather radar depicted showers in the vicinity of Hamilton and Lindeman Islands at 2234K and 2239K, moving north-west, see Figure 13.

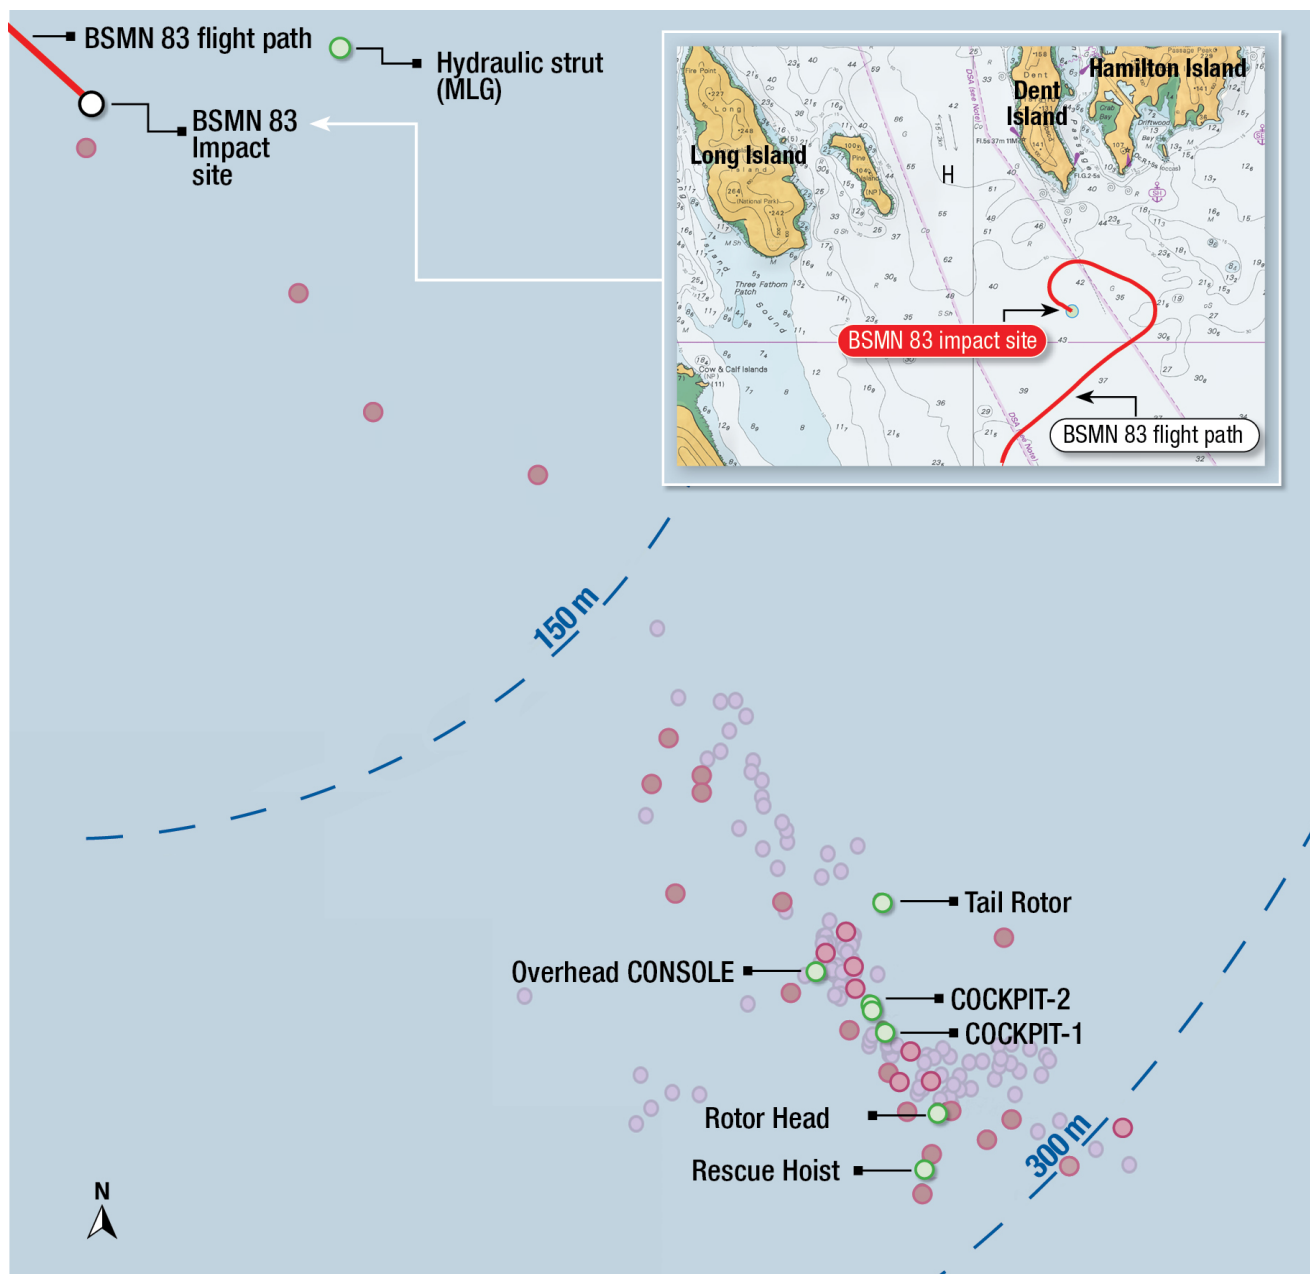
Figure 16: Aircraft impact site and debris field

- 1.11.2 Figure 16 shows aircraft debris spread 304 m across the seabed in a south-easterly direction from the impact site, and between 38.5 m to 41 m below the surface on the seabed. Sea floor currents in the area can be up to 4 kts (10 km/h), dispersing the wreckage, and subsequently hampering diving-recovery operations with visibility at times down to 30 centimetres. These conditions also meant that seabed material (sand and silt) covered wreckage items and made it difficult to locate previously identified items. The main wreckage-recovery phase took place between 04 Aug 23 and 15 Oct 23, at which point the ASIT's input to the onsite recovery process ceased. The recovery involved numerous assets from military, police and civilian agencies, with 64 recovery dives completed at an average time of 42 minutes in the water. Further details regarding the aircraft impact site and debris field is provided in the full technical report (Enclosure 2).

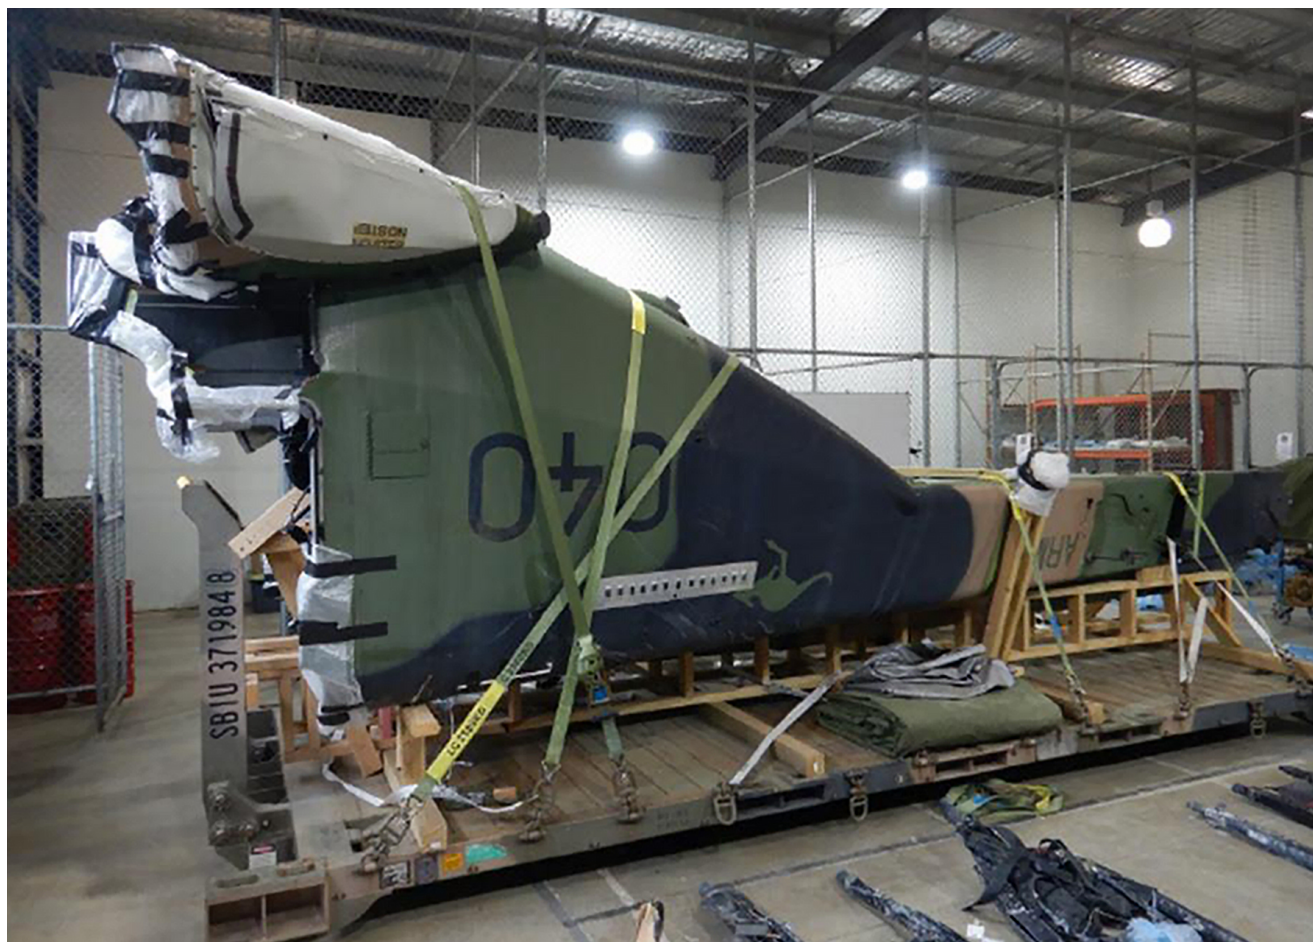
Figure 17: Rear fuselage and tail pylon section

- 1.11.3 The ASIT estimated that approximately 70% of the aircraft fuselage was recovered from the debris field, which included a significant amount of fractured pieces of the composite fuselage. The Main Rotor Gear Box (MRGB) assembly and sub-assemblies were recovered from the seabed. The MRGB was significantly damaged and had broken away from the main fuselage. Both engines were intact and remained connected to the MRGB. All four main rotor blades exhibited significant damage, with the outer sections of two (blue and black) blades experiencing substantial delamination and structural disruption. The tail section was recovered from the seabed with the tail rotor gear box (TRGB) and tail rotor blades still attached. Figure 17 is the recovered rear fuselage and tail pylon section. The aircraft floats were recovered as part of the rear fuselage recovery. The flotation equipment had not been activated by either water entry or deployed manually by the crew. Further imagery and details of the recovered wreckage is provided in the technical report at Enclosure 2.

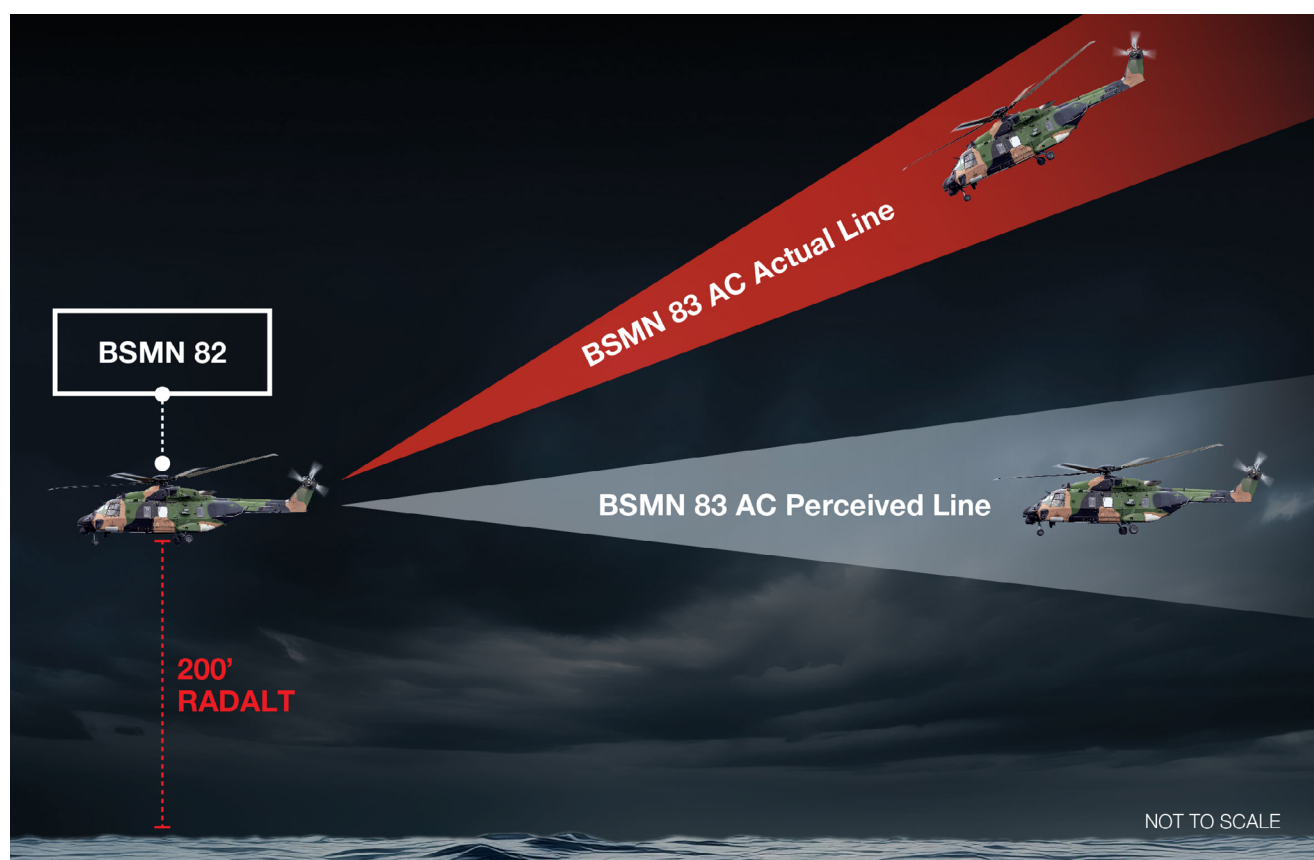
Figure 28: Actual vs Perceived relative position with preceding aircraft

It is very likely that BSMN 83's AC (FP) unknowingly experienced a loss of Spatial Orientation; commonly referred to as Type I (Unrecognised) Spatial Disorientation, through the climb.

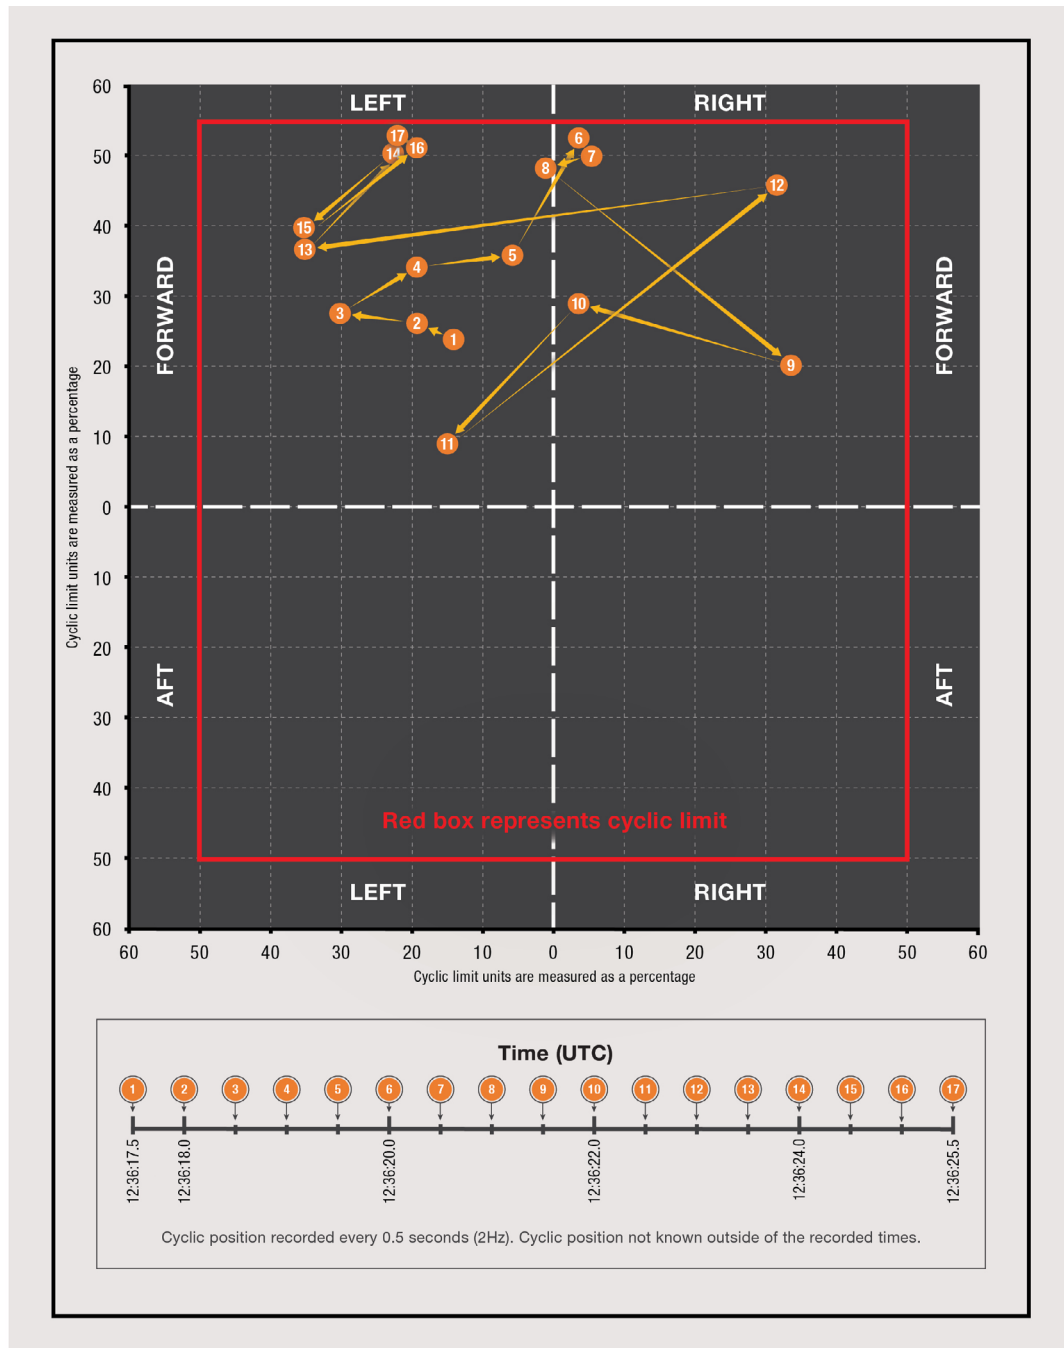
Figure 30: BSMN 83 cyclic movement 1236:17.5 - 1236:25.5Z

- 2.9.12 Figure 30 shows the VFDR cyclic control movement made by the AC (FP) just prior to the pushover through until the last valid recording (1236:17.5Z to 1236:25.5Z)⁵⁸. Time positions 3 through 8 on Figure 30 show cyclic inputs towards the forward cyclic limit that resulted in the pushover. Of note, the cyclic position remained in the forward quadrants from pushover to the last valid recording.

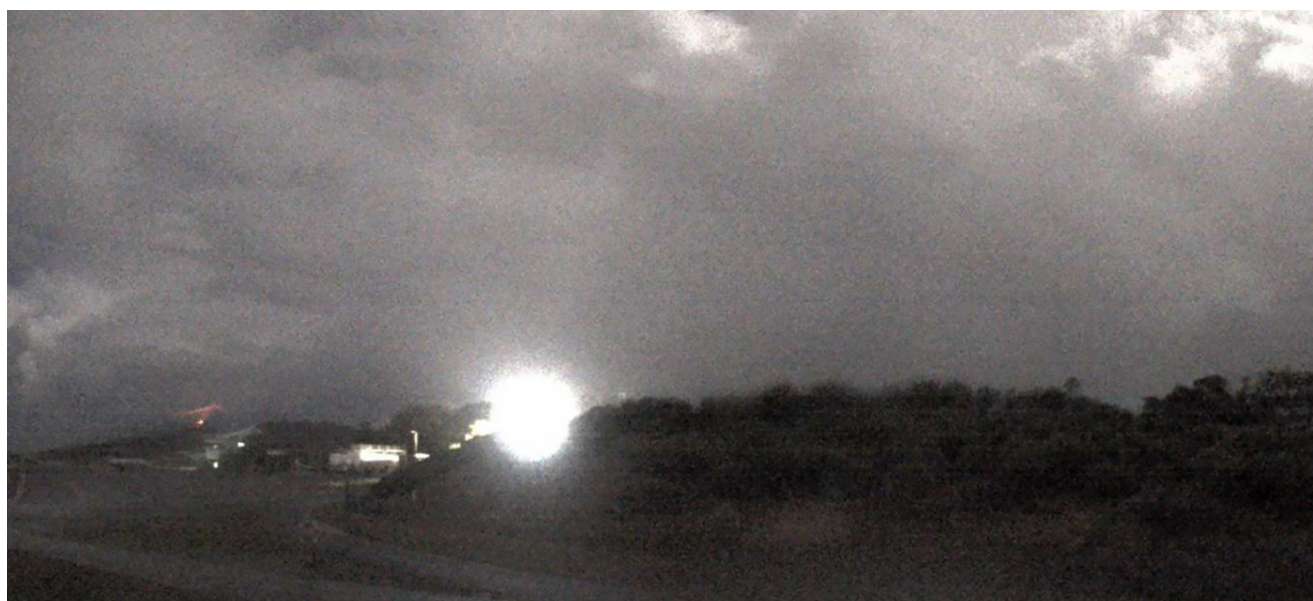
Figure 31: Hamilton Island weather camera at 1235 facing south

It is likely that visibility ahead of BSMN 83's flightpath immediately prior to the accident degraded as a result of flying through a shower.

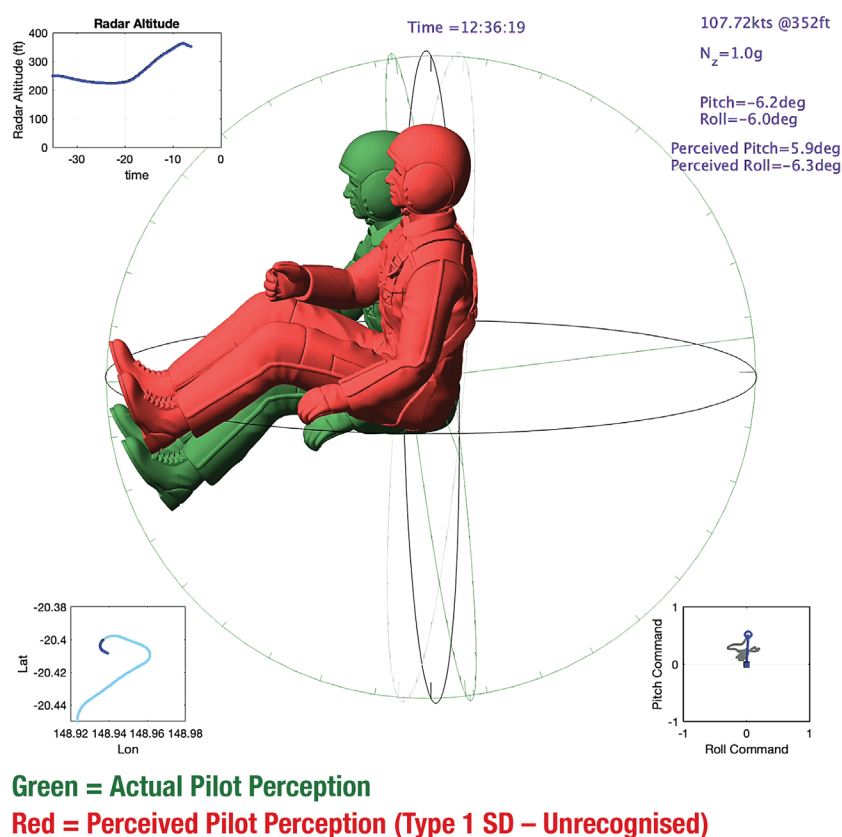
Figure 36: Pilot actual and perceived orientation at 1236:19Z⁷⁰

- 2.18.23 The modelling indicated that these sensors failed to detect a reversal in pitch angle of the aircraft from approximately +5 degrees nose-up to about -5 degrees nose-down. Consequently, the conditions were disposed for the FP to perceive a pitch-up attitude, as opposed to the actual aircraft pitch-down attitude, leading to a loss of Spatial Orientation. Figure 36 shows the perceived orientation of the FP at the top of the climb when the FP initiated large forward longitudinal cyclic input to at or near the forward stop.

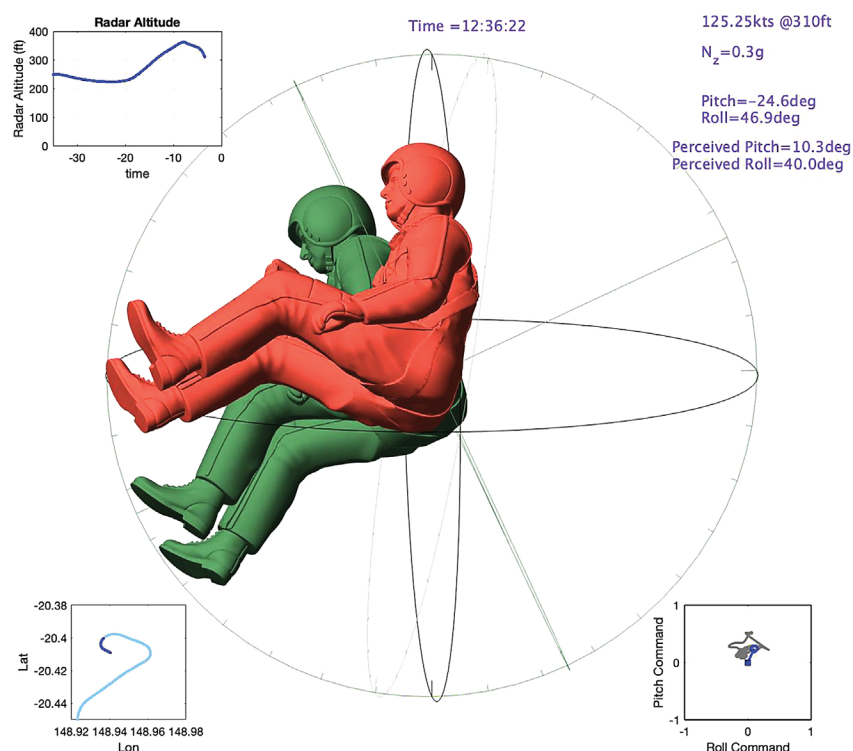
Figure 37: Pilot actual and perceived orientation at 1236:22Z - Type I SD

2.18.24 The modelling of the physical forces acting on the crew during the descent (see section 2.9) indicates that the acceleration force would have resulted in an increasing positive pitch perception even though the aircraft was pitched down. The actual BSMN 83 pitch-down attitude would cause aircraft velocity to increase corresponding to a downward acceleration. As shown in Figure 37 (lower right graphic), FDR analysis indicates that at 1236:22Z the FP moved the cyclic to the maximum forward position despite the aircraft pitch being 20 degrees nose-down. The cyclic control movement is considered indicative of misperception of pitch by the FP; that is, the FP perceived pitch-up despite the aircraft being pitched down.
