SPECIAL EDITION: THE HOW AND WHY
SUMMARISING OUR RECENT INVESTIGATIONS

**02 2021
EDITION**

Spotlight

FOREWORD

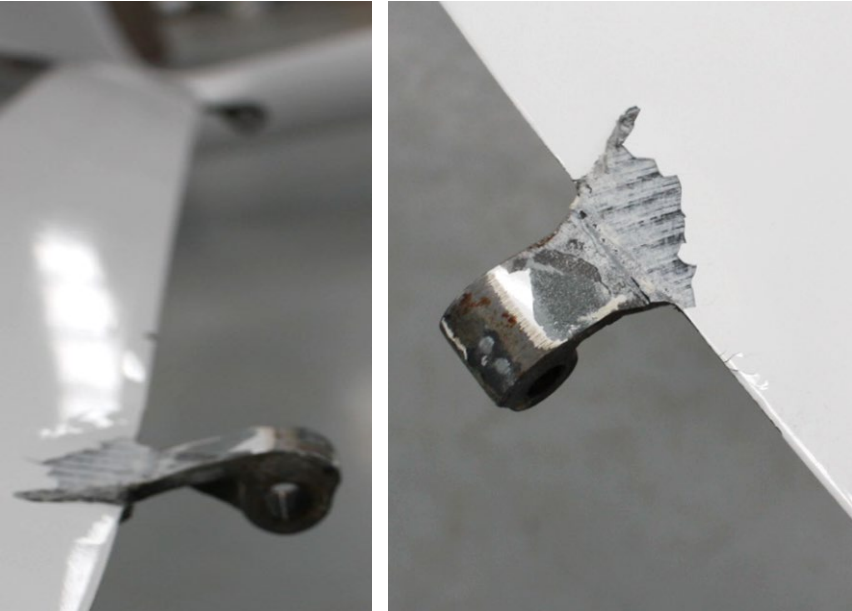
Hinge over-extension and supporting structure damage

Had the canopy detached from the airframe during flight and struck the empennage, it is expert opinion that the controllability of the glider would likely have been compromised.

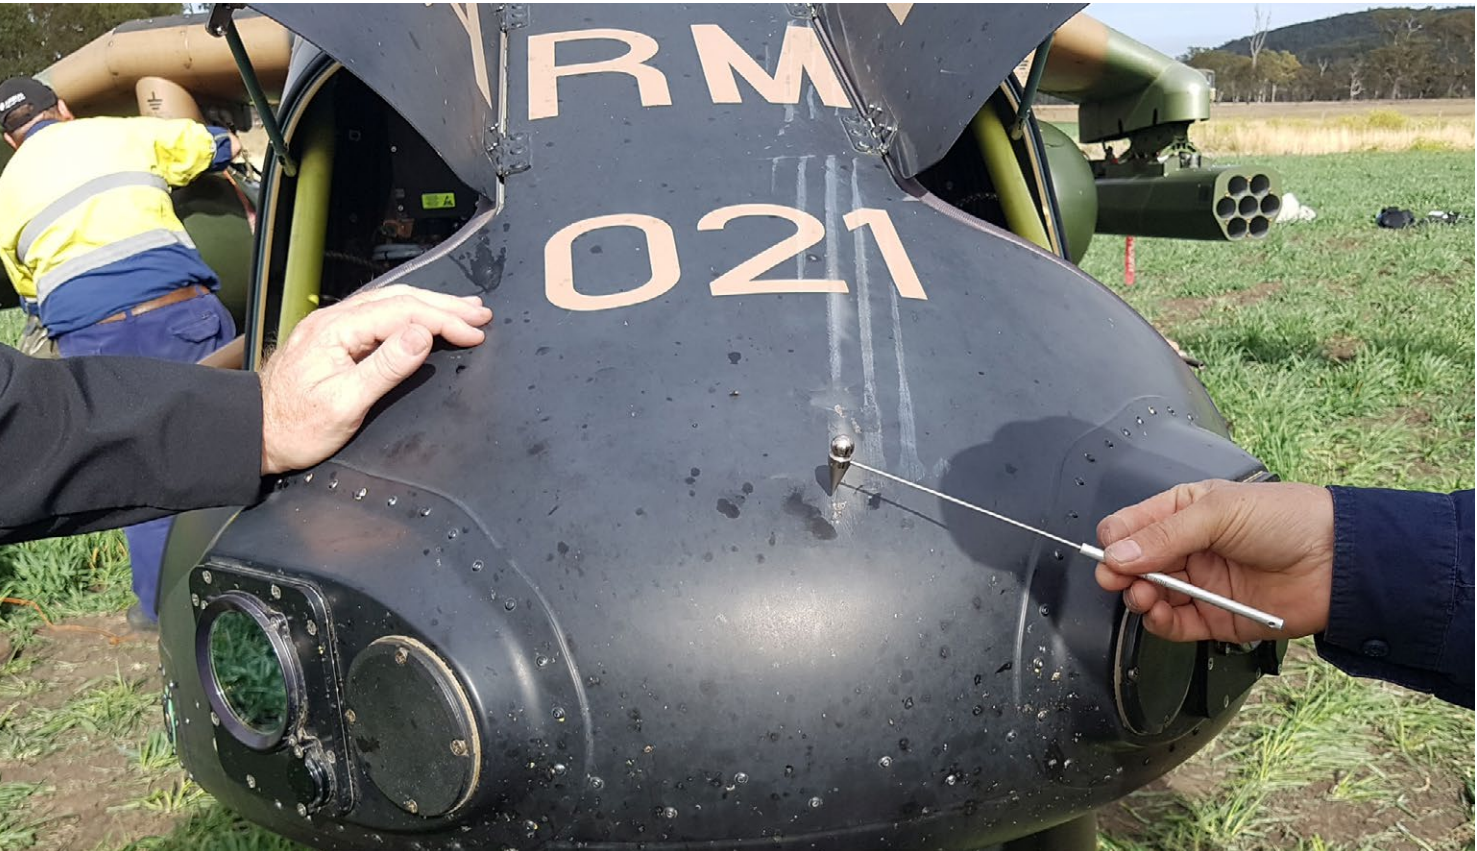
Tap test to nose section

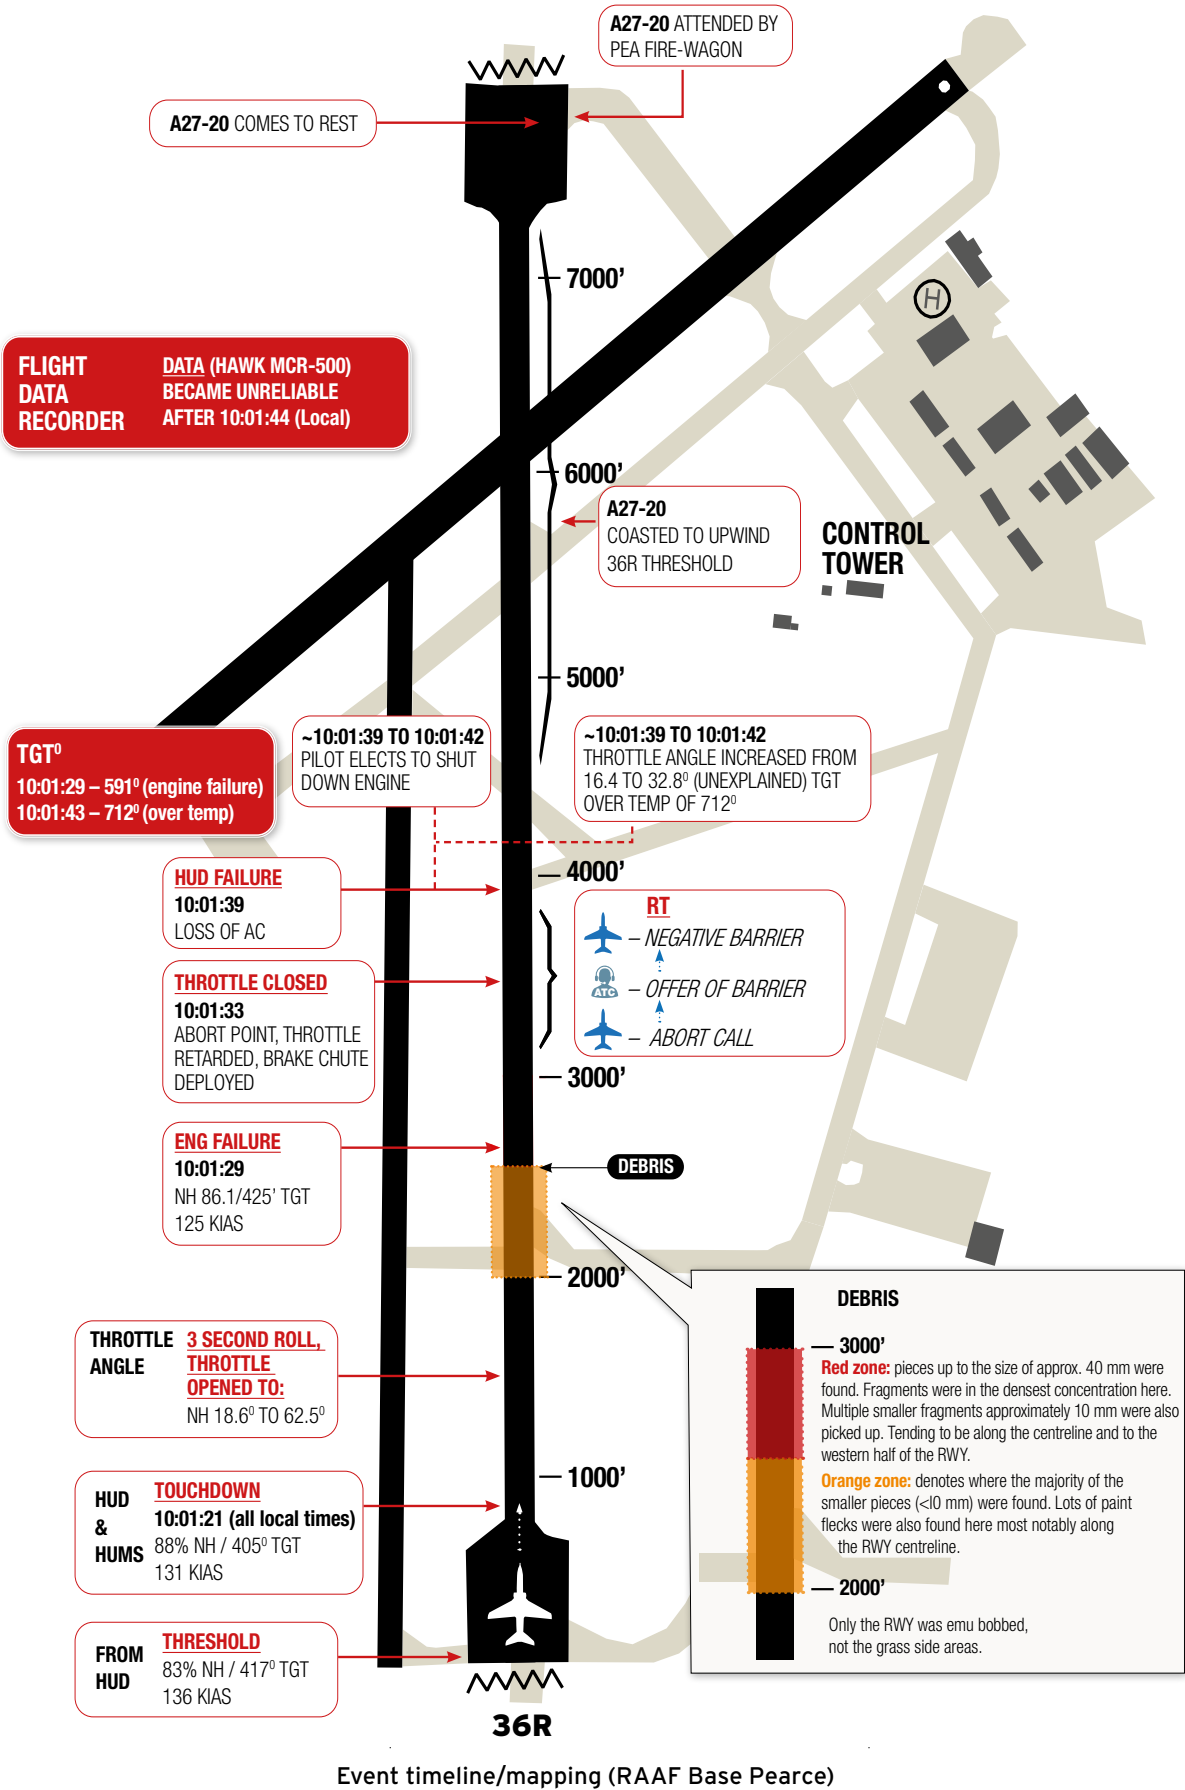
Installed engine inspection. Visual examination of the engine’s intake identified scoring marks to the outermost tips of a number of fan blades.¹⁴ Examination down the exhaust revealed

severe damage to a number of the LPT blades, some of which had aerofoil loss down to the blade platform. BAE’s borescope identified a fractured blade that had separated in the firtree below the platform.

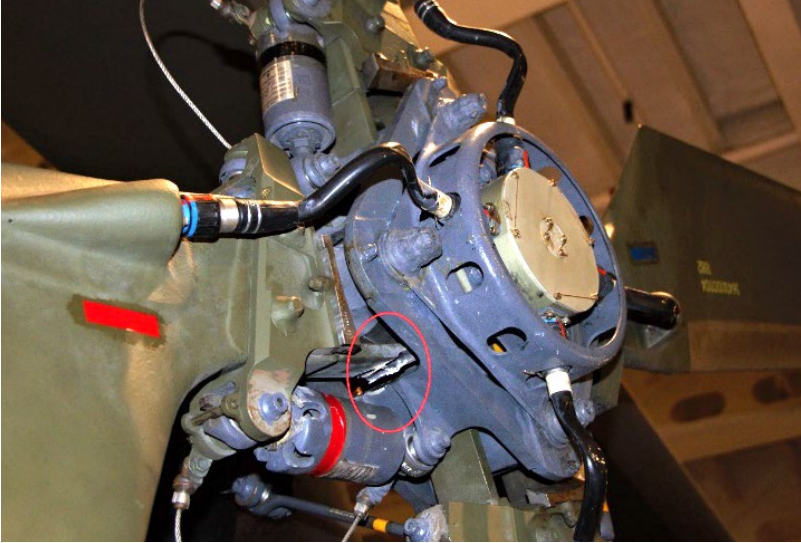
Red-blade roving strap showing impact damage

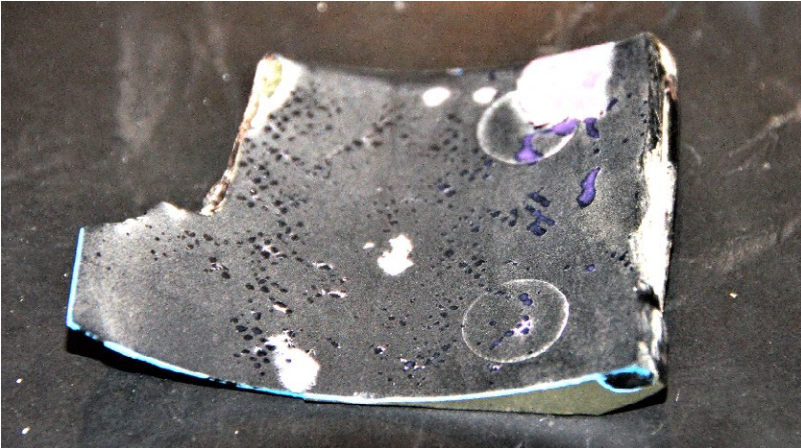
Portion of the detached locking stop showing signs of disbonding and evidence of wear
