SPECIAL EDITION: THE HOW AND WHY
SUMMARISING DFSB'S RECENT INVESTIGATIONS

02 2022
EDITION

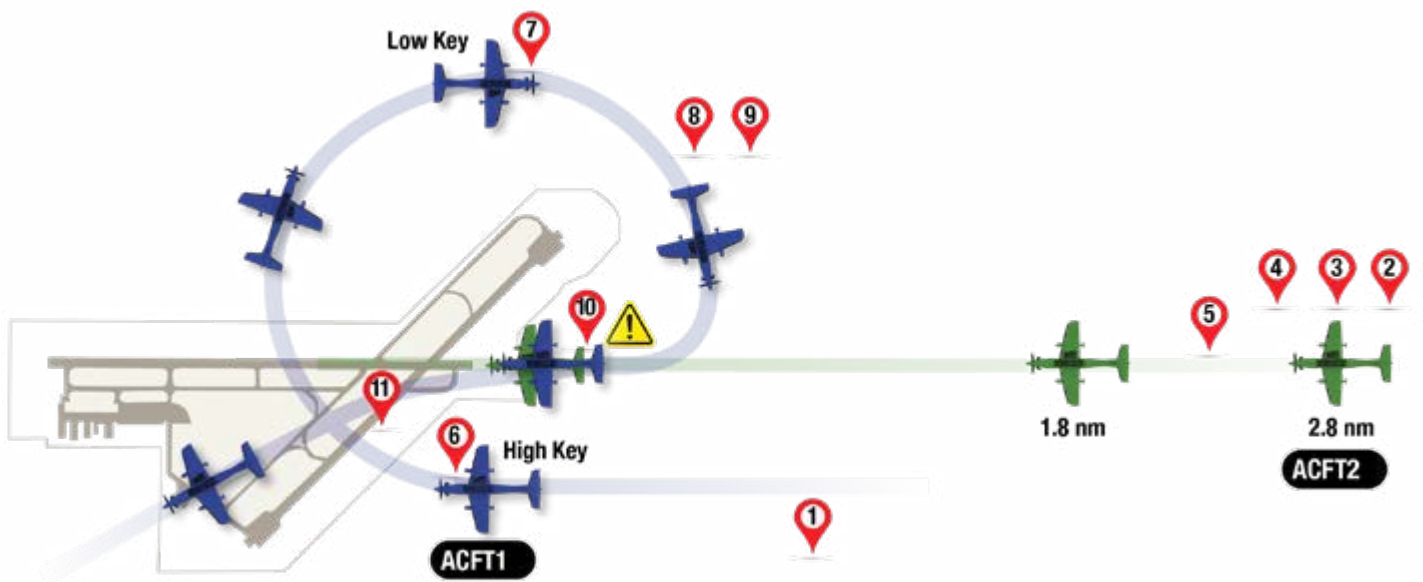
Figure 1. Timeline of events

Time	ACFT1  	TWR CONT  	ACFT2  
1	05:41:11	"ACFT1 approaching High Key"		
2	05:43:18		"ACFT1, traffic is ACFT2 on a 2 mile final"	
3	05:43:24			"ACFT2 3 mile, 3 greens, touch and go"
4	05:43:32		"ACFT2 cleared touch and go, check wheels"	
5	05:43:35			"Cleared touch and go, ACFT2"
6	05:43:40	"ACFT1 High Key"		
7	05:44:12	"ACFT1 high base, 3 greens touch and go"		
8	05:44:15		"ACFT1 number 2, check wheels"	
9	05:44:22	"Number 2, ACFT1, then <Landing Gear Tone>"		
10	05:45:08		  "ACFT1 Safety Alert, Go around Now."	
11	05:45:12	"Going around ACFT1"

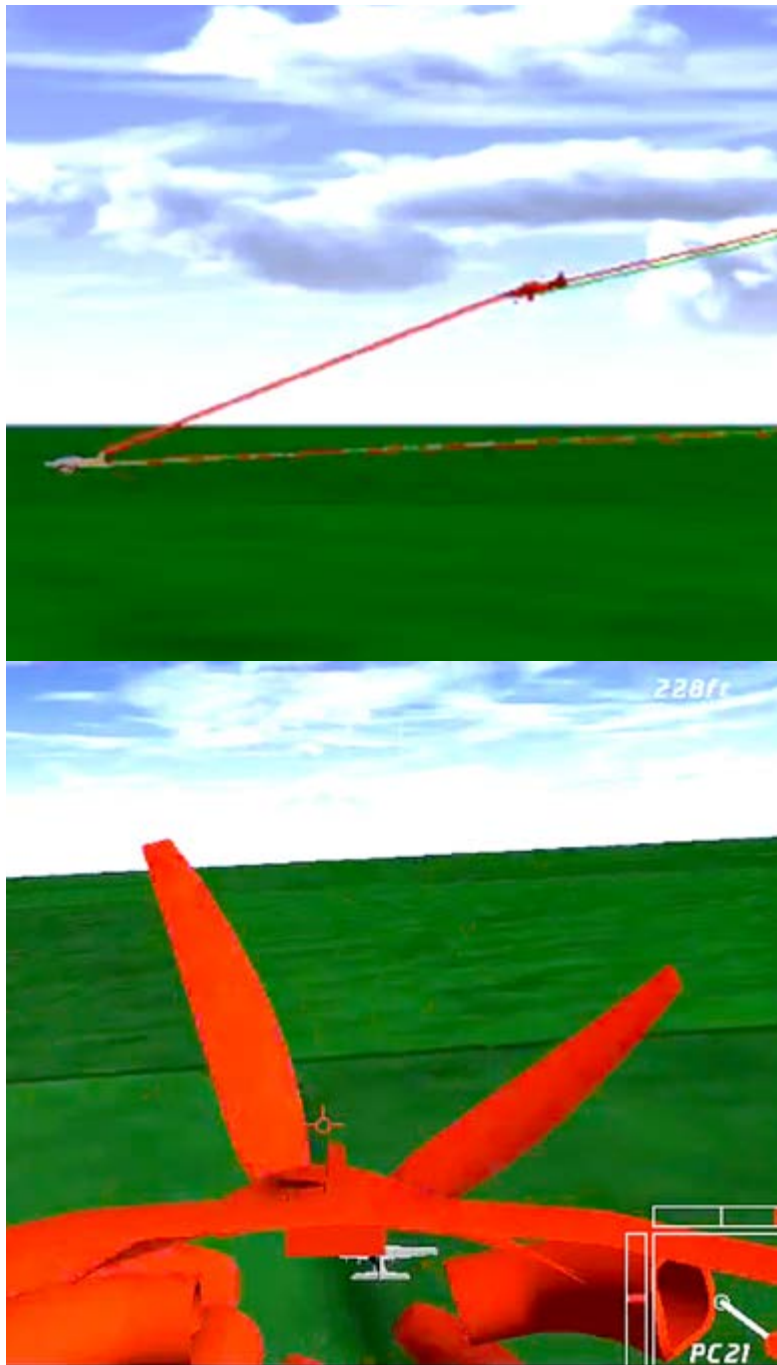
Defence Science and Technology recreation of near collision

During the event PFL, ACFT 1 experienced an average wind of 35 kts from approximately 250 degrees magnetic, with a maximum of 40 kts shortly after reaching LK and minimum of 20 kts once aligned with the landing runway. This required a significant correction of angle of bank by the student pilot between HK and LK in order to maintain the ground track required to reach the runway (45 degrees, vice 30 degrees in nil wind). It also compressed the timeframe in which the PFL was conducted.

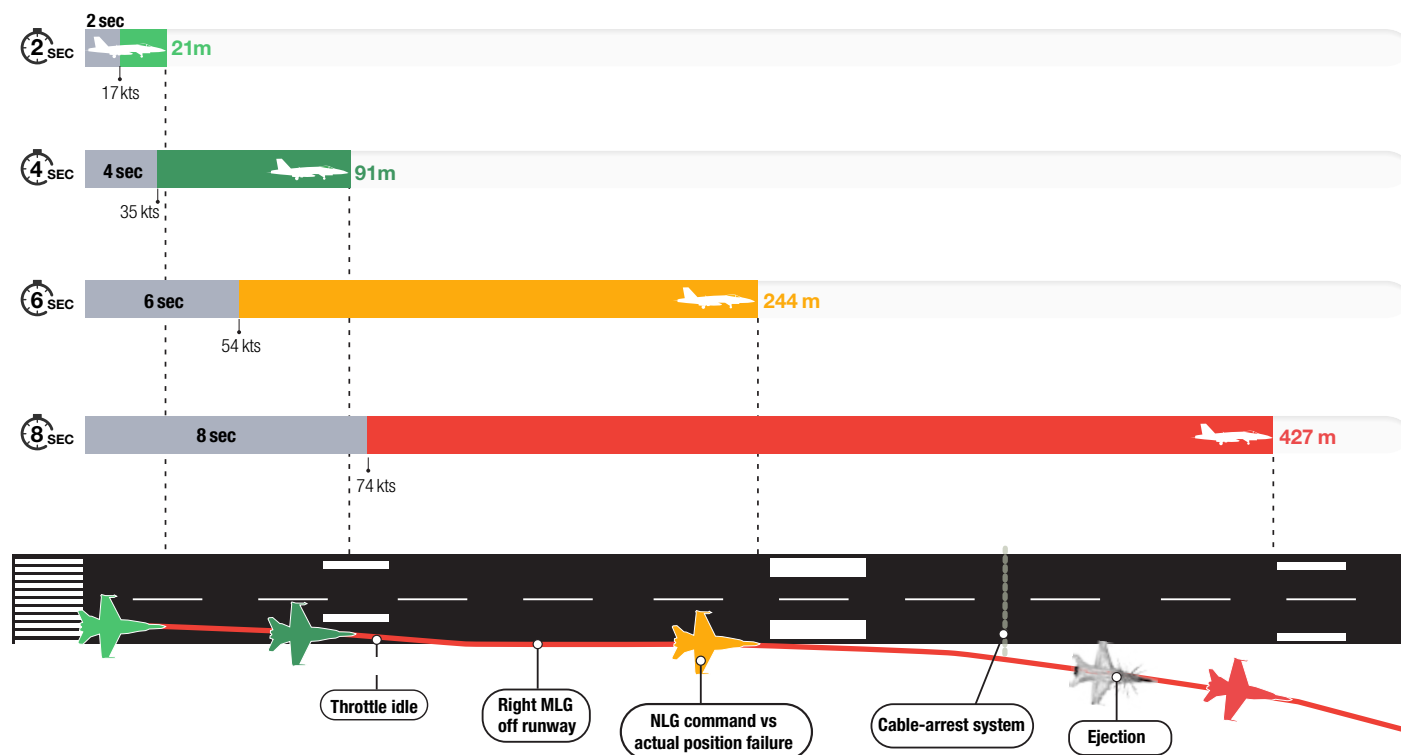
Impact of abort decision on stopping distance

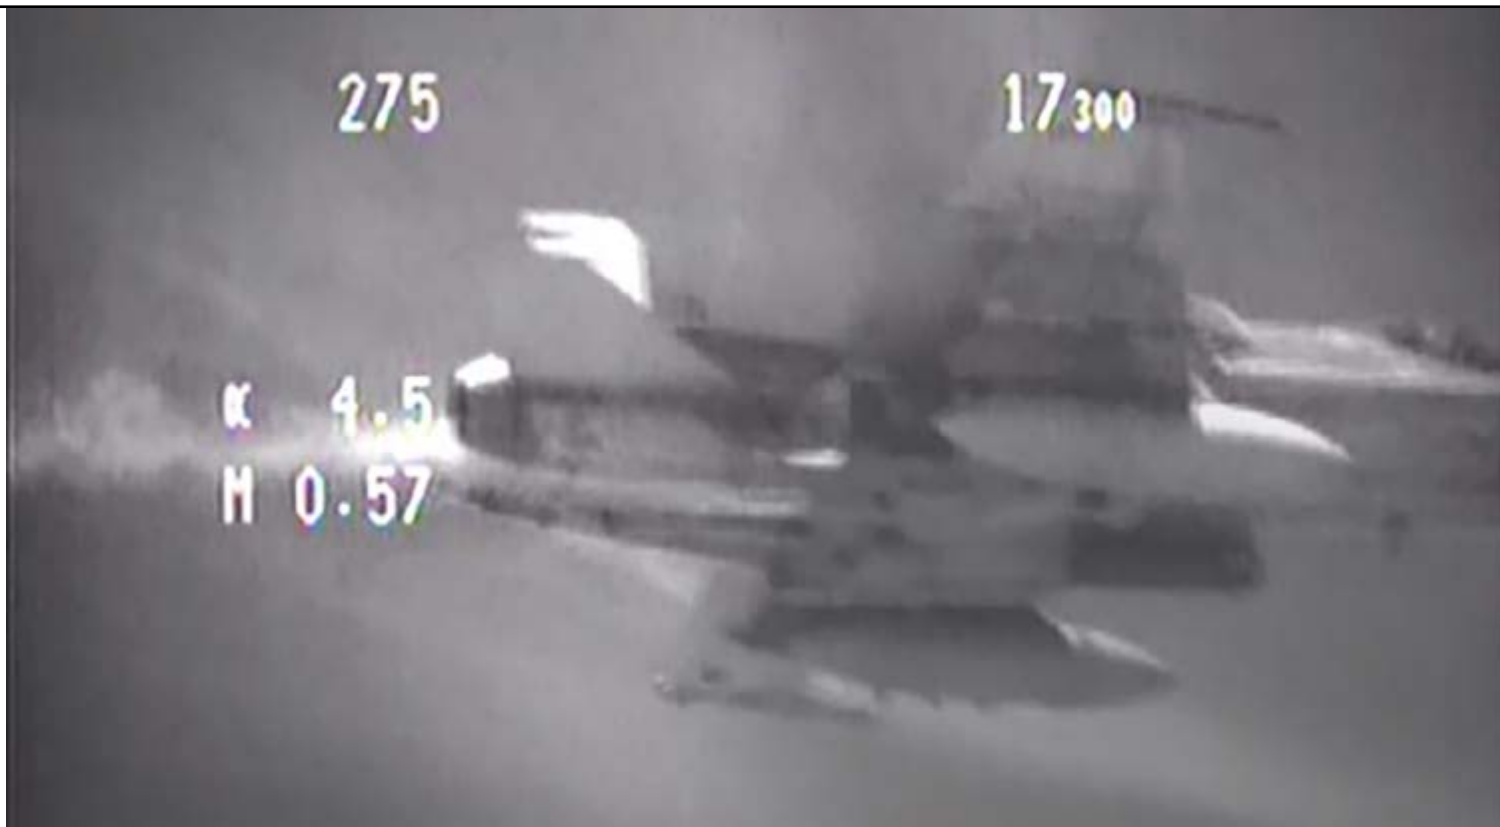
Observed vapour trail of ACFT 1

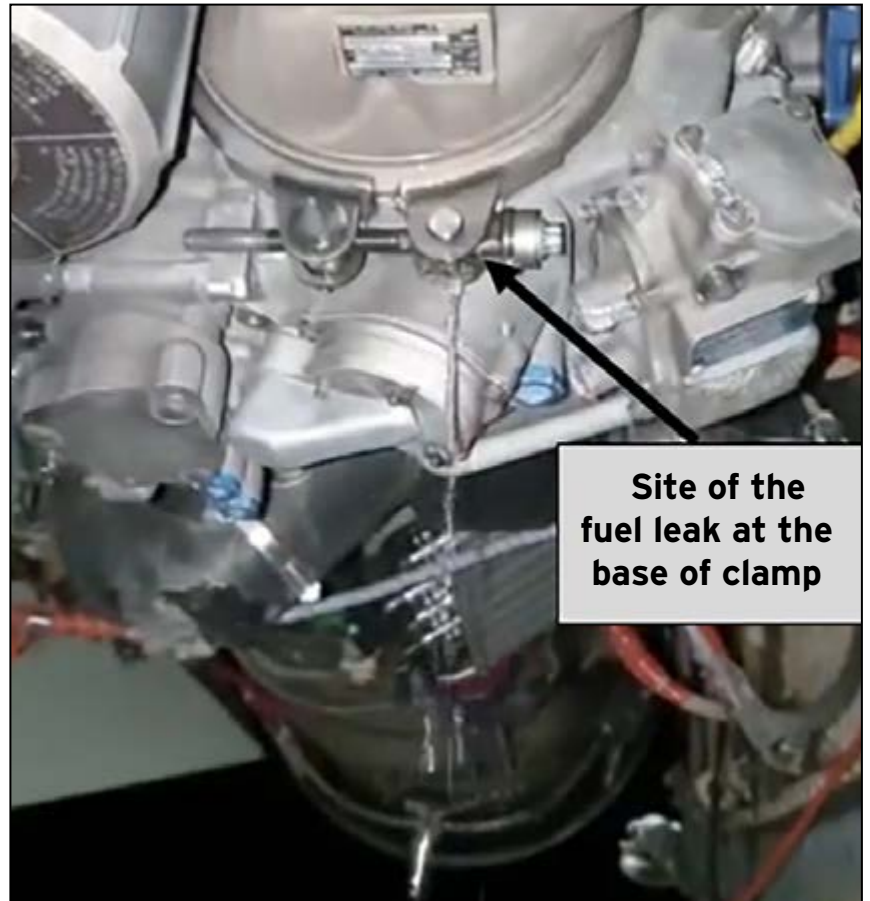
The ASIT concurs with the DST finding that the damage incurred to the three O-rings is very likely the primary cause of the fuel leak, discounting the initial determination that the loose clamp was the most likely causal factor.

Prior to the arrival of the investigation team and, in consultation with DFSB, the maintenance organisation carried out a preliminary inspection to ascertain where the fuel leak originated. This was determined to be at the base of the securing clamp, (6 o'clock position), between the interface of the main fuel pump (MFP) and the main fuel control (MFC). Once this was established and the aircraft deemed safe, it was placed into quarantine pending further investigation.

Site of the fuel leak at the base of clamp

In response, TAE released a Special Technical Instruction (STI) to determine the level of torque applied to the clamps securing the MFP to the MFC across the fleet. After implementing the STI, it was found that more than 50 per cent of the installed clamps did not achieve the designated criteria for their correct installation.

Due to the instigation of the STI, a selection of under-torqued clamps that had failed the STI criteria were removed from service and sent to DST for further analysis. The remainder of the clamps that had also failed the STI were re-torqued to 105-115 inch lbs in location and remain in service.

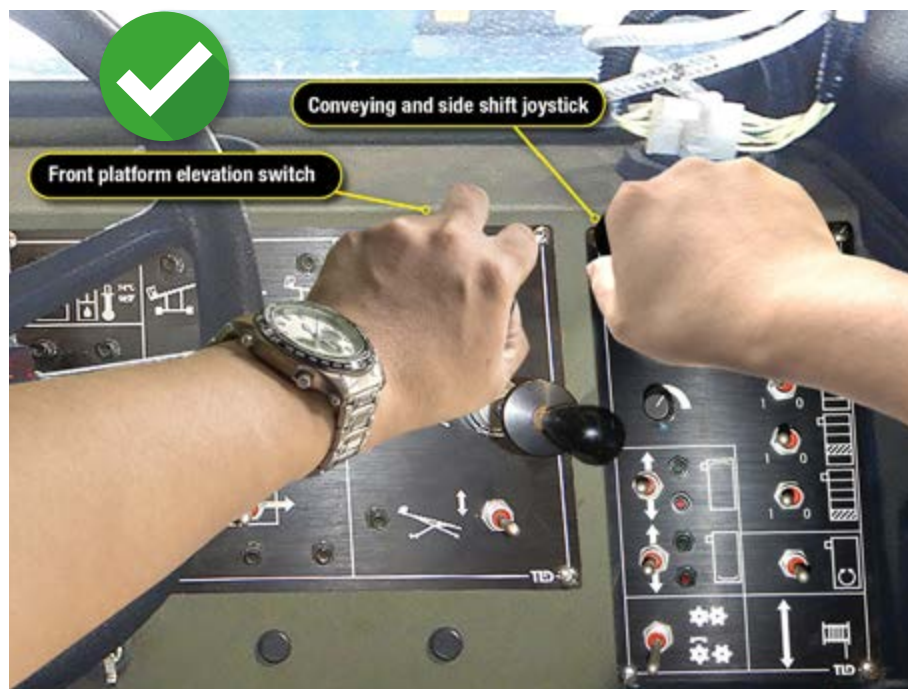
Correct switch selection for cargo deck adjustment

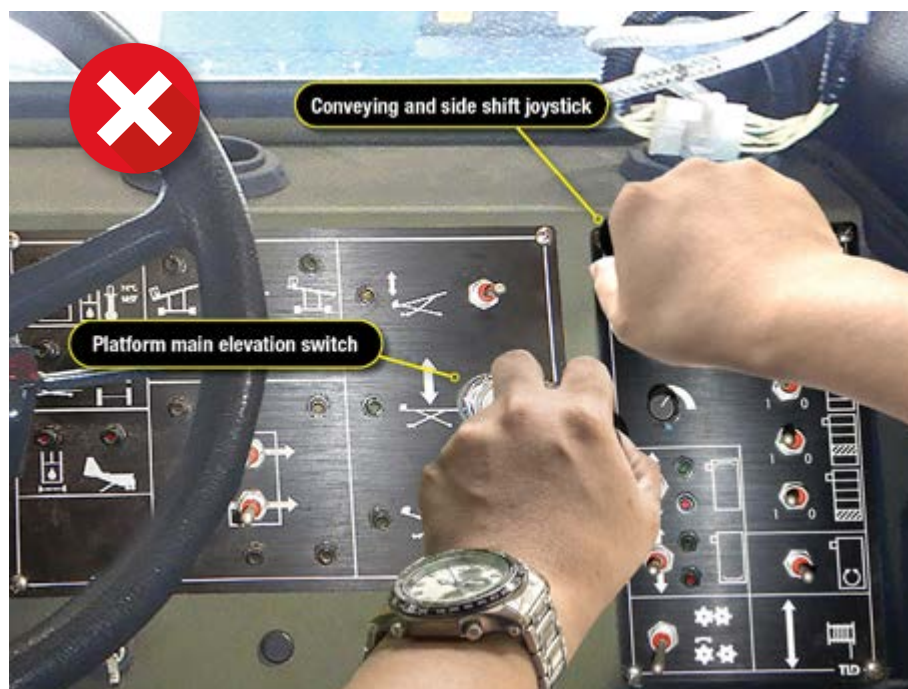
The C-17 arrived on schedule and the unload of passengers went as planned; however, while unloading cargo from the rear ramp of the aircraft, a 4100 lb (1860 kg) pallet unintentionally departed the rear of the PFA-50 and fell approximately 1.5 m before landing inverted on the

Incorrect switch selection for cargo deck adjustment

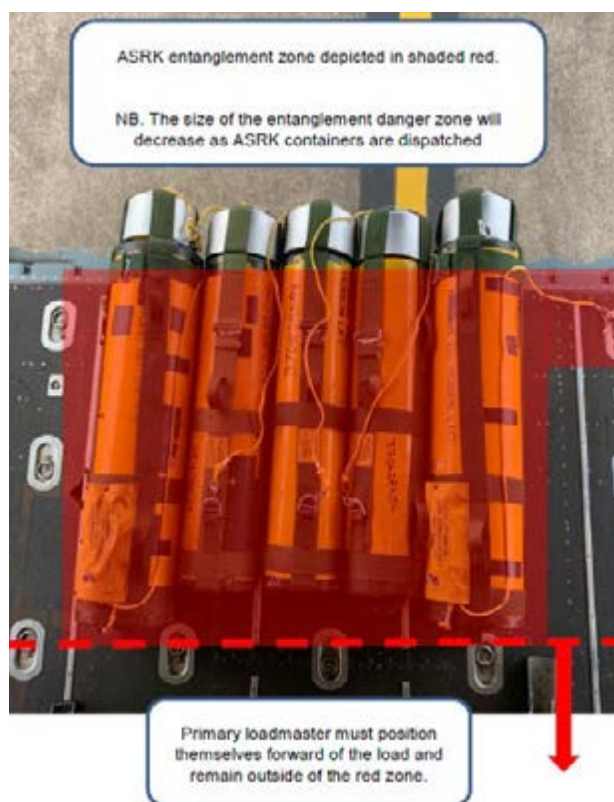
Figure 1. ASRK entanglement zone

Figure 1 (page 32) shows the ASRK entanglement zone as it was during the incident. Figure 2 (page 32) depicts the amended rigging procedure which ensures that the tie-down rope is no longer able to flap around in the airflow and no longer poses an entanglement risk.

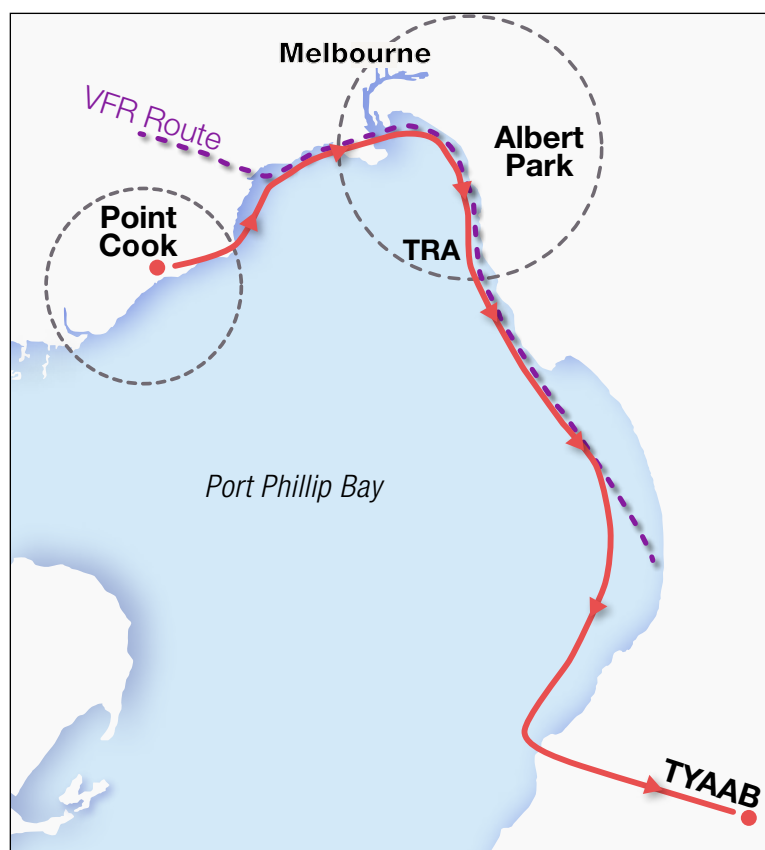
Approximate planned track of the Mustangs

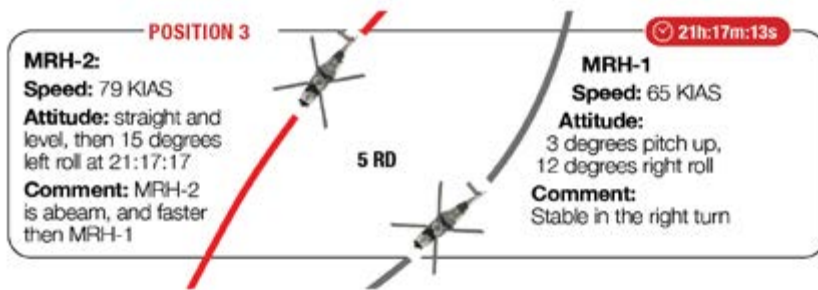
Figure 5. Position 3 of event sequence

Following the high angle of bank, the FP of MRH-2 rolled out of the turn, re-establishing the aircraft to approximately straight and level flight.
