**SPECIAL EDITION: THE HOW AND WHY**  
AVIATION SAFETY INVESTIGATIONS

# *Spotlight*

### **Investigation Special 2026**

Nine expert articles exploring flight-safety incidents,  
contributing factors, and their lessons for Defence aviators

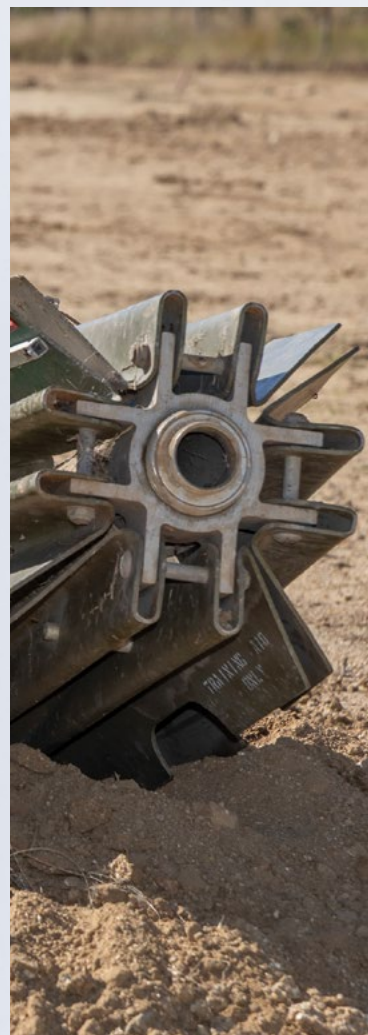
An unexploded Mk82 weapon, partially buried on impact

A mechanical fault in BRU-32 MQJ164 caused the uncommanded release. Deficiencies in the hook-latch springs were the likely cause.

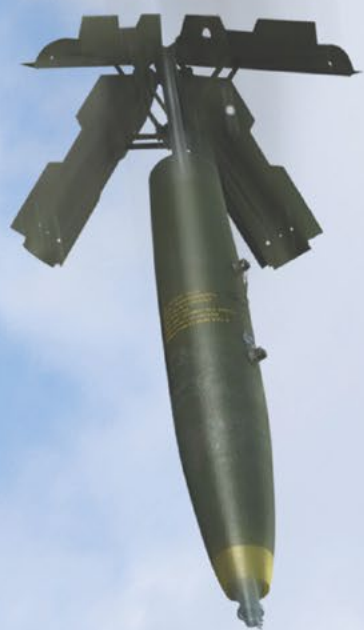
This asset had a history of similar issues. MQJ164 was linked to a 2012 uncommanded release and multiple earlier partial unlocks.

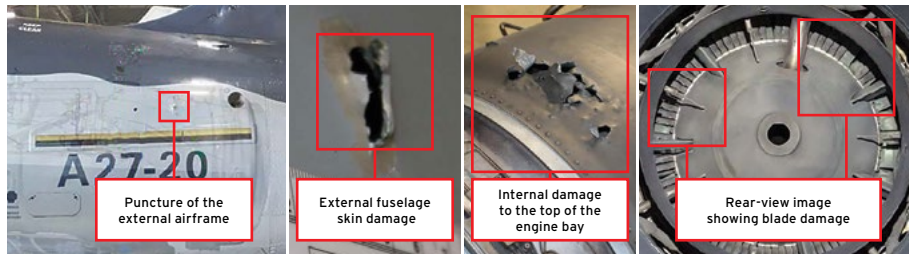
**Figure 1: Catastrophic engine damage to a Hawk in 2019**

The trainee would have been conscious of a recent RAAF Hawk catastrophic engine failure that occurred on 14 May 2019. This aircraft experienced an Adour Mk871 catastrophic engine failure during a touch-and-go take-off roll at RAAF Base Pearce. Onsite visual inspection of the engine identified damage to the low-pressure turbine, where a number of blades appeared to have been released. The fuselage of the aircraft had been punctured in one location on the left-hand side of the engine bay, and further non-penetrative damage was identified in the skin of the aircraft (Figure 1). The Mk951 engine-replacement project has re-engined the Hawk fleet and eliminates Mk871 engine risks.

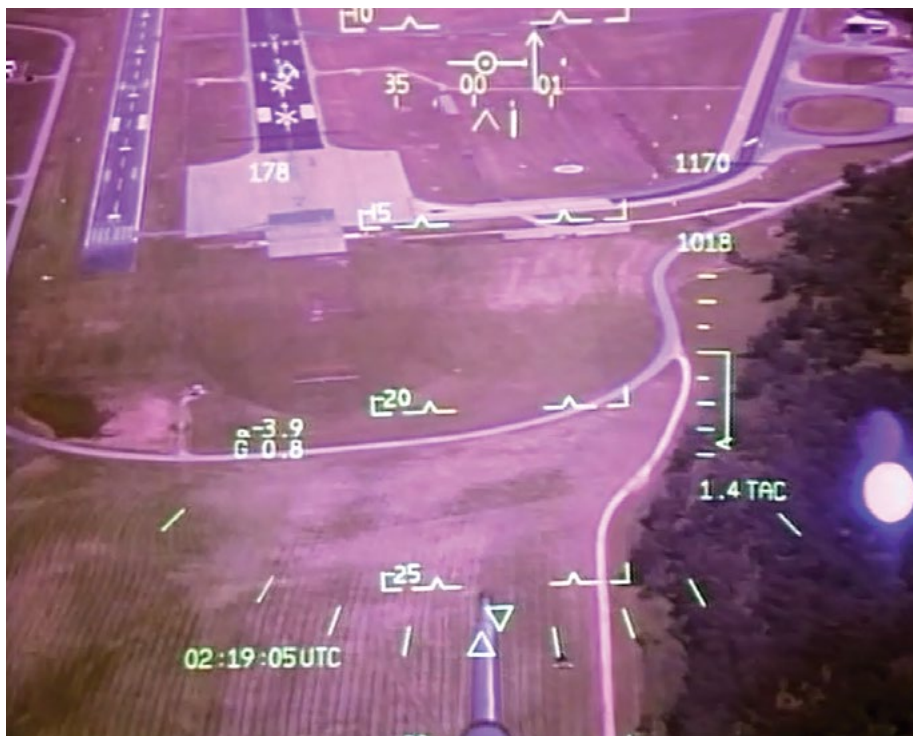
**Figure 2: The approach to the runway: 1.1 nm**

This negative angle of attack (~2-3 degrees at touchdown) resulted in the nose wheel touching the runway prior to the main wheels and approximately 40 KCAS faster-than-normal landing speed for the aircraft weight. This resulted in initiation of the bouncing sequence

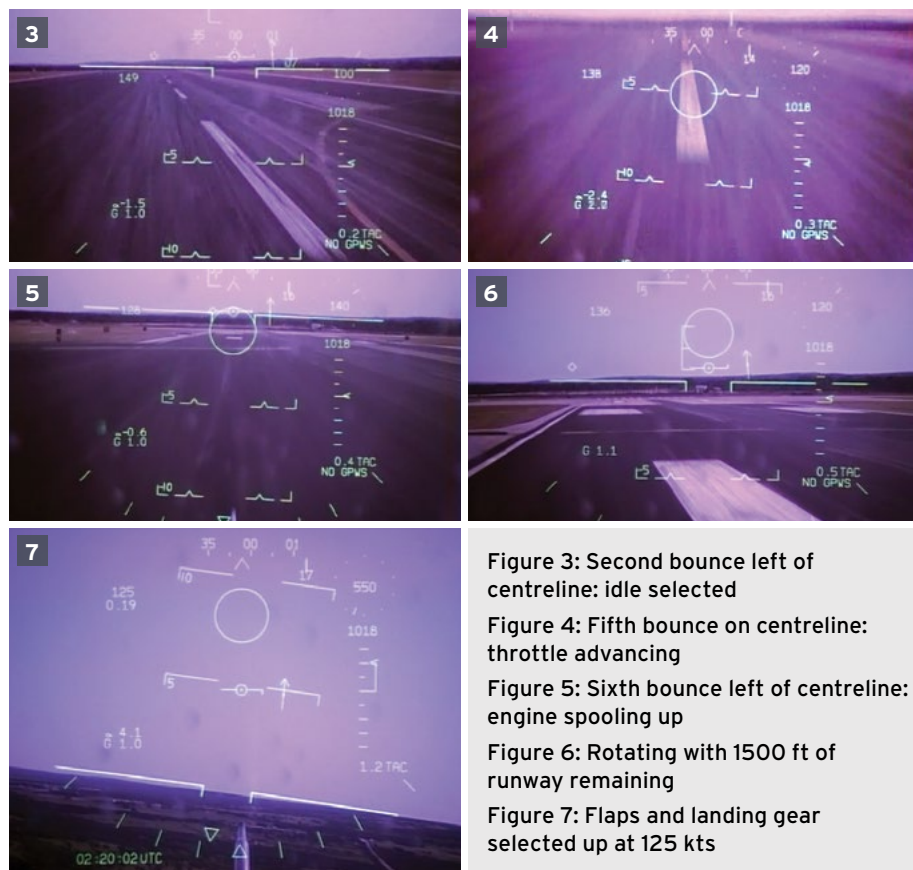
**Figure 3: Second bounce left of centreline: idle selected**

The residual aircraft speed versus remaining runway braking distance rapidly eroded any chance of bringing the aircraft to a safe stop off the initial landing attempt. While it is highly undesirable for a suspected engine-damage scenario to result in reselection of maximum power, this was effectively the only action remaining available to the trainee other than ejecting during the bounce sequence.

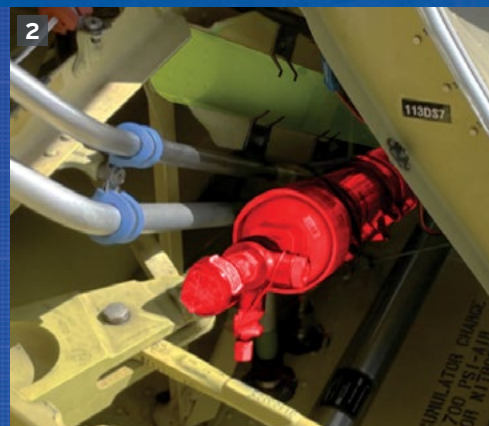
The formation then flew to Gold Coast Airport to refuel. While conducting an inspection on the helicopter, the AT discovered that the wheel-brake accumulator gauge cover was cracked. It quickly became apparent to the AT that the accumulator itself had dislodged from its mounting brackets

and was sitting freely on the flight-control rods in the upper-forward pylon of the Chinook. The crew assessed that the accumulator had significant potential to interfere with or jam the flight controls, potentially setting the conditions for a catastrophic outcome. The crew raised a Class B aviation

Figure 2: The green area indicates where the accumulator should sit, while the red area indicates where it was found after breaking loose

dislodged as a result of a complete failure of two wide clamps that secured the accumulator to the airframe in the forward-pylon section of the aircraft. This failure was attributed to cracking of both of the wide clamps holding the accumulator in place.

The investigation found that the cracking of the clamps was likely due to the tension and bending loads created by the mismatch between the wide clamp's geometry and the position of grooves (designed to align with the clamps) on the brake accumulator. It is likely the cracks in the clamps began months prior to the safety event; however, they would have been very difficult to detect due to the positioning of the accumulator.

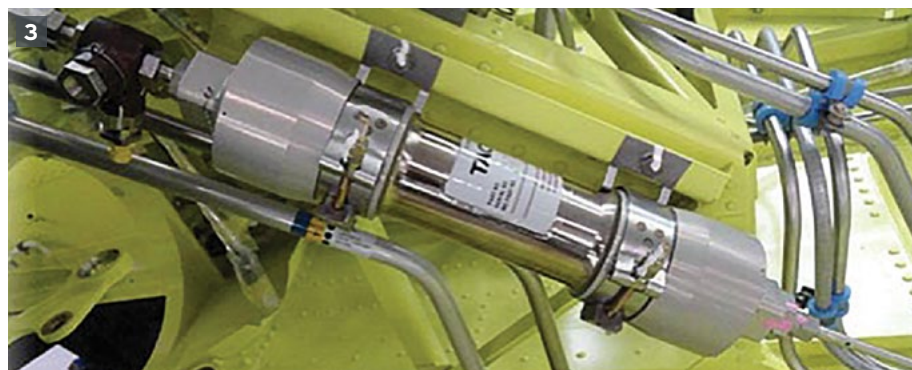
**Figure 3: Accumulator mounted with non-approved wide clamps (from Service Bulletin 724-29-1018)**

**Figure 4: Broken brackets from A15-306 (from the ASIR)**

*Although it is permissible to install or leave installed a suspect and uncracked Clamp, Boeing recommends removing any suspect Clamp and replacing it with an authorized Clamp as soon as authorized clamps become available. ▀*

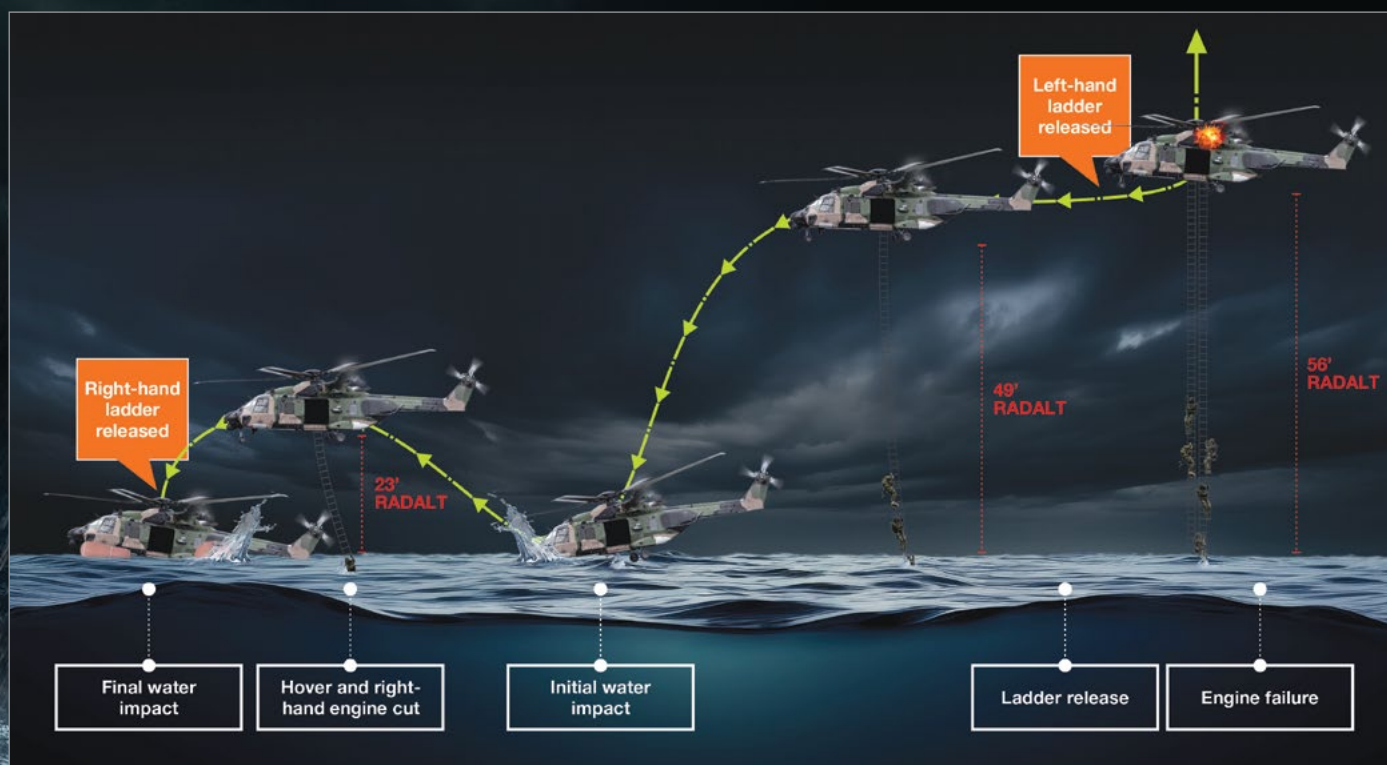
Figure 1. Aircraft flight profile following its left-engine failure

In the seconds that followed, the aircraft's right-hand engine automatically entered its maximum One Engine Inoperative power rating, and the flying pilot slowly transitioned forwards in an attempt to clear the divers below<sup>1</sup>. However, main-rotor speed began to decay as the single-engine power was insufficient to prevent the aircraft from descending towards the water. The crew attempted - but failed - to activate the Emergency Flotation System, and only one of the two diver ladders was released in time. The right-hand aircrewman, operating with night-vision goggles (NVG) in a dark cabin, was unable to locate and operate the release mechanism in time, causing the divers on that side to be dragged unexpectedly through the water.

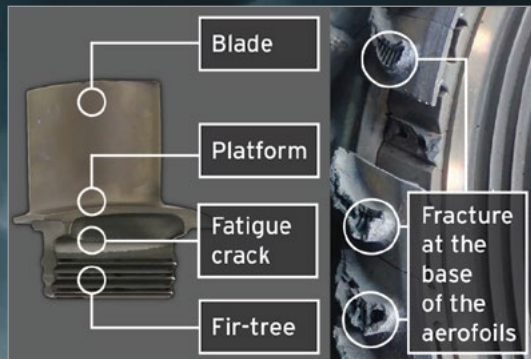
**Figure 2: HP1 blade anatomy and damage**

The root cause of the engine failure was the rupture of a single blade from the high-pressure turbine 1 (HP1) wheel in the left engine. Defence Science and Technology Group confirmed that the failure of Blade 34 from the HP1 wheel occurred due to a fatigue crack initiating beneath the blade's platform at the top of the third fir tree (Figures 2 and 3). As a consequence of this blade failure while operating at high speed, the detached Blade 34 caused secondary damage and separation of the remaining blades of the HP1 wheel (Figure 2). The blade debris then travelled

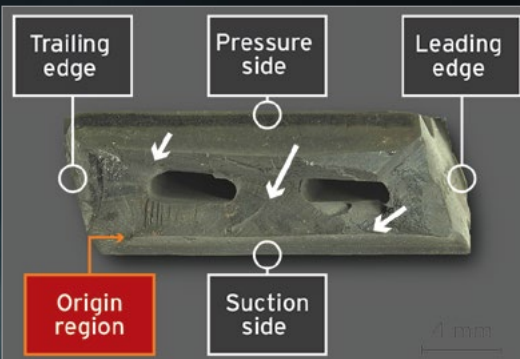
**Figure 3: Blade 34 fracture surface**

Although this was the first such failure experienced by an Australian MRH-90, the issue had been previously identified across the global NH90 fleet. In 2017, the engine's original-equipment manufacturer issued a service bulletin recommending - but not mandating - replacement of HP1 blades. Defence accepted the manufacturers' assessment that the design safety case remained within certification limits and chose
