Foreword

DF
/ 11131	
4	Growler unconta engine failure
9	Black Hawk rotor
16	PC-9 near miss
24	Bell 429 loss of c
30	C-17 load shift
34	Bell 429 cockpit f

the aviation safety magazine of the Australian Defence Force

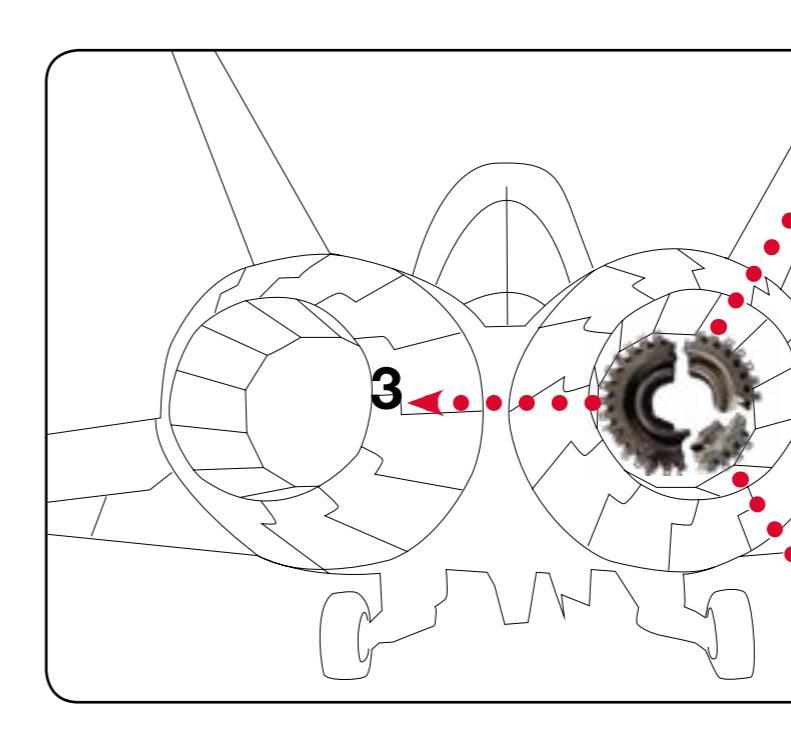
Approximate course of travel – first-stage disc

Segment 1 was ejected through the engine casing and airframe directly into the runway beneath the aircraft. Segment 2 was located on an adjacent runway approximately 1000 feet to the right of where the right-hand engine initially failed. Segment 3, the largest segment, was lodged in the intake duct of the aircraft's left-hand engine (having passed through several significant engineering/metallic structures in the process).

Segment 3, the largest of the ejected fan segments, punctured a hole in the left-hand engine casing and was recovered from between the lefthand engine inlet and left-hand intake device.

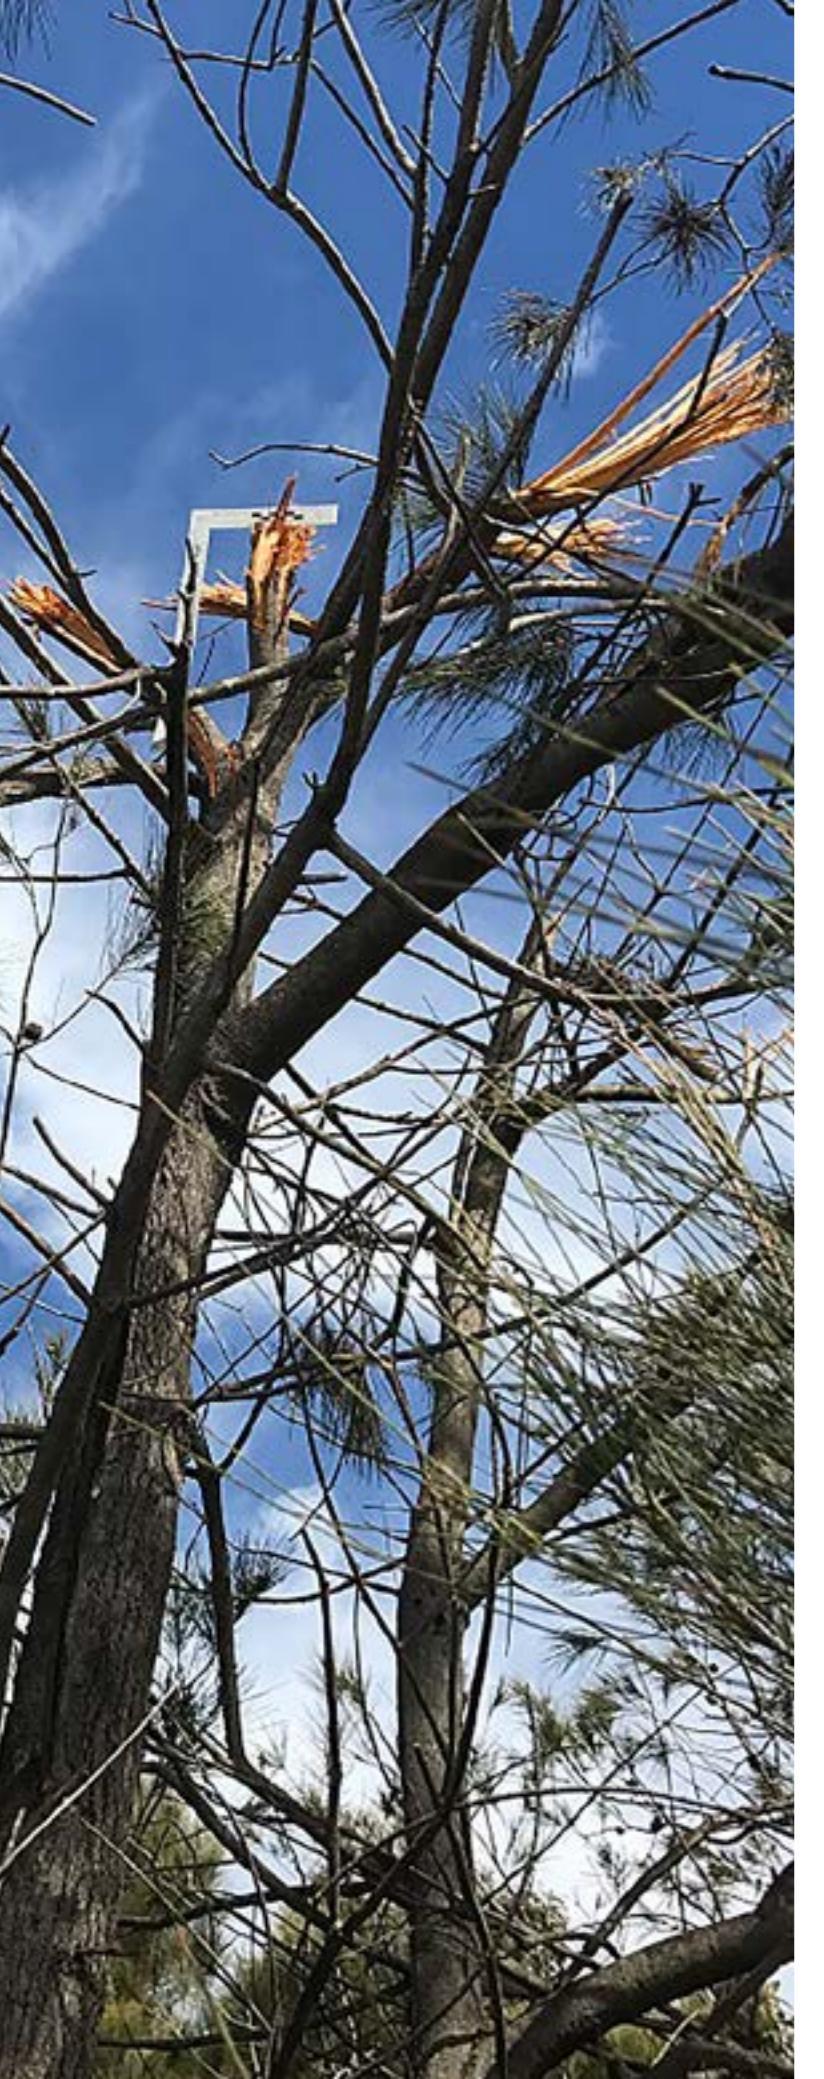
Left: The sheoak main trunk and branches following main rotor impact.

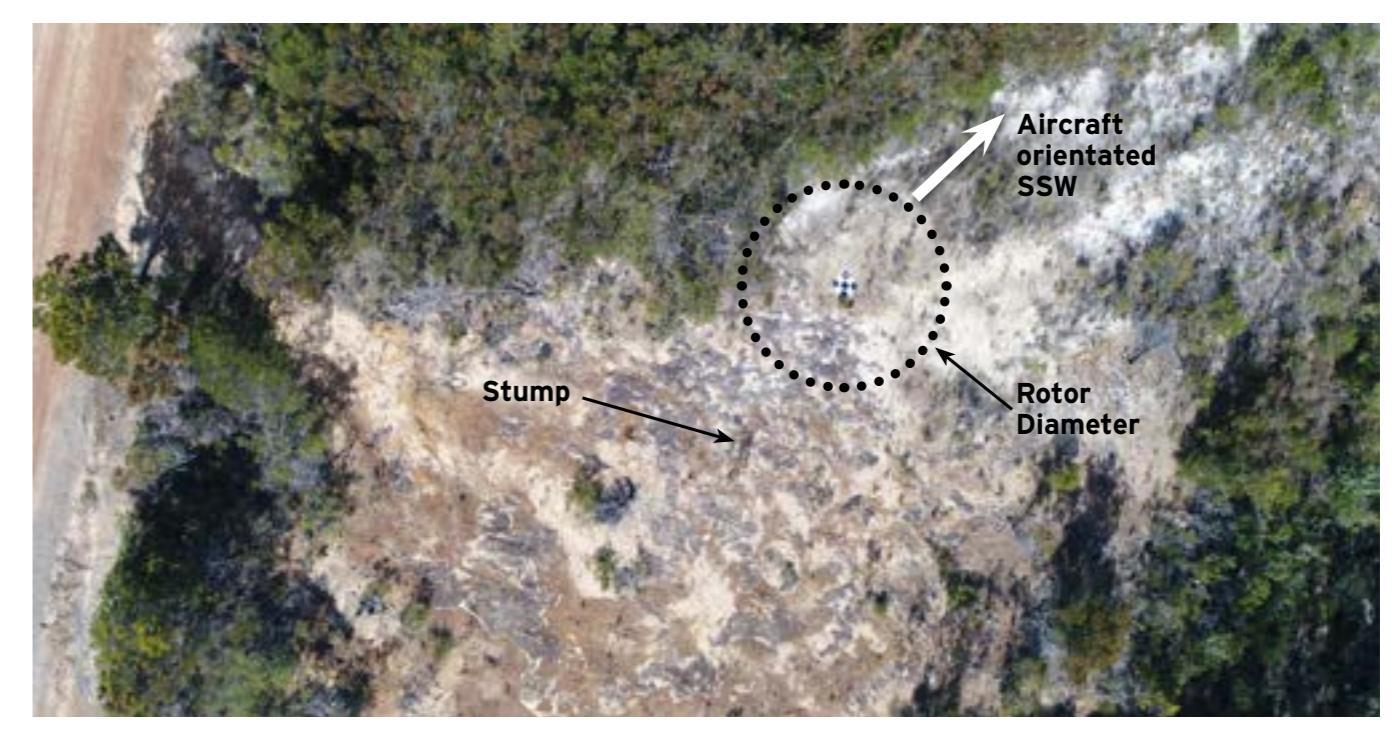
Top-down-view of Esky Pad showing the position of the aircraft and the stump located to the rear of the aircraft.

The confined area Esky Pad is an elongated confined area bounded by a gravel road to the east and vegetation increasing in height from three to five metres on the immediate boundary and 10 to 15 m within 20 m of the centre of the open space. Inspection of the confined area found that two trees had been impacted by the main rotor. The largest and most prominent was a 15- to 20-ft tall sheoak, with a diameter of up to 70 mm at point of impact.

The second was a single 20 mm diameter eucalyptus sapling within the sheoak dripline. Damage to the upper canopy was consistent with a vertical descent onto both trees. The debris field consisted of splinter fragments of tree varying in size up to 20 cm in length extending from the nine o'clock through to four o'clock position based on an aircraft landing heading of 221. The main rotor contact ceased within 30 cm of reaching the larger diameter 200 mm main trunk

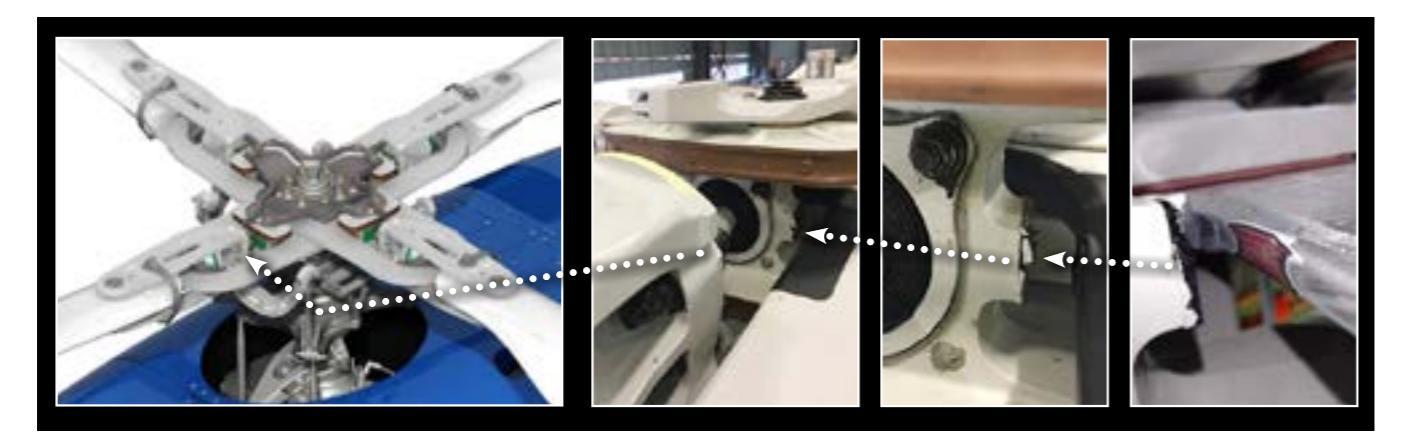
The aircraft sustained significant damage as a result of aerodynamic forces associated with the low NR and sustained collective application.

MRH lead-lag damper and yoke damage.

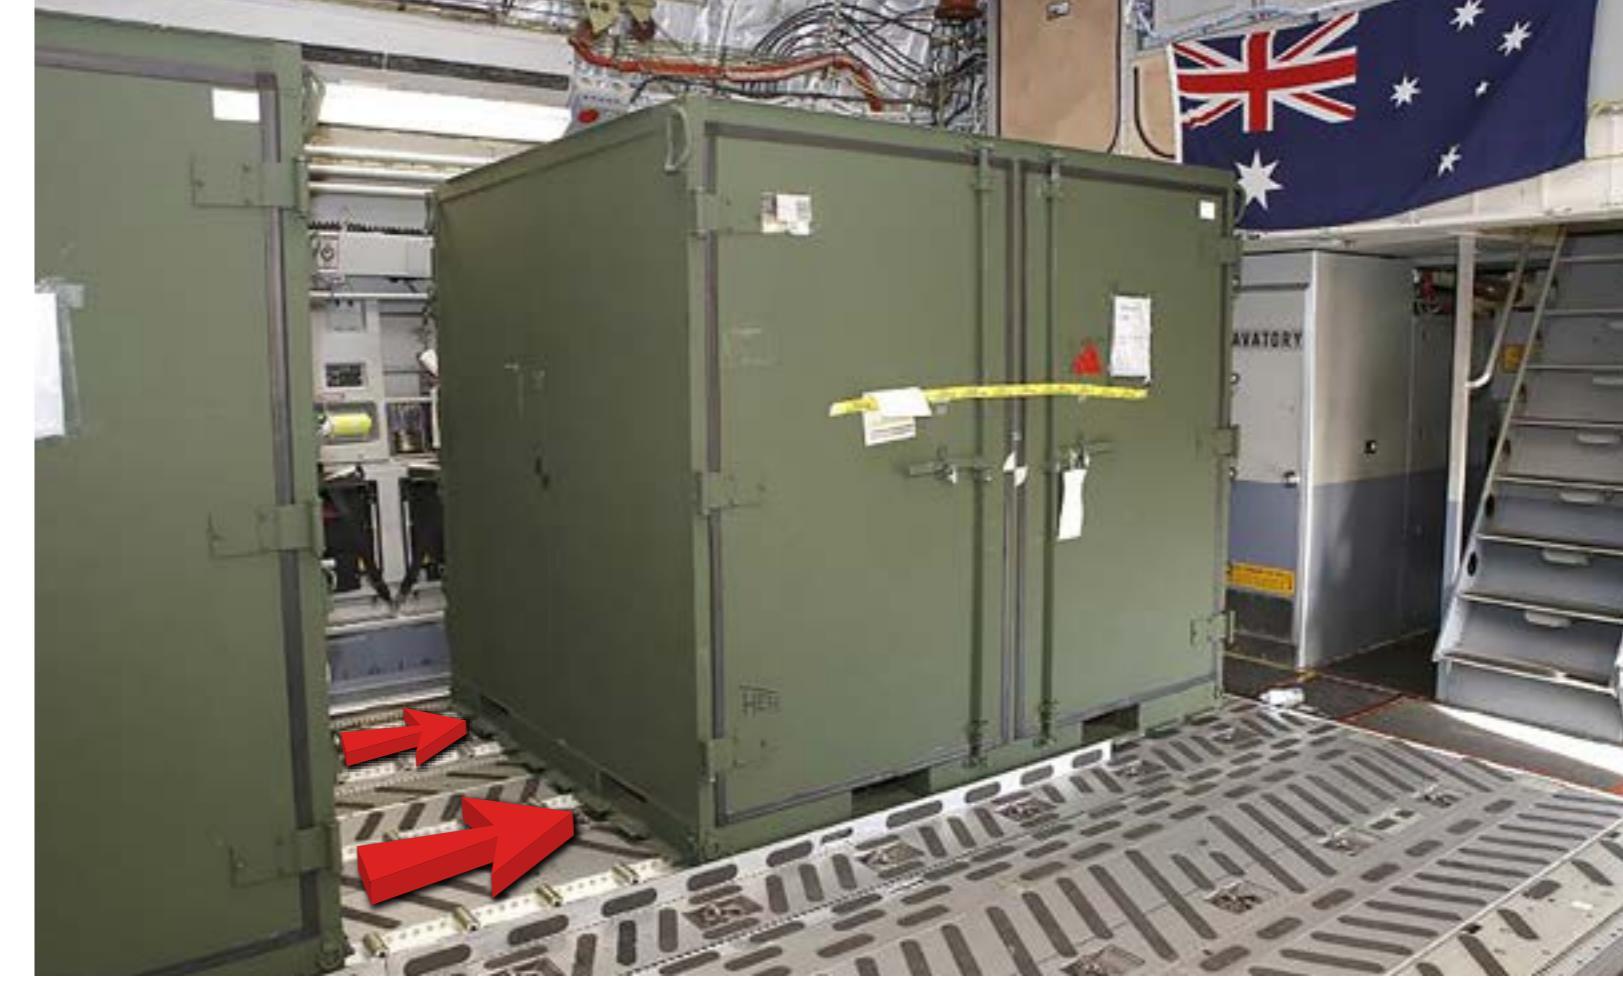
- The harder-than-normal braking during landing (noting that the landing was within the authorised operating envelope for the aircraft).
- The single lock available at P1L (noting that the P1L-C was authorised for carriage at P1L, and within the weight limitations of that position).

P1L-C after load-shift (red arrows indicate shift).

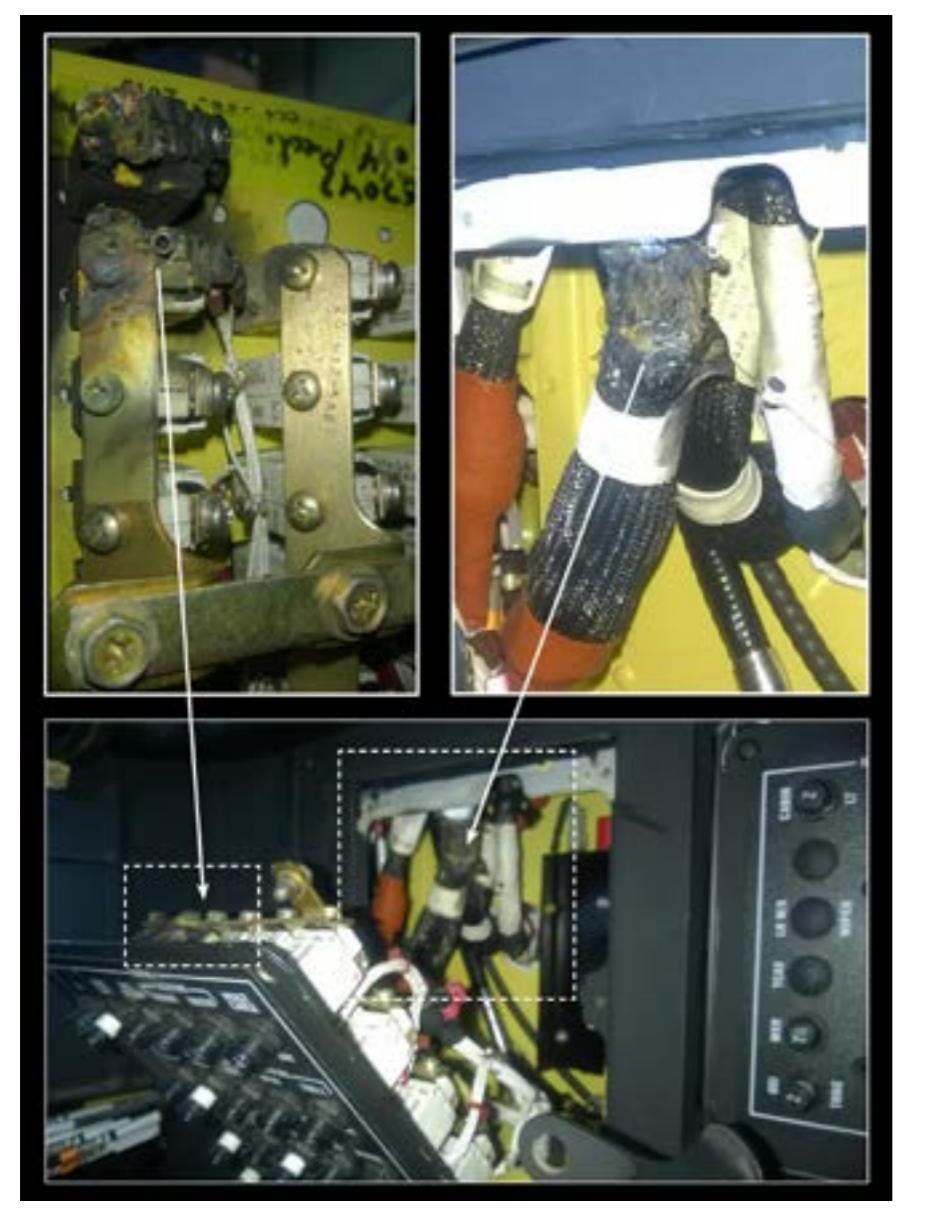
Damage to N49-047 showing damage to forward left circuit breaker and W101 loom assembly in the vicinity of connector 4296J9.

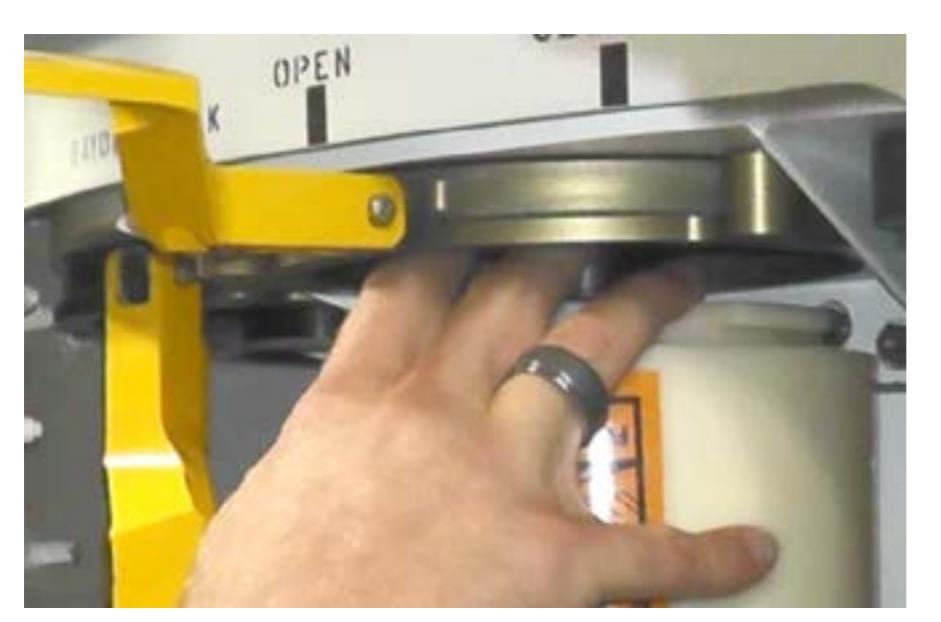
The Aircraft Maintenance Manual contains a procedure for opening and closing the SSL. Although open to interpretation, the procedure for closing the SSL appears to describe the

Fingers in crush zone.

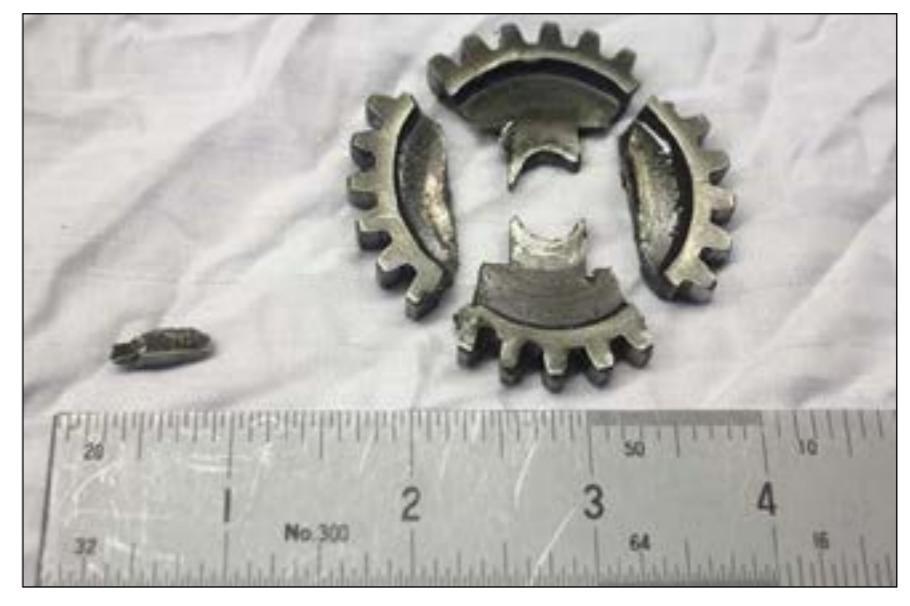
Failed oil pump drive gear and drive key.

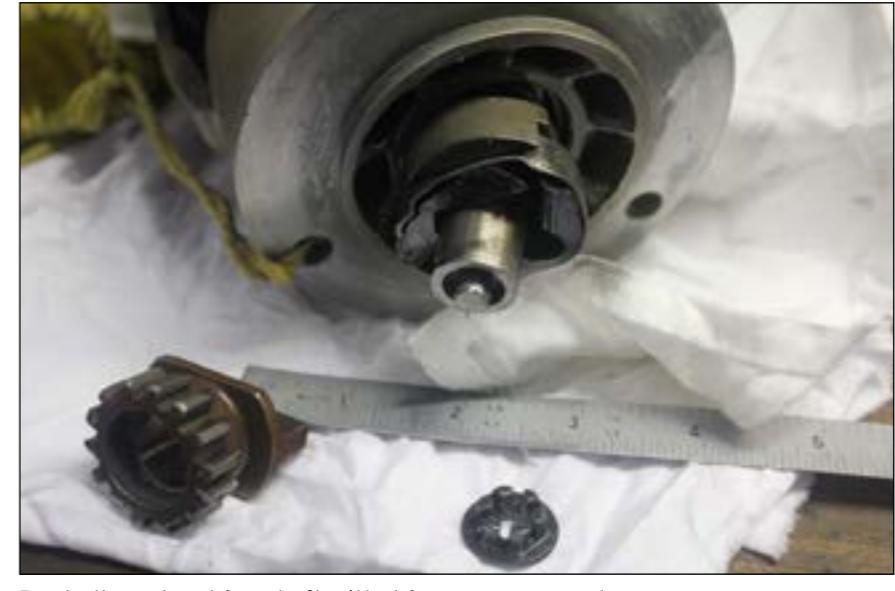
Bent alternator drive shaft with drive gear removed.

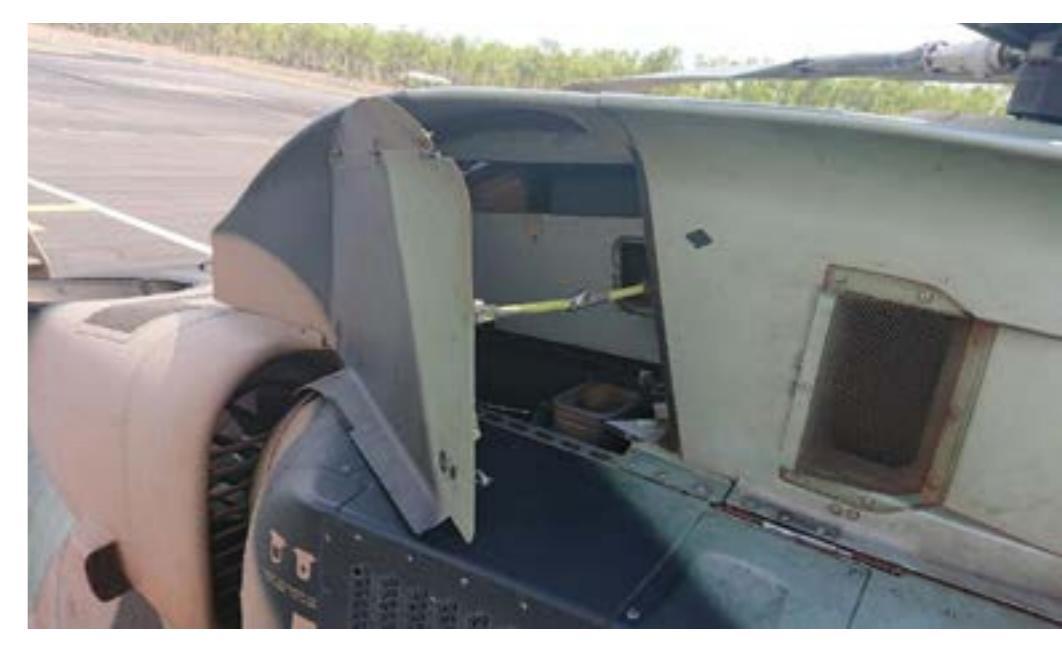
The inner fire panel was observed to be in the open position, with the fire panel retaining tab in the unlocked

The upper fixed cowling and right-hand access door damage.

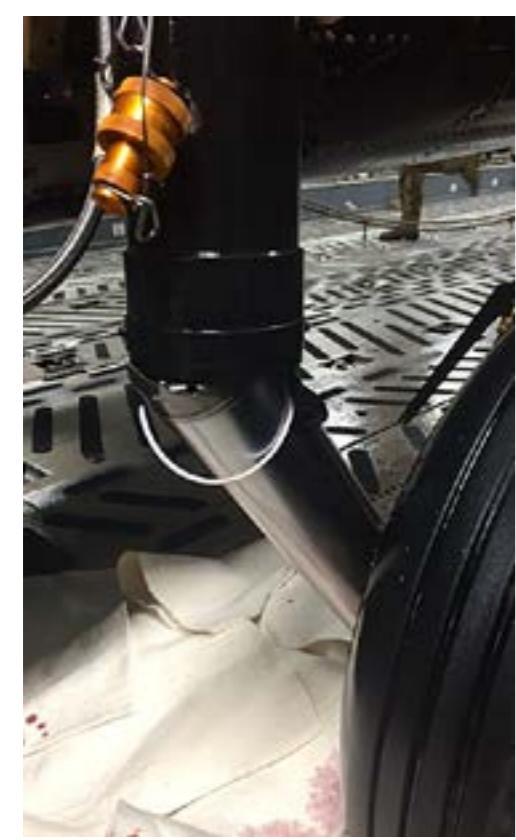
The failure caused a significant volume of hydraulic fluid to be expelled under pressure inside the C-17; spraying the Black Hawk and members of the maintenance team. This was subsequently documented in accordance with WHS policy. Fortunately, there were no injuries sustained and the C-17 was not damaged.

Upper and lower strut sections post separation.
