AVIATION SAFETY

Spotlight

01 2018

One crowded moment

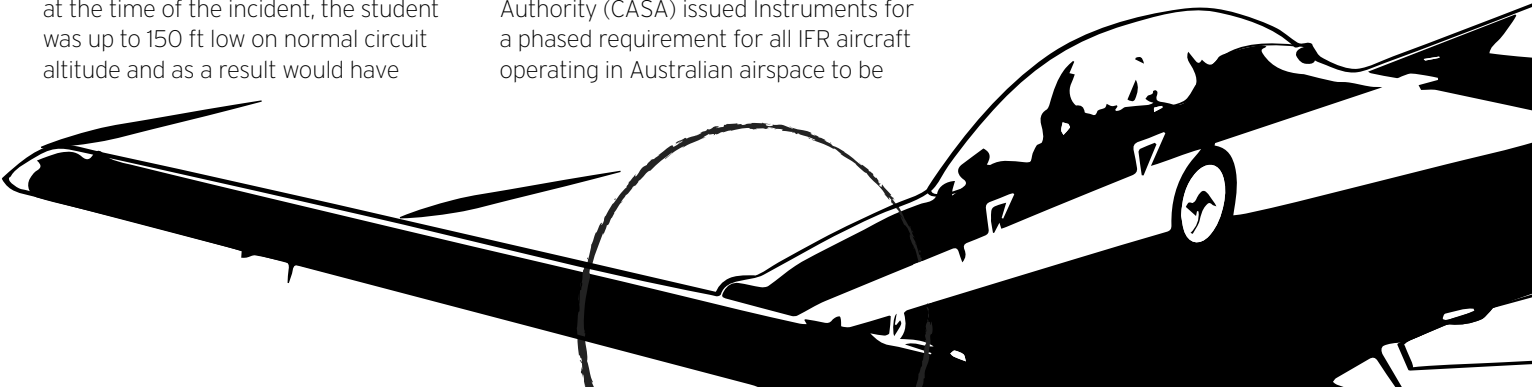
Figure 1: Incident diagram

On 13 April, 2017, a near miss occurred in the circuit at RAAF Gingin, between a Republic of Singapore Air Force PC-21 on late crosswind and a RAAF PC-9 on early downwind. Both aircraft took avoiding action with a miss distance of just 100 ft vertically and an estimated 500 ft lateral displacement.

While the PC-21 was established in the circuit at Gingin, radar tapes showed the PC-9 join the circuit via a PFL at a suitable distance ahead of the Singaporean aircraft. Appropriate separation remained for the next three circuits and both crews consistently turned crosswind about 2 nm from the upwind threshold.

On the incident circuit the crew of the PC-9 turned at approximately 2.5 nm and the PC-21 turned at 1.5 nm – this difference was enough to set the pre-conditions for a mid-air collision.

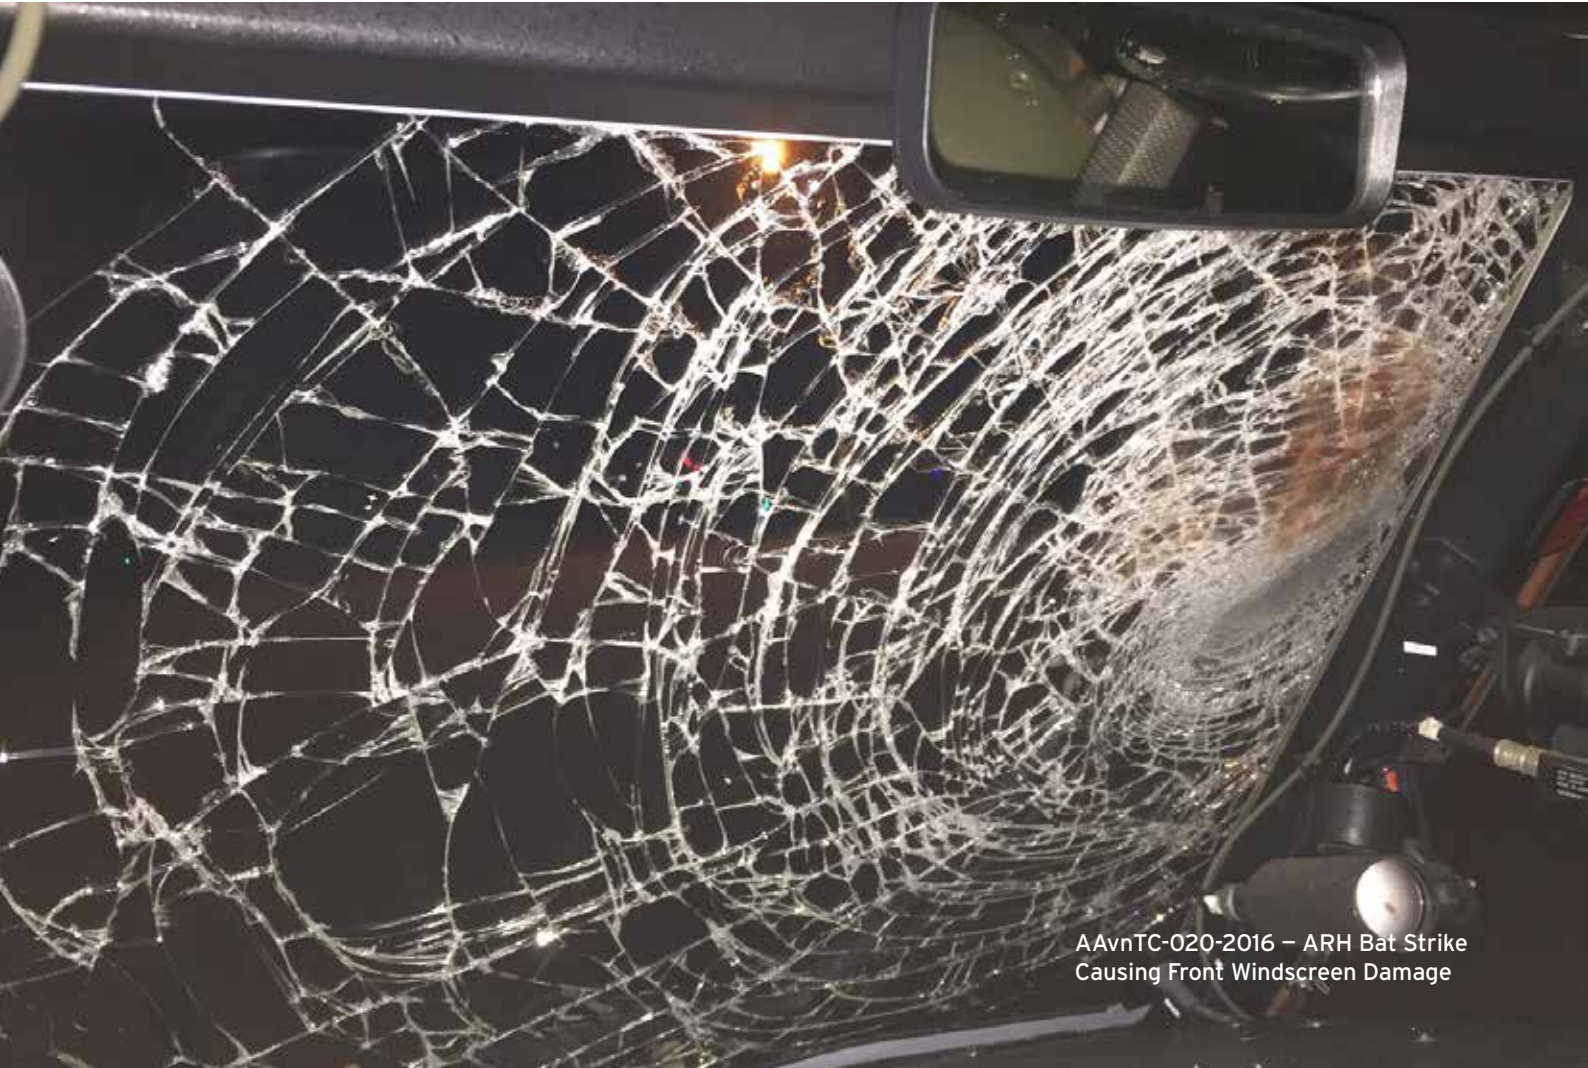
AAvnTC-020-2016 – ARH Bat Strike Causing Front Windscreen Damage

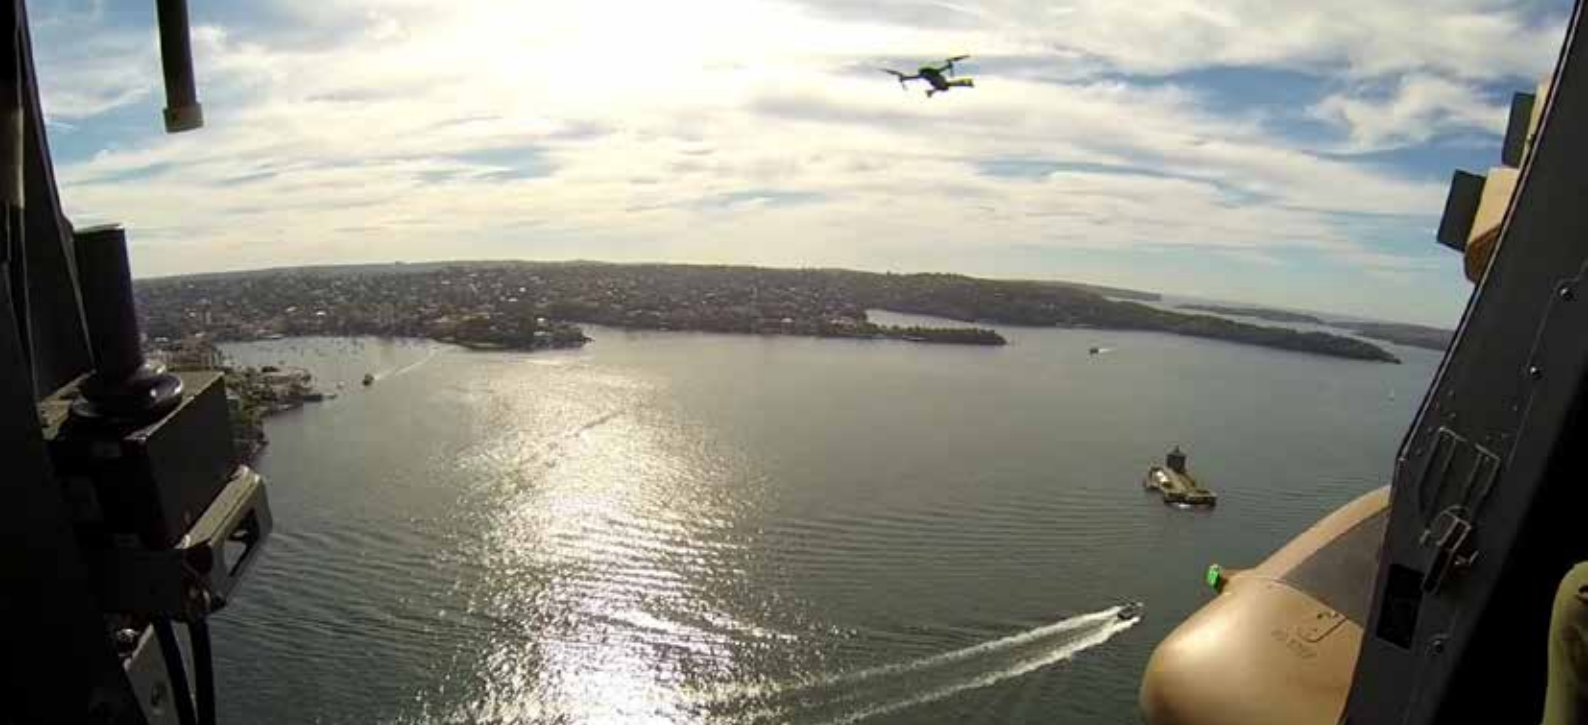
Drone flying at 500 feet over Sydney harbour. Image captured from the back of an MRH90 by LS Jordan Berkhout, 808Sqn.
