Spotlight

Dec 2023

FOREWORD

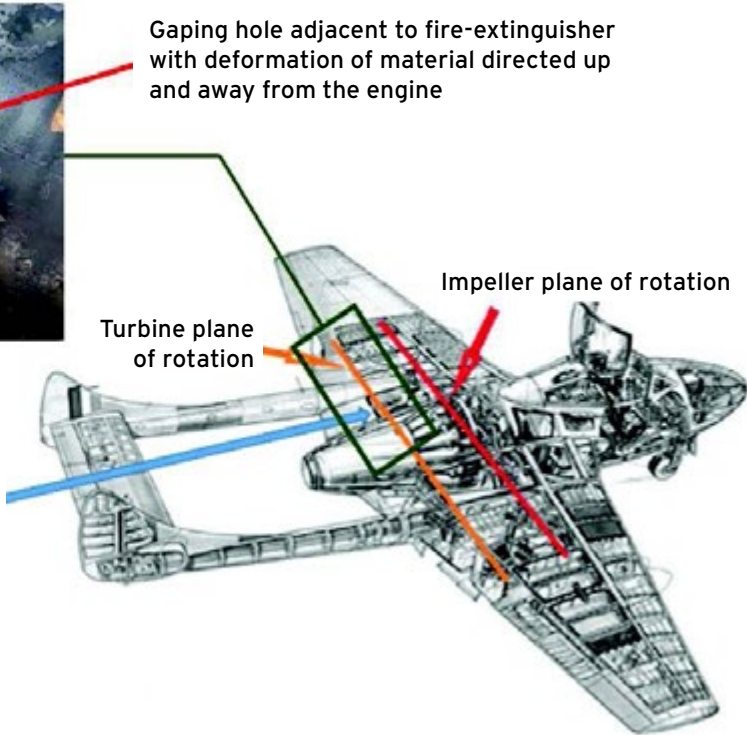
Damaged fire-extinguisher manifold

Further inspection revealed that the fire extinguisher, normally located beneath the port-side wing-flap cavity, had separated from its manifold as did the flap itself, with both components departing the aircraft. Considering the substantial level of damage sustained by the aircraft and engine within the turbine plane of rotation, the ASIT noted the fire extinguisher’s vulnerability to damage from an uncontained engine failure.

A combination of the exit of engine debris and heat escaping from the exhaust area under the wing-flap very likely caused an over-pressurisation and rupture of the fire extinguisher. Although the loss of the fire extinguisher was extremely likely not causal to the event it was considered to be a secondary effect.

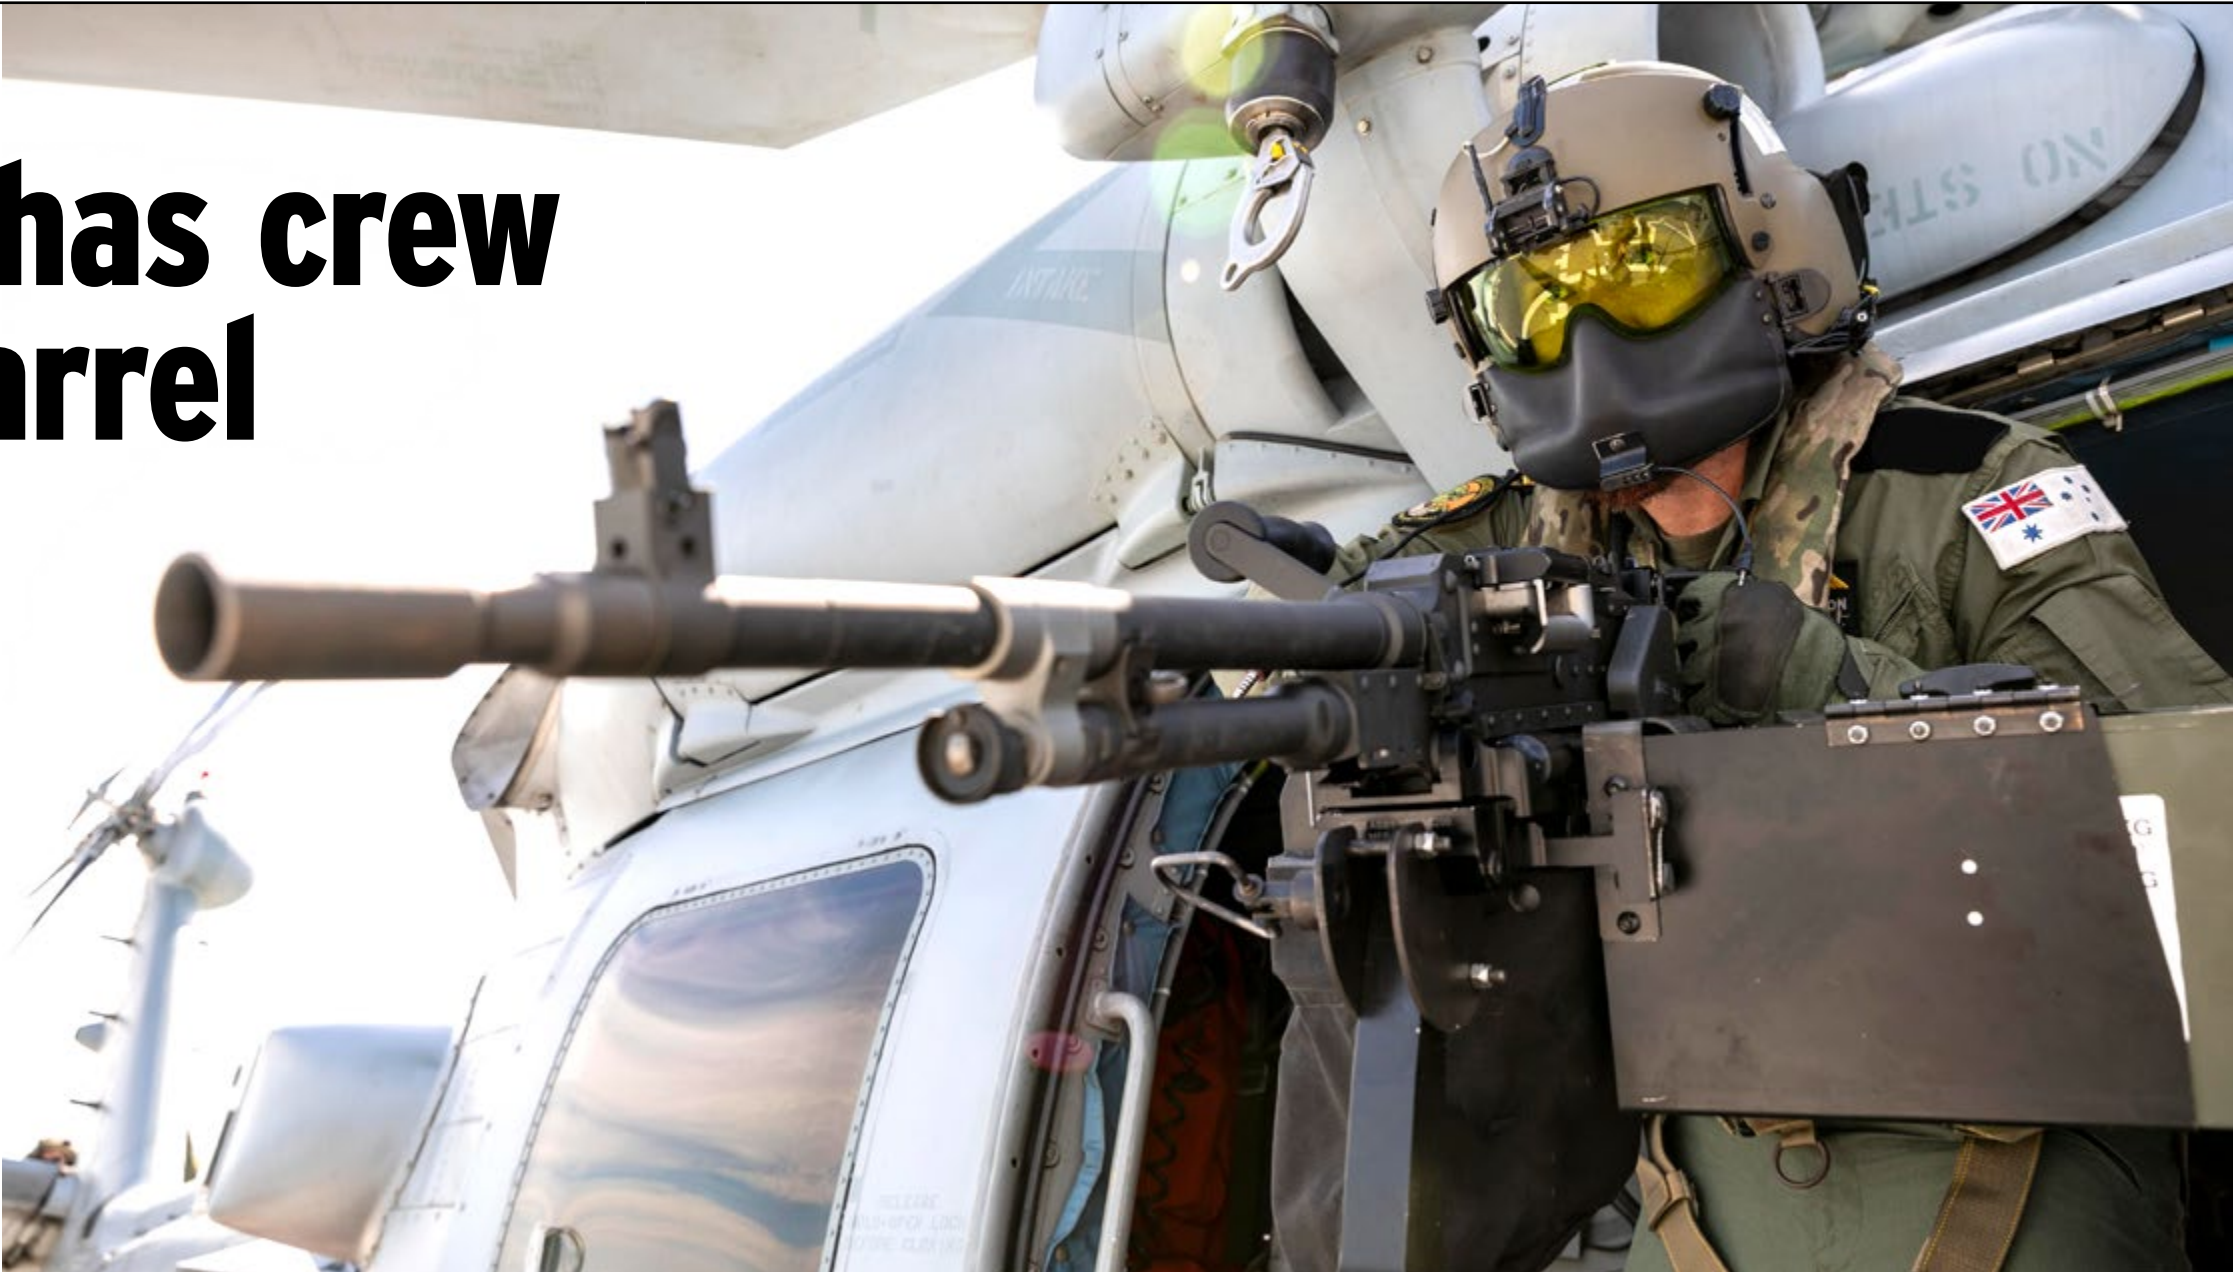
During the firing element of the gunnery serial, the crew heard a ‘bang’ from the weapon.

The ASIT found that there were differences between the USN M3M cooling and firing limitations used by the crew and those provided by the weapon’s original equipment manufacturer (OEM), FN Herstal¹. The limitations available to the crew were found to be less restrictive than the OEM. In addition, information in publications regarding what constitutes effective cooling of the weapon to avoid barrel damage was not available to the operating aircrew.

Analysis of the barrel showed that the material properties of the barrel had changed due to the excessive heat.
