AVIATION SAFETY INVESTIGATION REPORT

6th Aviation Regiment – NHIndustries MRH-90 Taipan
A40-040, Spatial Disorientation leading to Controlled Flight
Into Terrain (CFIT), Whitsunday Islands, QLD, 28 July 2023.

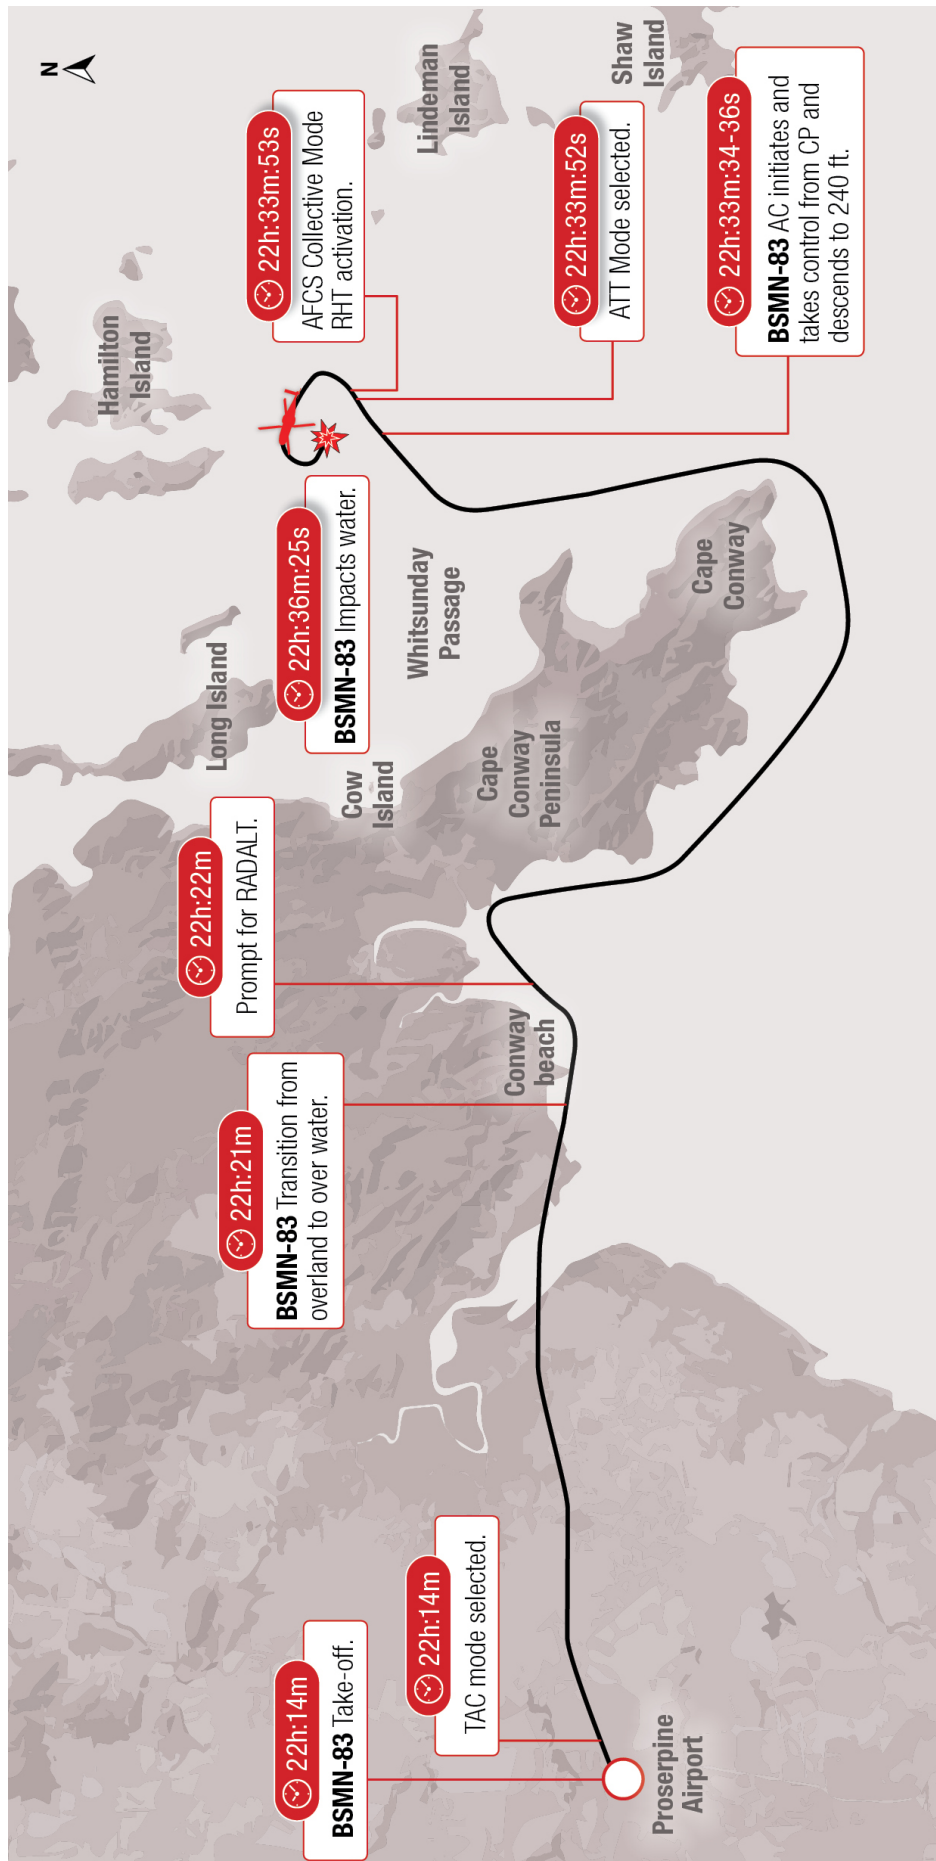
Figure 2: Sequence of events from take-off to impact

- 1.2.6 BSMN 83 called 'feet wet'⁵ at 2221K, approximately 1 nautical mile (NM) to the west of Conway Beach and at approximately 325 ft AGL. As the formation approached the ridgeline crossing of the Cape Conway Peninsula to enter the Whitsunday Passage, low cloud⁶ prompted BSMN 81 to amend the flight plan by turning right to track coastal over water around the peninsula (see Figure 2). The aircraft FCS remained in TAC mode (see paragraph 1.7.22 for further discussion).

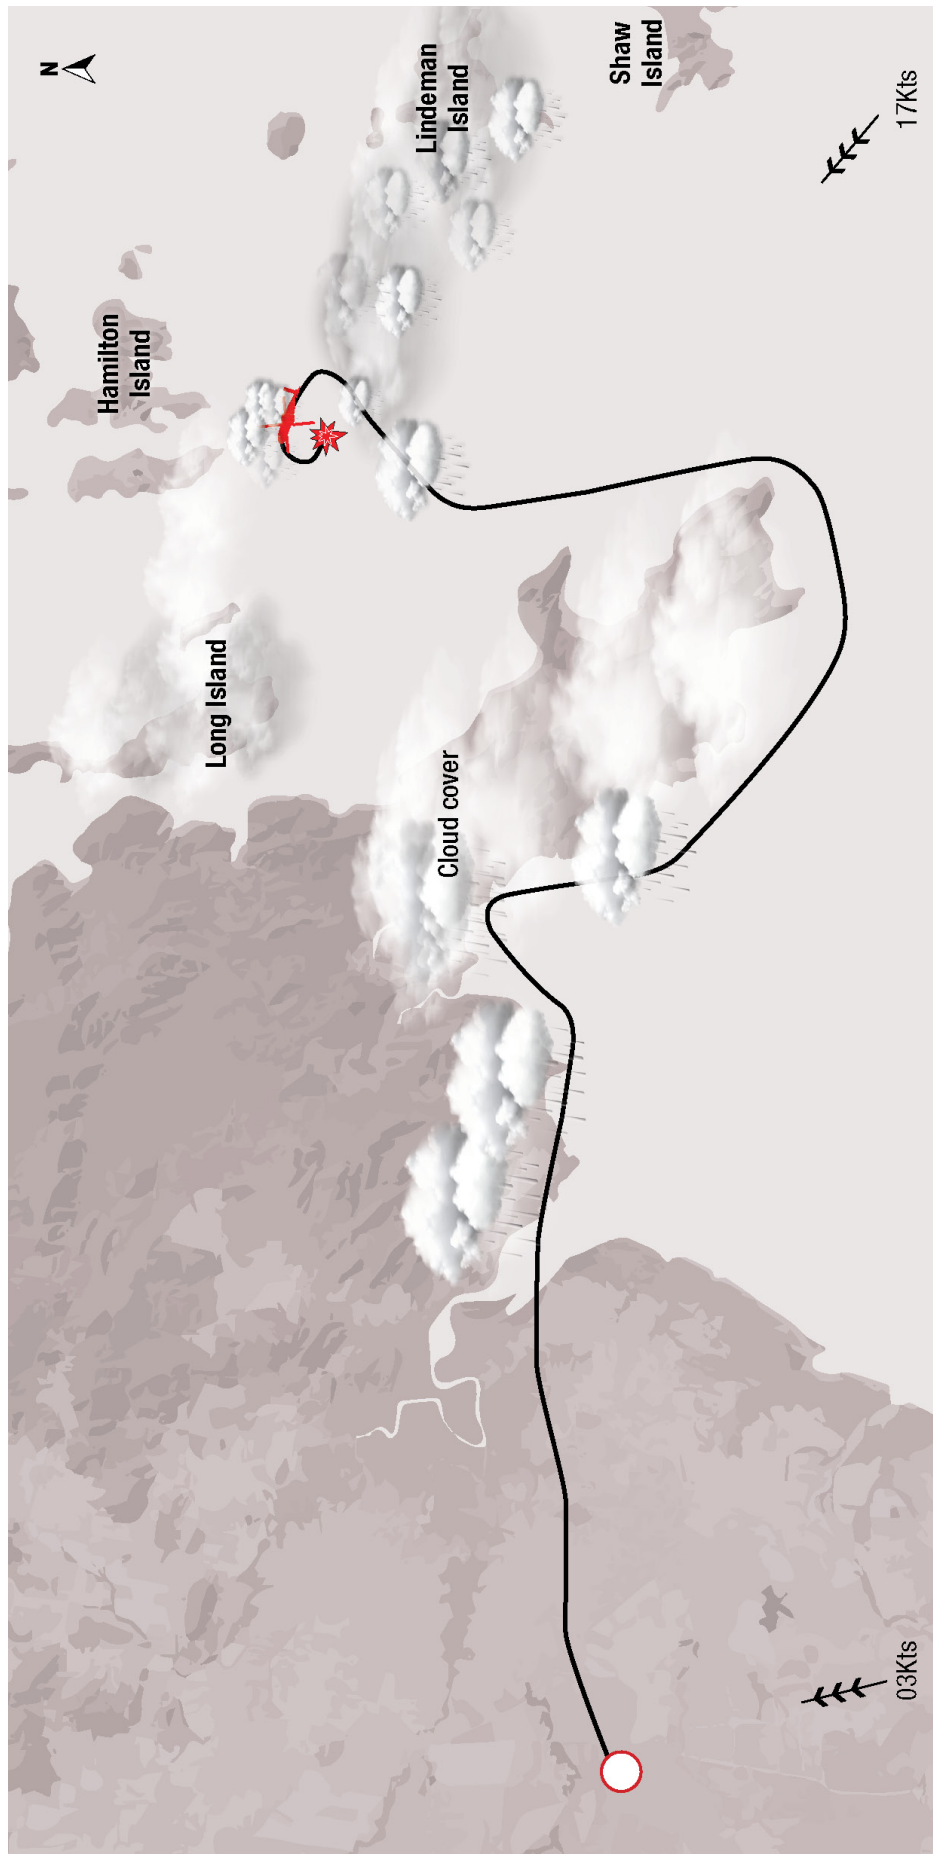
Figure 22: Cloud cover on the peninsula saddle

- 2.4.8 **Rehearsal of Concept (ROC).** As the final sequence of mission orders, the formation conducted a ROC to go through crew duties, mission criteria, and contingency plans. Contingencies for cloud on the saddle (see Figure 22) and changed flight paths were discussed. Between Mission Orders and the conclusion of the ROC, BSMN 83 RH ACMN requested that the doors remain closed until approaching the IP, in order to protect the ACMN from expected adverse weather. Previous experience of the RH ACMN, including a mission the night prior, had identified that the issued cold weather gear was not effective at protecting the ACMN from inclement weather and cold temperatures. Based on the anticipated rain showers and wind chill factor associated with flying with the doors open, the decision to keep the doors closed until the final leg of the flight path leading to the landing points (IP to target run) was confirmed. The decision to close the doors is discussed further in paragraph 2.4.10.

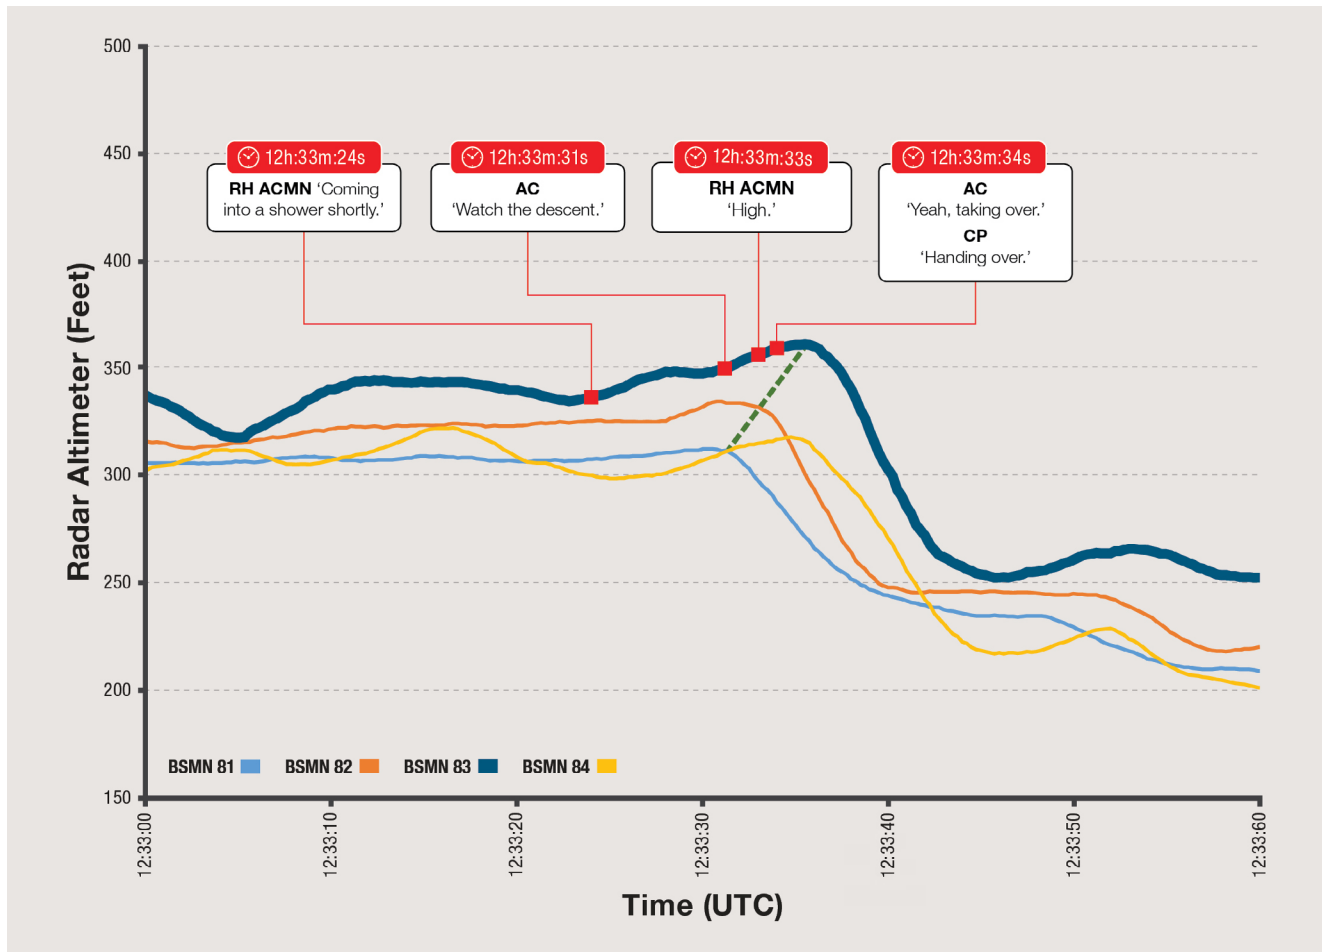
Figure 24: Formation RADALT height from 1233:00Z-1233:59Z

- 2.7.5 At 1233:24Z the RH ACMN announced, 'Coming into a shower shortly.' This coincided with a climb away from the formation. Figure 24 shows the delayed and accordion effect (green line) in formation, where BSMN 81 starts the planned descent, BSMN 82 follows 2-3 seconds later and then BSMN 83. BSMN 84 was sitting further back from the rest of the formation which is why their path (yellow) does not match the rest of the formation. The VFDR voice data indicates that the BSMN 83 CP is under an increased workload, and the AC is aware of this, and monitoring their workload and performance. It is very likely that the increasing complexity of the situation⁴⁴ prompted the AC to take control of the aircraft at 1233:34Z. It is also likely the AC was influenced by the better visual picture of BSMN 82 from the right-hand seat (RHS).

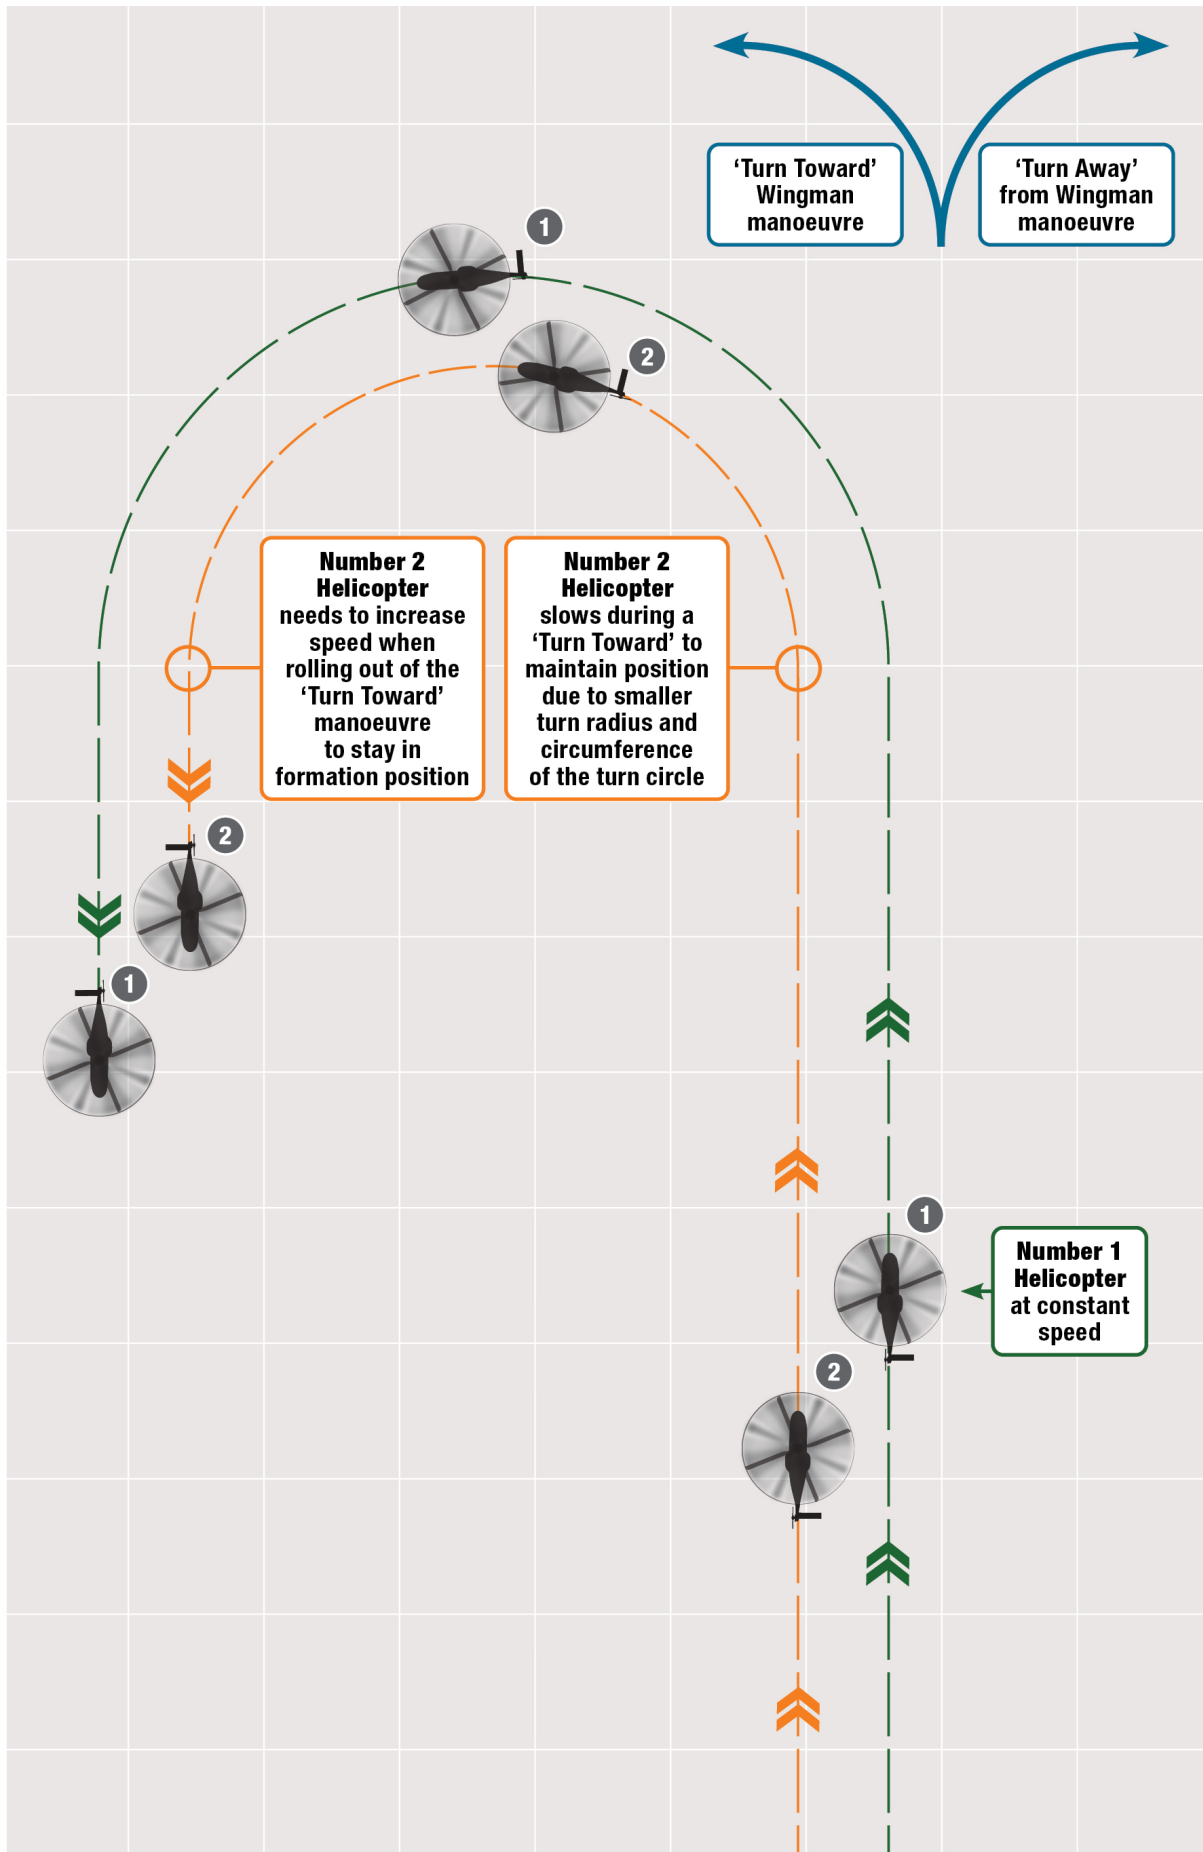
Figure 25: Illustration of formation turn geometry

- 2.7.7 At 1234:13Z the formation flight lead (BSMN 81) announced and commenced a left hold, opposite to the holding direction briefed in Mission Orders, to avoid rain showers between the IP and the target. A left turn, in heavy left formation, in the number 3 position, is considered more challenging than a right turn due to geometry of the turn (see example at Figure 25). Notwithstanding the permitted use of the arc of manoeuvre (see Figure 20), this normally requires BSMN 83 to be on the inside of the turn at a reduced speed to maintain position. It is also very likely that, given the position of BSMN 83 in the formation, they were required to look toward the sector with limited horizon.

- 2.8.4 When a turn towards the formation occurs (in this case, left turn, as BSMN 83 was on the inside of the turn to BSMN 82), the inside aircraft needs to slow to maintain line position because of the smaller turn radius (see Figure 25). Allowing the aircraft to slide behind the line (skinny) and towards the tail of the lead can be advantageous, as the inside turn radius becomes closer to the lead's turn radius, resulting in a smaller airspeed reduction for the wing aircraft to maintain station. This allows smaller control inputs by the wing aircraft's FP to maintain station, as more energy (higher airspeed) is retained. However, the wing aircraft must still anticipate, accelerate, and match lead's speed rolling out of the turn to maintain station. VFDR analysis identified that at this point, BSMN 83 had slowed from formation speed in the turn (from 83-84 kts at 1235:56Z to 77 kts by 1236:08Z). Just prior to the rolling out of the turn, BSMN 83's AC (FP) made cyclic and collective control inputs to increase speed, however, the collective input was not commensurate with the cyclic control input. It is very likely that these control inputs were made without reference to performance instruments (see section 2.16). Both are required to increase speed, therefore, the larger collective input instigated a rate of climb in addition to the intended increase in speed.

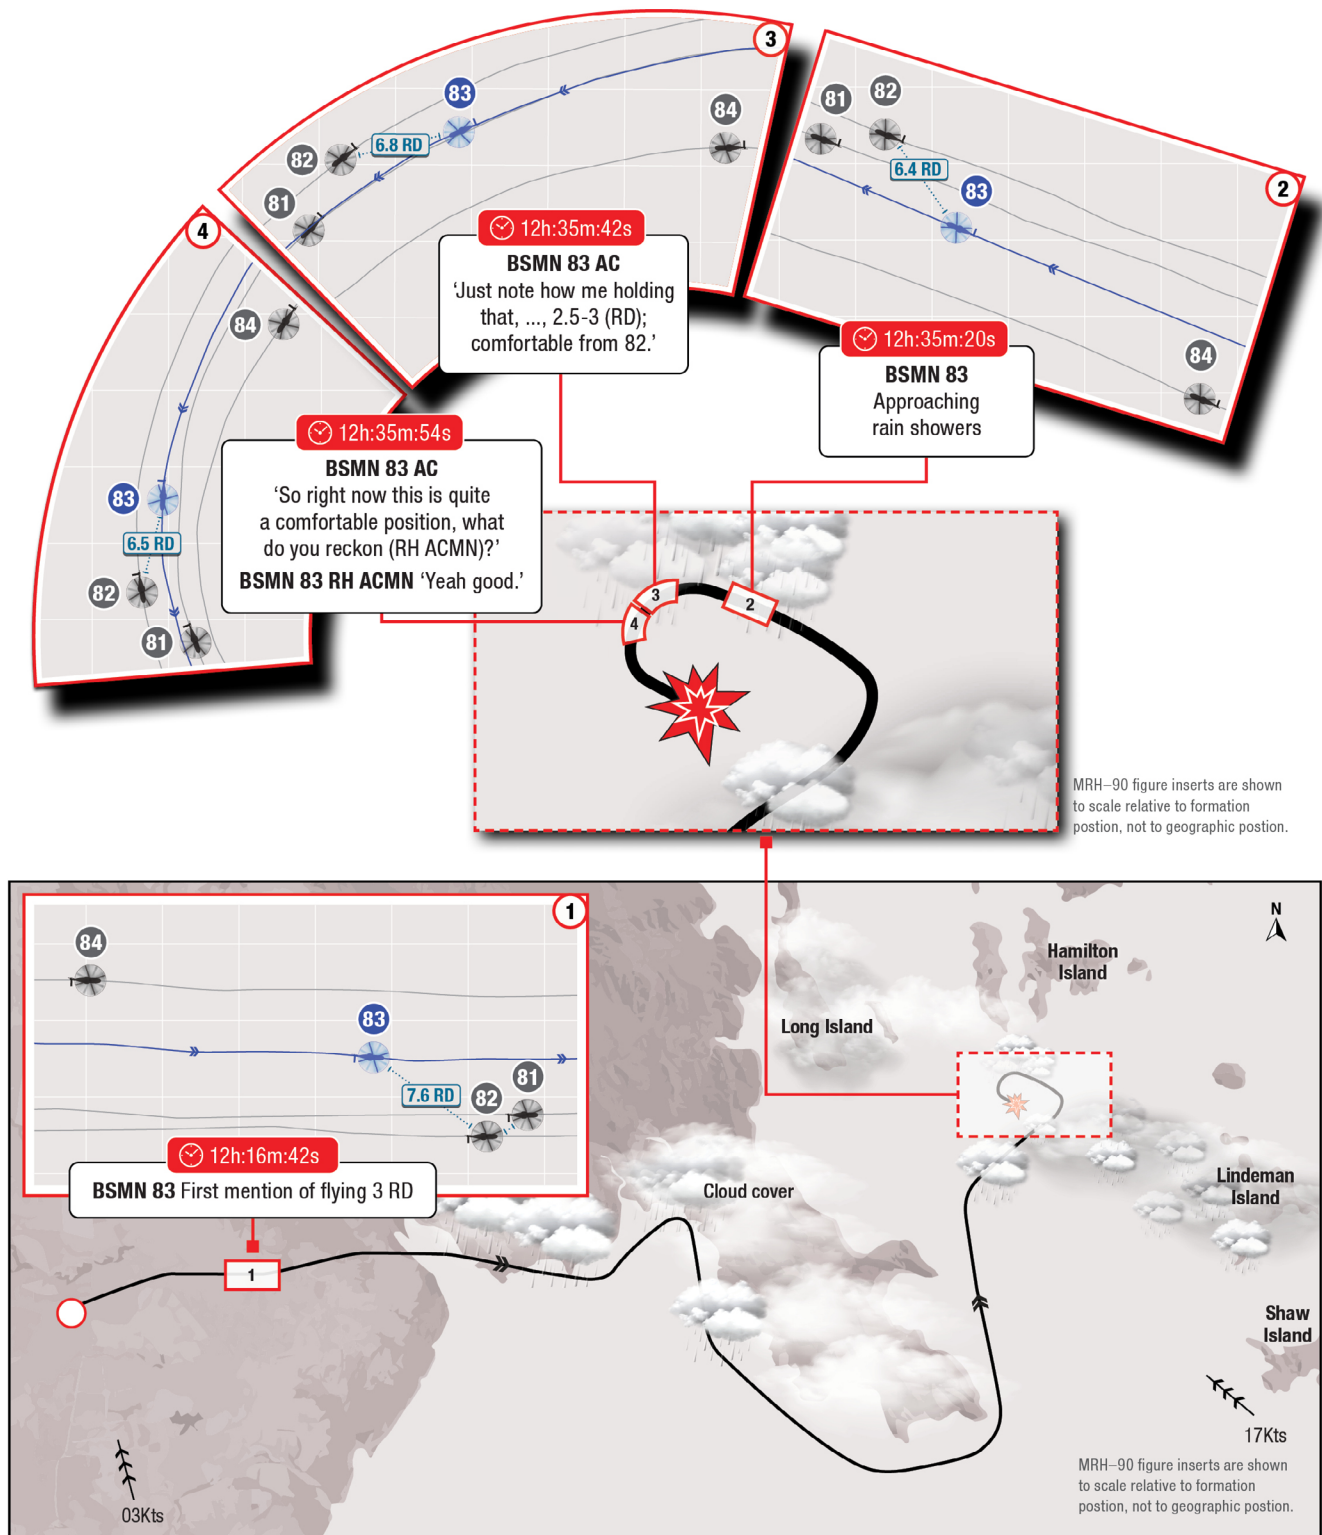
Figure 26: BSMN formation relative position (including spacing - RD)

- 2.7.10 Figure 26 shows the BSMN formation's relative geometry at four positions along the flight path from the VFDR data where the BSMN 83 crew had commented on weather, or on their visual assessment of maintaining between 2.5 and 3 RD spacing from BSMN 82. The figure also shows the actual RD between BSMN 82 and BSMN 83 at these positions (confirmed by DSTG analysis). The ASIT found that the BSMN 83 crew assessment of spacing from BSMN 82 throughout the flight was consistently in error by more than double (actual > 6 RD), believing they were much closer than they really were. The ASIT has not been able to determine how this significant error in assessed range occurred but notes the MRH90 STANMAN (Reference L) night flying chapter states, 'Reduced perception makes it difficult to accurately determine separation from other aircraft' (see section 2.18 for further details on visual limitations).

The ASIT could not determine the reason why the crew of BSMN 83 assessed their visual range to be closer than the actual range to BSMN 82.

- 2.7.11 Figure 26 also details the BSMN formation aircraft ground tracks at the four positions in the heavy left formation. Insets 2, 3 and 4 highlight that entering showers, BSMN 83 moves from the left side of the formation, to behind, then slightly on the right-side of BSMN 81's (lead) ground track. Figure 20 shows the permitted arcs of manoeuvre for wing aircraft in heavy left formation, noting that stabilised positions behind lead are normally avoided, as opening and closure rates are difficult to judge when directly behind another aircraft.

- 2.7.12 Based on the analysis of the VFDR flight path data (Enclosure 7), it is almost certain that BSMN 83 was flying a 'staggered/echelon'⁴⁶ formation position solely off BSMN 82 in the final left turn (refer Figure 26, inset 3 and 4). This resulted in BSMN 83 flying a 'trail' position behind BSMN 81. BSMN 83's AC (FP) did not change the trail position on BSMN 81; noting arcs of manoeuvre are permitted, but sustained flight in trail less than 10 RD under NVD conditions is prohibited IAW the MRH90 STANMAN (Reference L). A heavy left position would have required the FP to take line cues from BSMN 81 and spacing cues from BSMN 82. The staggered/echelon position allowed the FP to focus attention solely on BSMN 82 for both line and spacing, freeing attentional resources in a high-workload environment⁴⁷.

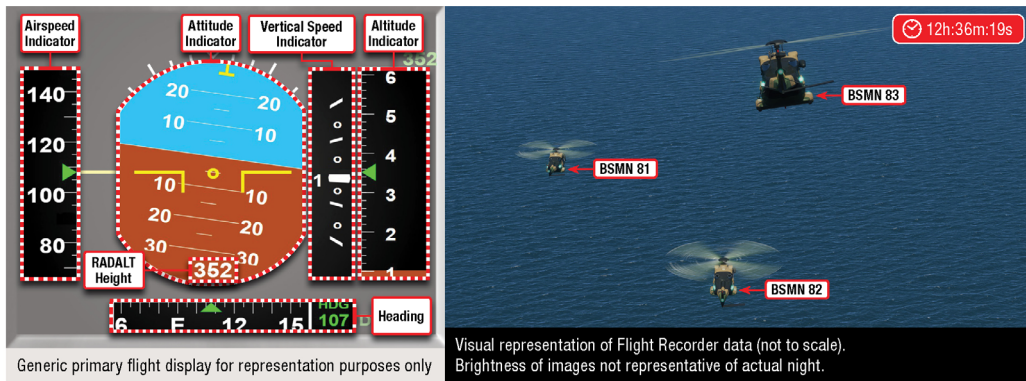
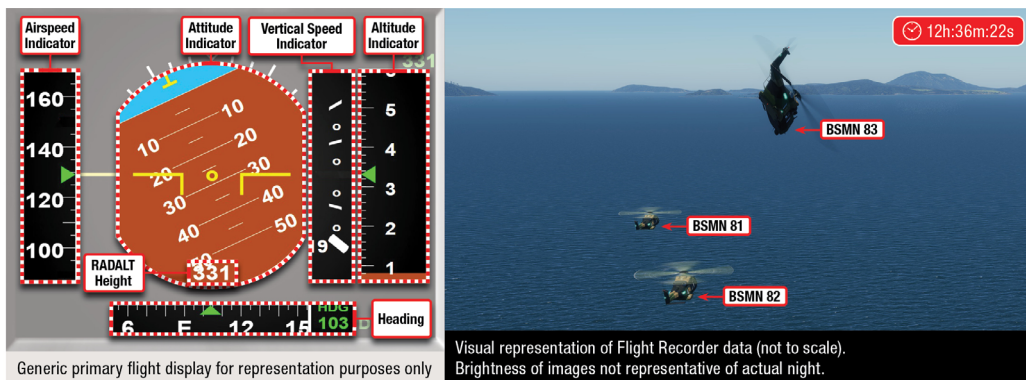
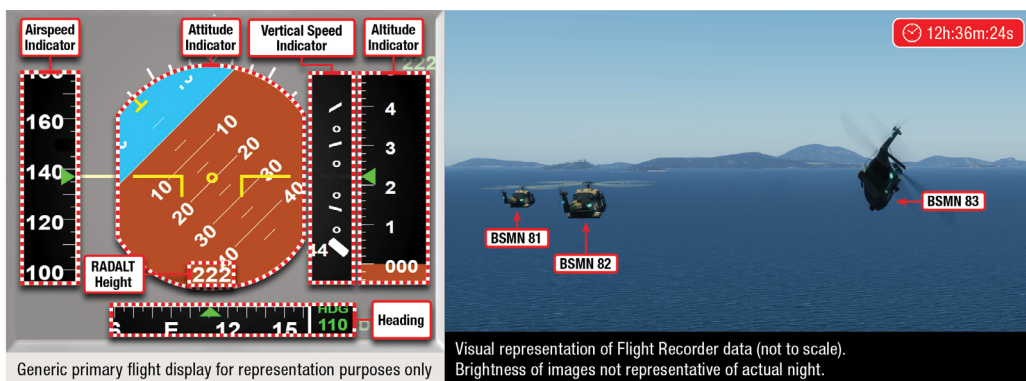
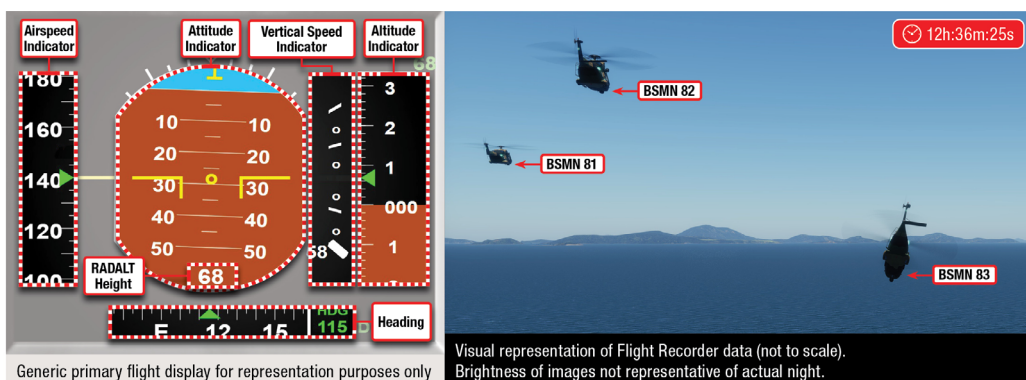
Figure 29: Aircraft state during Phase 3

2.9.1 This section covers the period from the initiation of the pushover, until the impact with water. Table 5 and Figure 29 detail the rapid change in the state of the aircraft throughout Phase 3 (6 seconds).

PUSHOVER	MANOEUVRE	LAST VALID RECORDING
Time	1236:19Z	1236:22Z	1236:25Z
Radar Altimeter Height	352 ft	331 ft	68 ft
Pitch	5 deg nose down	27 deg nose down	28 deg nose down
Angle of Bank (AoB)	8 deg (left)	25 deg (right)	2 deg (left)
Rate of Descent (RoD)	180 ft/min	1953 ft/min	5865 ft/min
Airspeed	108 KIAS (200 km/h)	129 KIAS (239 km/h)	140 KIAS (259 km/h)

- 2.9.7 It is the view of the ASIT that the undetected pitch attitude reversal, and the absence of communication, combined with the unsafe control input, further supports that the AC (FP) was unaware of the true state of the aircraft. While the AC (FP) likely perceived the aircraft to be in a nose-up pitch attitude with an airspeed of approximately 80 KIAS, the actual state of the aircraft was nose pitch down with an airspeed of 111 KIAS.

- 2.9.11 **Control inputs during the descent.** The vertical acceleration (G-force) experienced during the pushover manoeuvre went from positive 1G (normal flight parameter) to negative 0.02G (weightless condition). In a low-G state, control power is reduced, and there is a delayed control response (flight control saturation) (Reference HH). This likely led to the AC (FP) experiencing control inputs being dampened, delayed and out of sync. FDR analysis shows lateral cyclic displacement to the right (+34 %) at 1236:21Z, resulting in the aircraft rolling to 47 degrees AoB. However, while the aircraft passed through 25 degrees right AoB a lateral cyclic displacement to the left (-14 degrees) was conducted that had no immediate effect on the roll rate to the right. The aircraft continued through 25 degrees AoB ultimately reaching 47 degrees AoB to the right before aircraft angular movement commenced to the

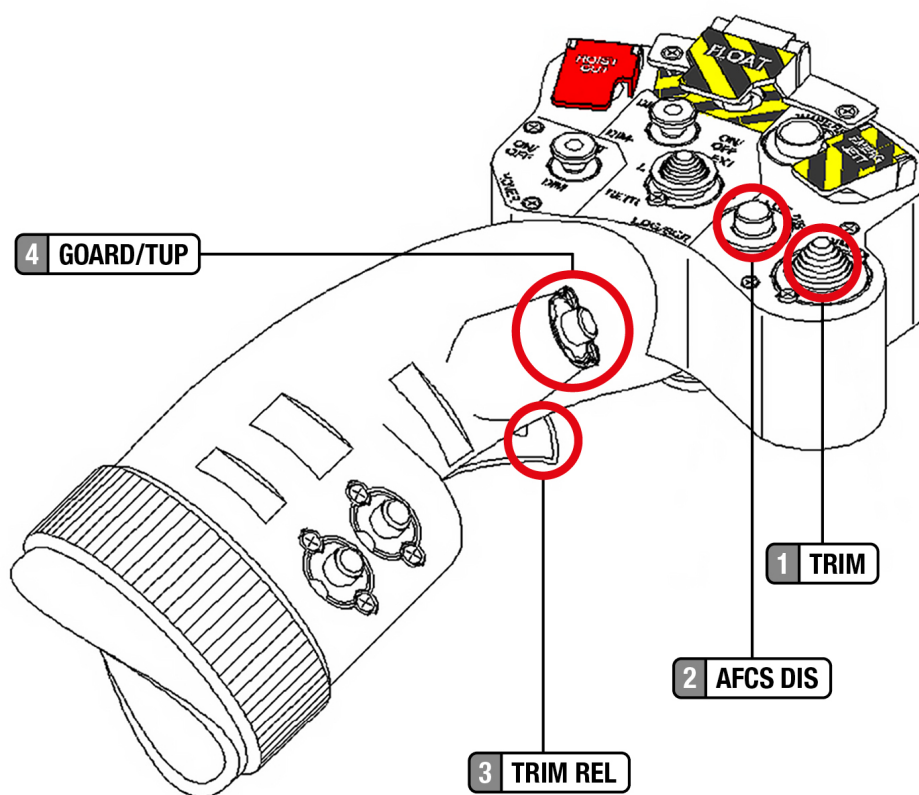
Figure 33: MRH-90 Collective Lever Grip

2.14.2 **Use of Radar Height (RHT) in formation flying.** MRH90 STANMAN (Reference L) states that when RHT is engaged, it is possible to de-activate, override or re-reference the 'hold', in one of three ways (refer Figure 33 for switch positions on the collective lever grip):

- by moving the collective against the trim
- by depressing the collective trim release spring-loaded switch, commonly referred to by MRH-90 pilots as the trigger switch
- by moving the four-way switch for collective trim (forward and aft).

2.14.3 If the pilot moves the collective against the trim; that is, without depressing the trigger switch, the aircraft will return to the previously set RHT datum once the manual collective input is removed. In both other methods, the aircraft will reset the height of the aircraft at the point at which the mechanism (either trigger or trim) is released.

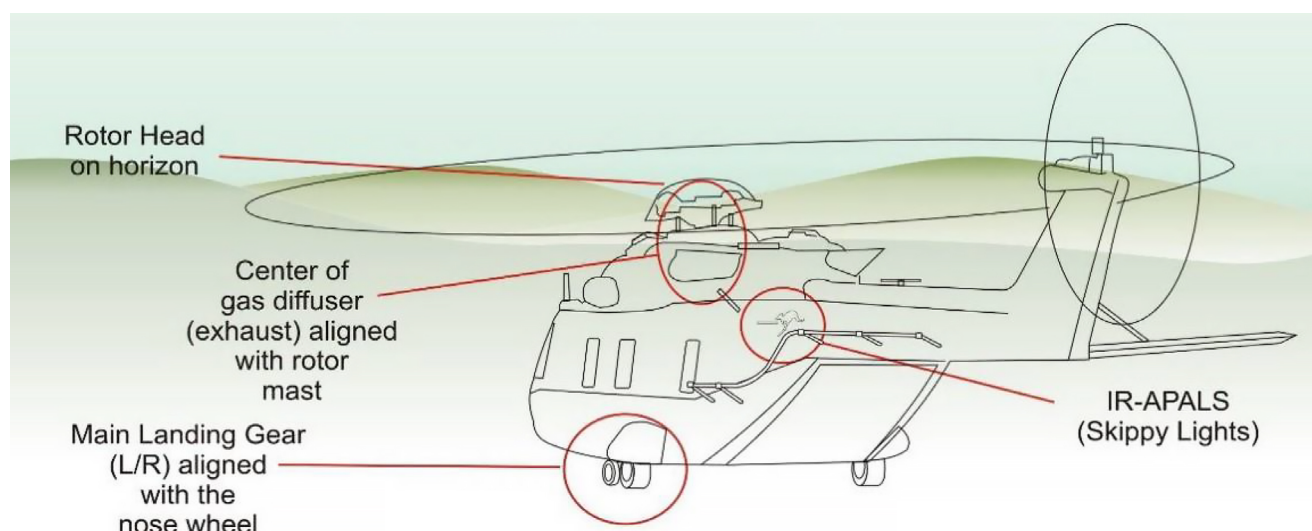
Figure 34: Stagger/echelon line-up features

- 2.15.6 Review of the Aviation Pilot Regimental Officers Basic Course (ROBC) Program MRH-90 Course (Reference NN) identified that during the primary phase, students are taught to incorporate HMSD symbology into their scan for forward flight. Scan for forward flight maintenance is Attitude-Vector-Look Out-Performance. During formation flight, students are taught that the line-up features for formation flight include the rotor head on the horizon to provide vertical alignment (Figure 34). When the horizon is not visible, the HMSD horizon bar can be placed against the rotor head to provide vertical alignment.

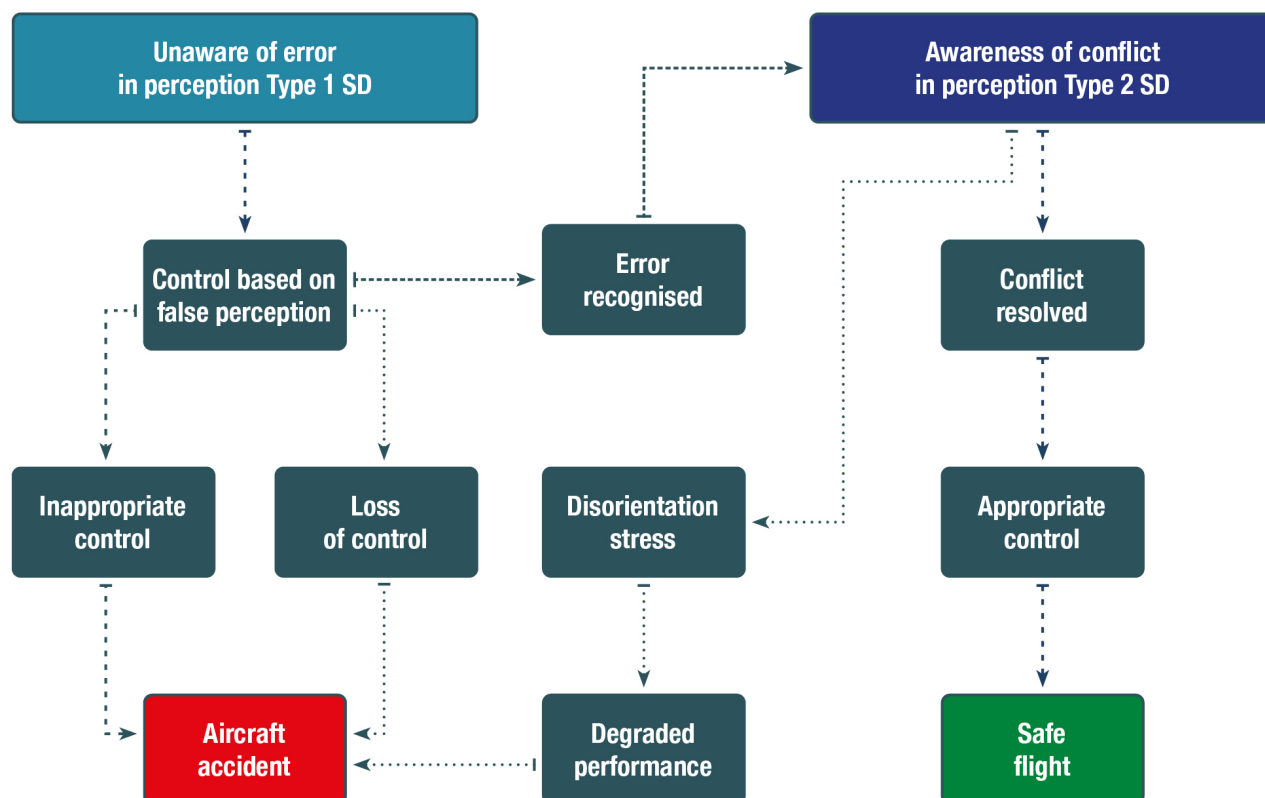
Figure 35: Illustration of how Type I and Type II Spatial Disorientation can influence the pilot's control of the aircraft⁶⁵

- 2.17.5 For the purposes of this report, SD is categorised in two broad categories, explained below and illustrated in Figure 35:

- 2.17.6 With consideration to Endsley's model of SA, SD represents a loss of Level 1 SA. As the pilot has not detected a conflict between their own perceptions and that given to them by the instruments or the outside visual world, the erroneous information is integrated within their mental model. As a result, Level 2 SA and Level 3 SA is significantly degraded.

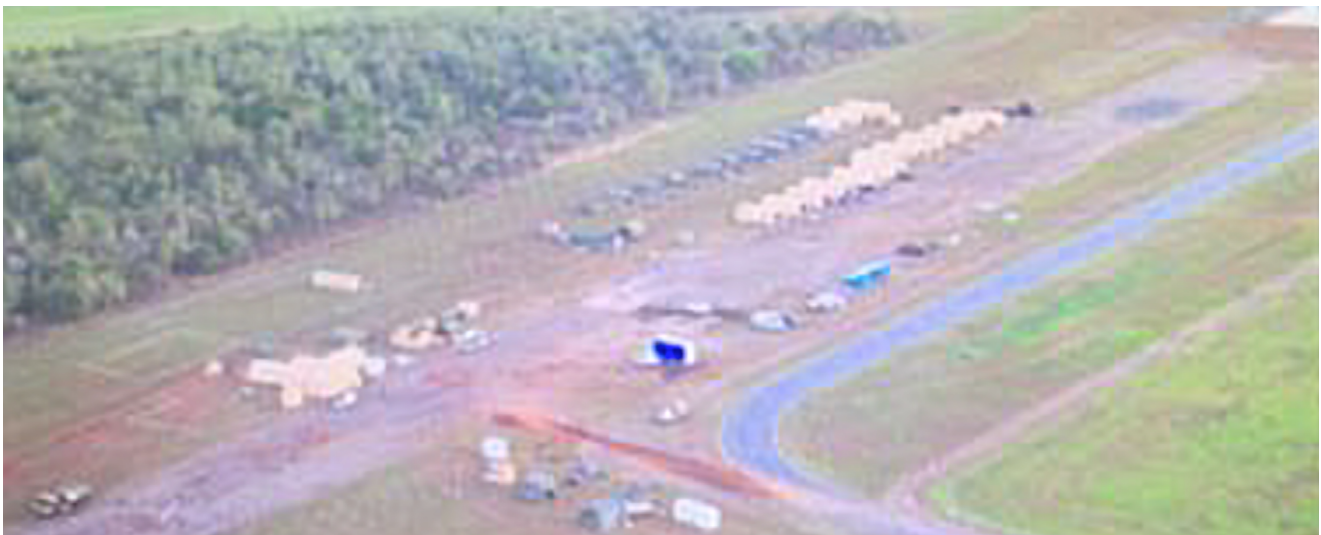
Figure 38: Camp layout at Proserpine Airport

- 2.19.12 **Sleep environment.** Interviewees described the sleep environment as stretchers in tents of up to 18 people. The tents were located at an active civilian aerodrome (Proserpine - see Figure 38) and,

It is likely that the sleep environment contributed to BSMN 83's AC and CP obtaining restricted sleep, which was of poorer quality.

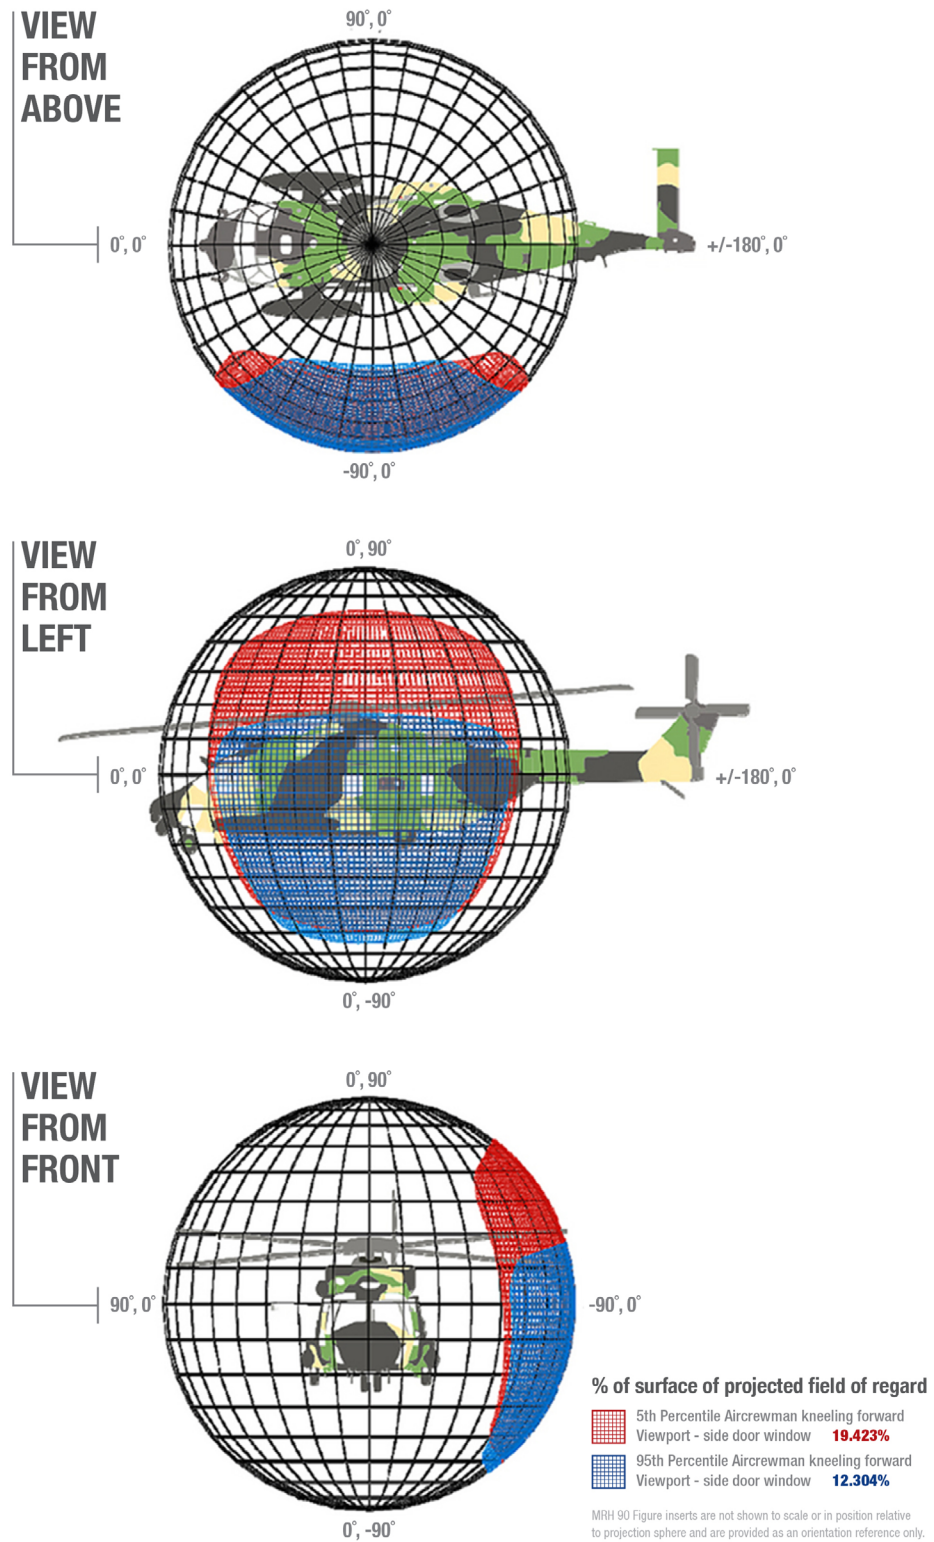
Figure 40: Projected Field of Regard of an MRH-90 aircrewman occupying a kneeling position by the side cabin door window

2.24.1 **ACMN Field of Regard.** The ASIT considered the role of the ACMN in supporting Situation Awareness for the crew. In Reference BBB (2005), Aircraft Research and Development Unit (ARDU) identified that with the doors closed, the Field of Regard (FoR) of the ACMN would be reduced, resulting in increased reliance on the pilots for aircraft-to-aircraft clearances. Figure 40 shows the assessed FoR for ACMN occupying a kneeling position by the side cabin door window.

- 2.24.2 MRH-90 ACMN, in both 5 Avn Regt and 6 Avn Regt, occupy the Row 7 forward facing seats (see Figure 21) as their primary workstation. The ASIT did not identify FoR mapping for this seating position; however, assessed that the FoR would likely increase to the forward of the aircraft, and reduce to the rear of the aircraft in a forward seating position.

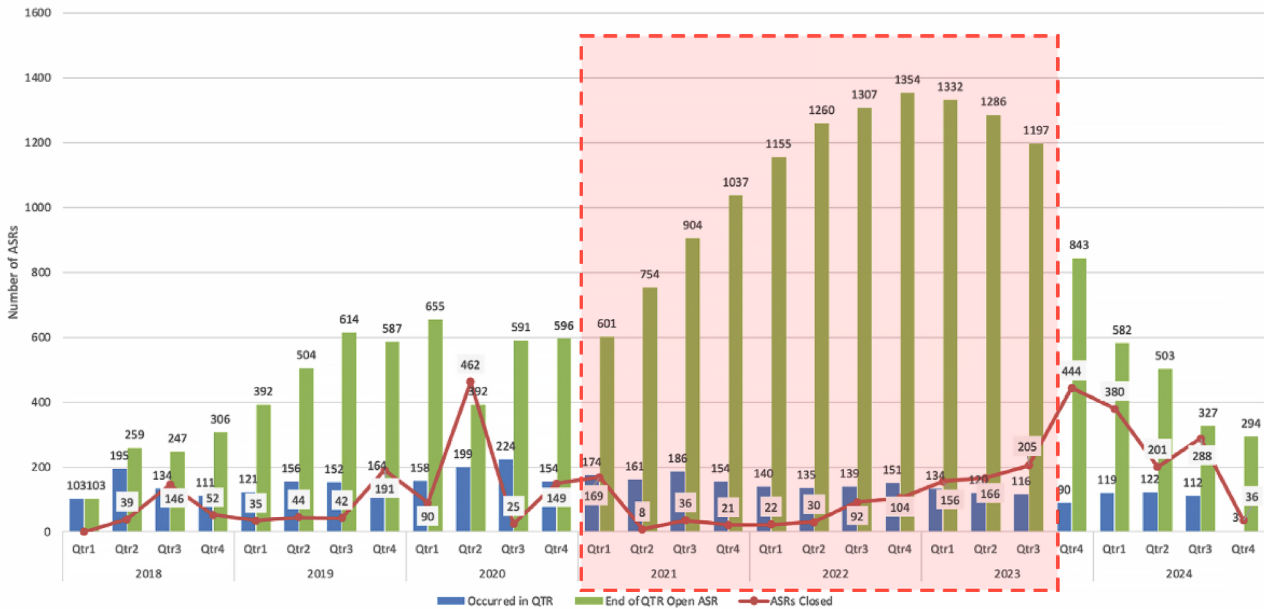
Figure 43: Total Army ASR rates for new/open/closed from 2018-2024

track to closure those ASRs. The ASIT found a steady increase of open ASRs from 2018 through to Q1 2023¹¹⁴ (as depicted in Figure 43) coupled with declining closure rates over the following year. While the ASIT acknowledges that this was coincident with the establishment of AVNCOMD, it may represent a missed opportunity for Army Aviation to fully understand and assess the hazards in the system during that timeframe. The ASIT acknowledges that significant effort has gone into reducing the number of open ASRs, as evidenced in Figure 43, from mid-2023 to the present.

- 2.39.16 The ASIT found the absence of traditional AHRBs likely created safety oversight challenges, potentially leaving hazards unmonitored and unresolved. Without the required AHRB meetings, safety trends risked being overlooked and ASR closures were delayed, disrupting the closed-loop safety system essential for managing risks proactively. This also weakened the organisation's ability to achieve continuous improvement and organisational learning.

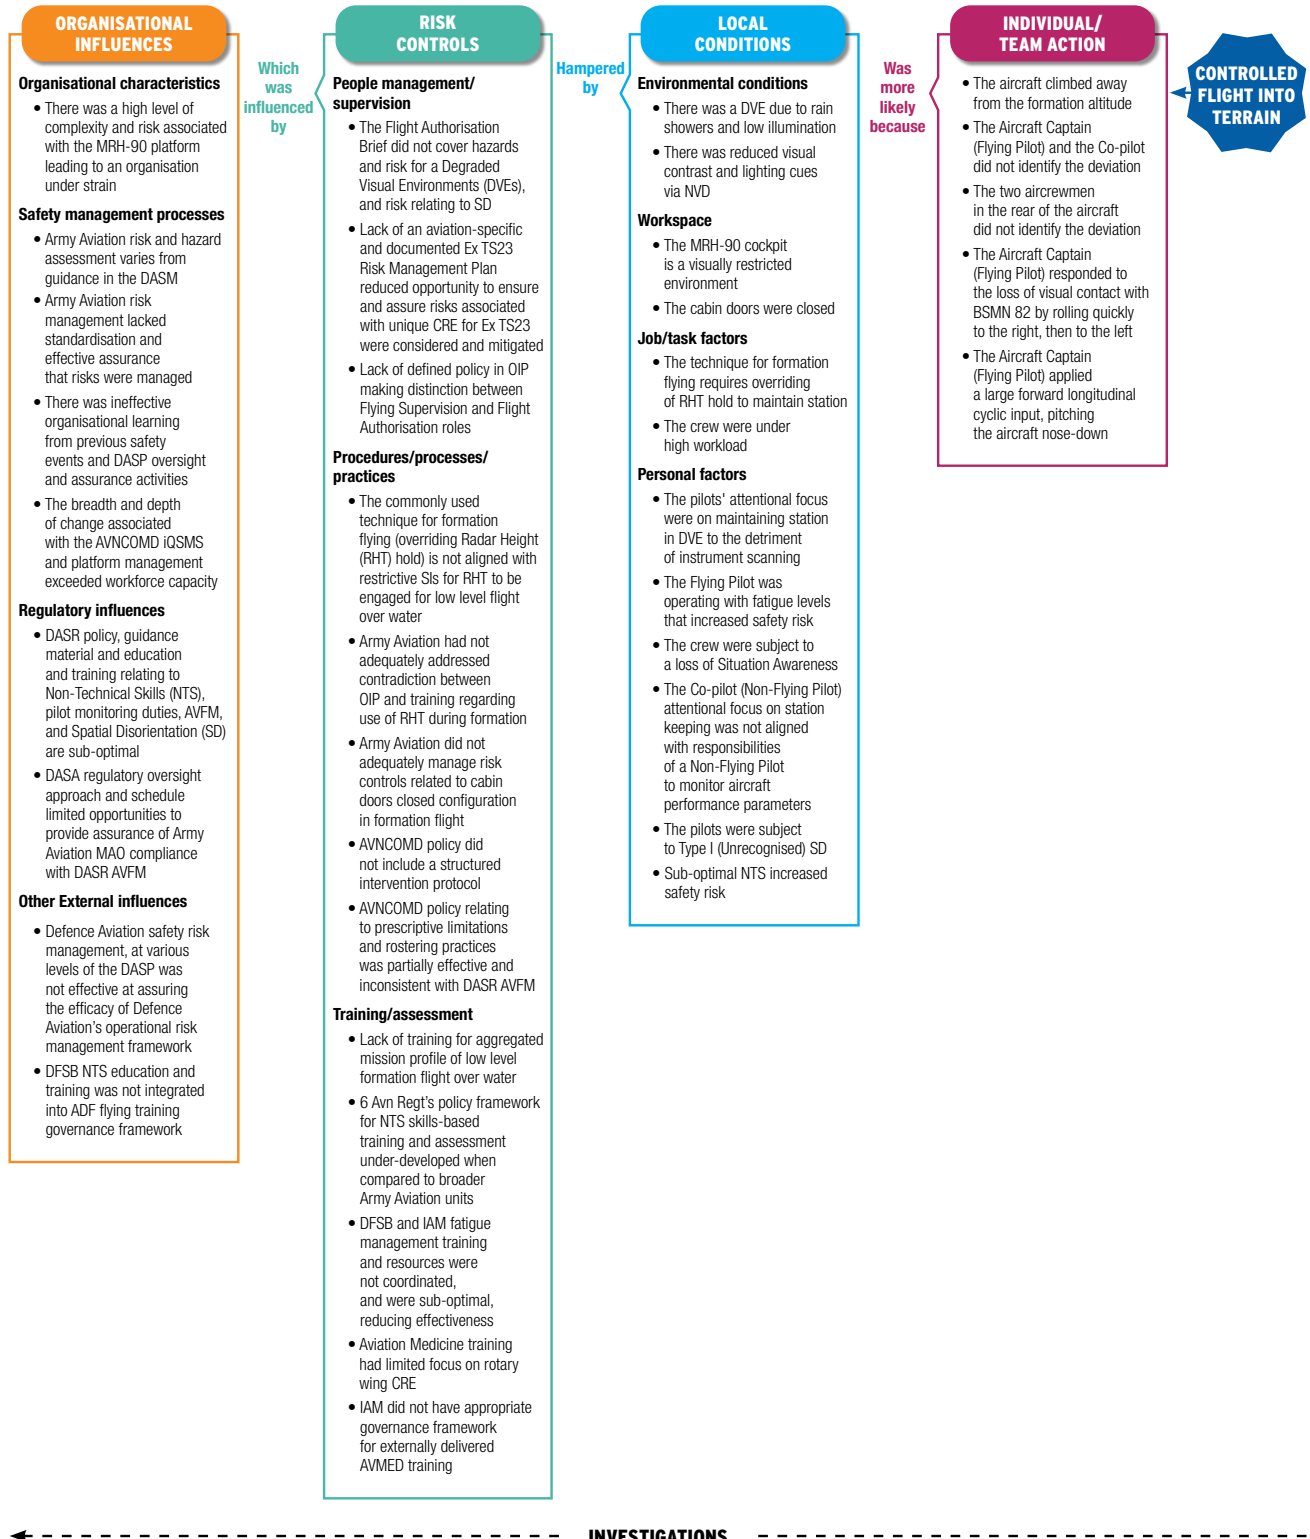
Figure 44: DSAM Taxonomy

5.5.12 Figure 44 shows the key findings, categorised in accordance with the DSAM in order to demonstrate the linkages between the initial actions of the crew, the local conditions that influenced them, the absent or deficient risk controls and the organisational influences.
