SPECIAL EDITION: THE HOW AND WHY
SUMMARISING OUR RECENT INVESTIGATIONS

**02 2021
EDITION**

Spotlight

FOREWORD

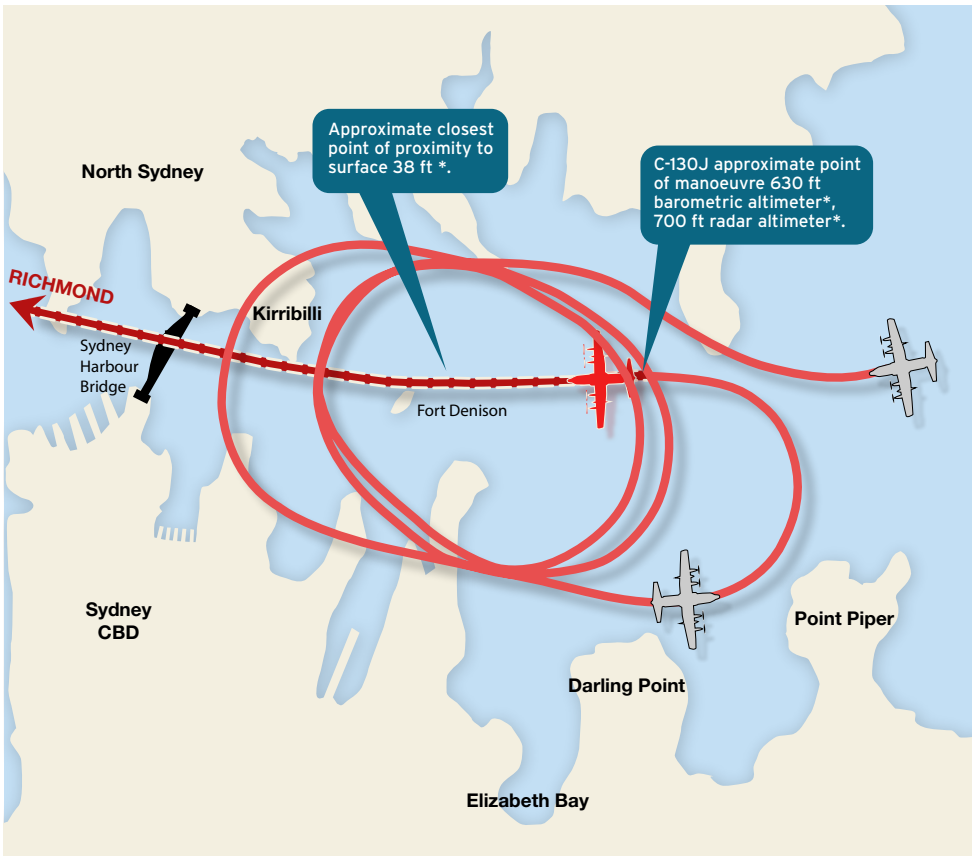
Sydney Harbour with display track

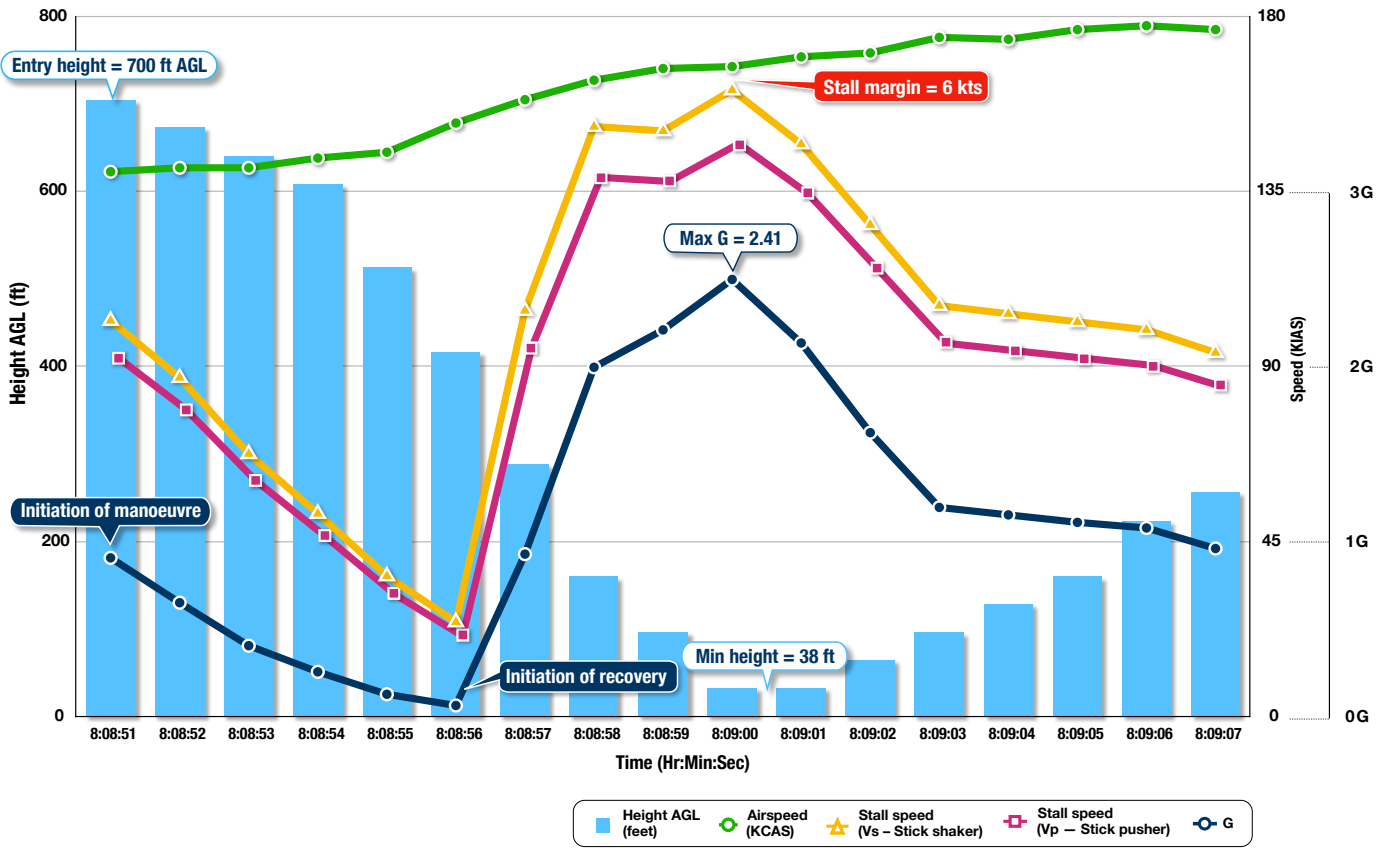
Due to the low cloud; however, the aircraft captain decided to modify the manoeuvre by pitching only 15 degrees nose down, and recovering immediately and not below 250 ft MSD. Instead, the aircraft captain inadvertently pitched 28 degrees nose down.

Aircraft parameters during recovery

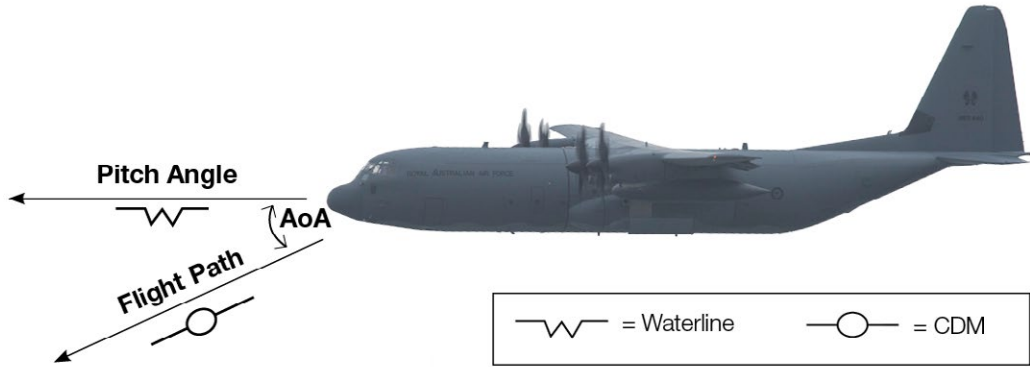
Angle of attack/flight path as the aircraft pitch passed the horizon

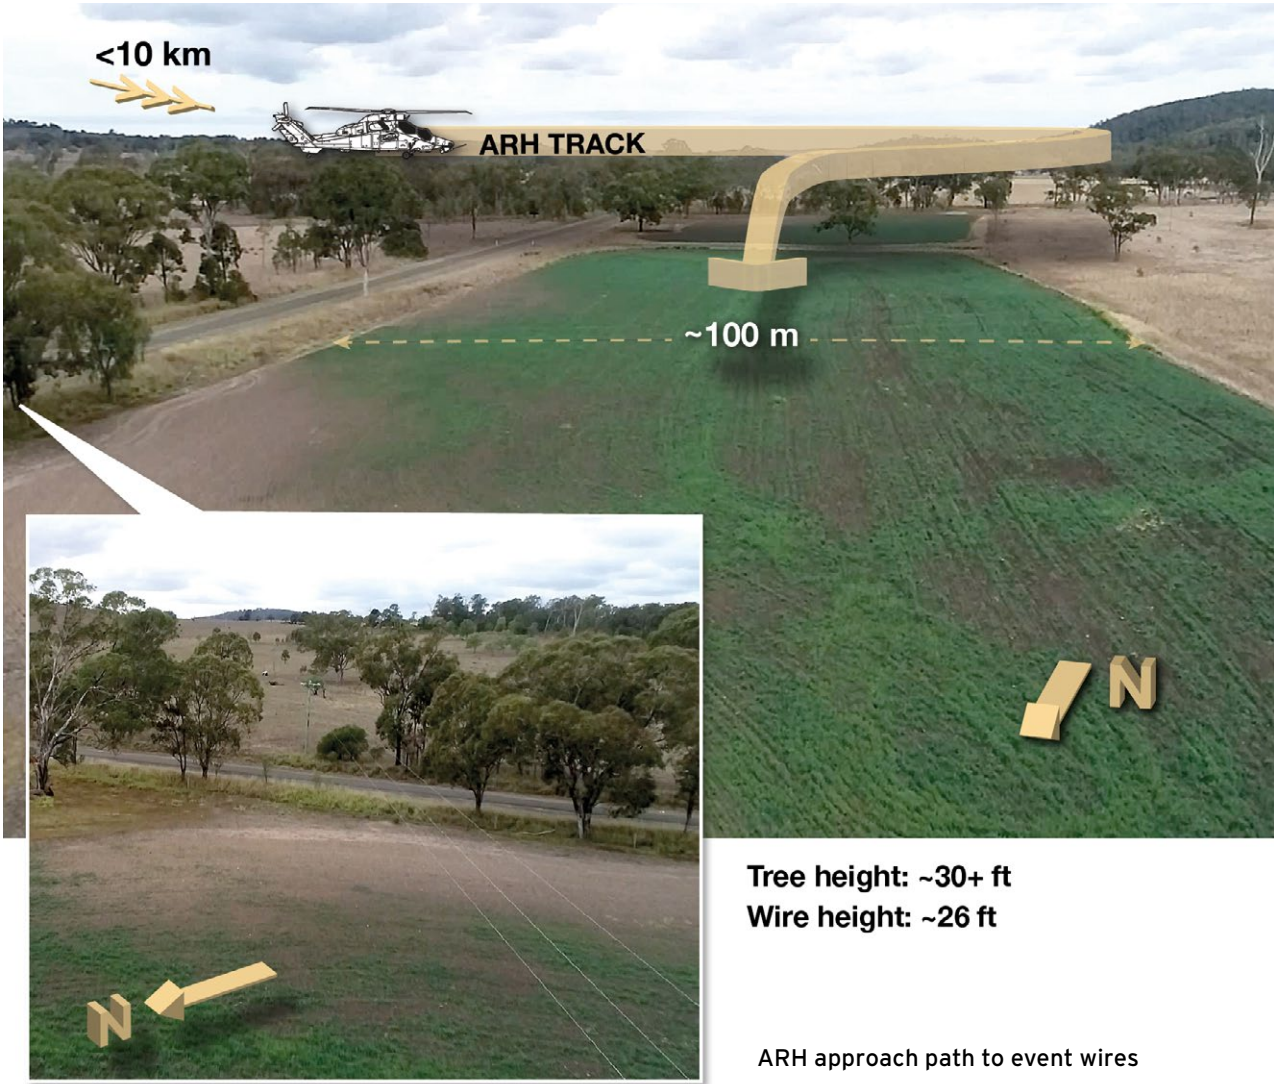
As the aircraft progressed and cleared a set of trees, the briefed powerlines were seen about 500 m ahead. This coincided with the intended flight path (to the north-west of the now observed wires) also coming into view. Due to the elevated terrain and trees on the north-western side of the planned route, the QFI assessed that the terrain to the south-east of the seen powerlines better suited NoE flight.

Based on this assumption, the QFI directed the trainee to fly south-east of the observed wires and to track north, north-easterly

The in-flight maps depicted the event wires crossed from right to left of the new flight path (which spurred from the observed wires). The QFI recalled prioritising lookout into the intended flightpath over checking the map for wires, and therefore did not see the wire obstacle. Unbeknown to the aircrew, the right-hand support pole for the unidentified wires that lay across the revised navigation track was obscured by roadside trees, making un-alerted visual detection of the wires difficult.

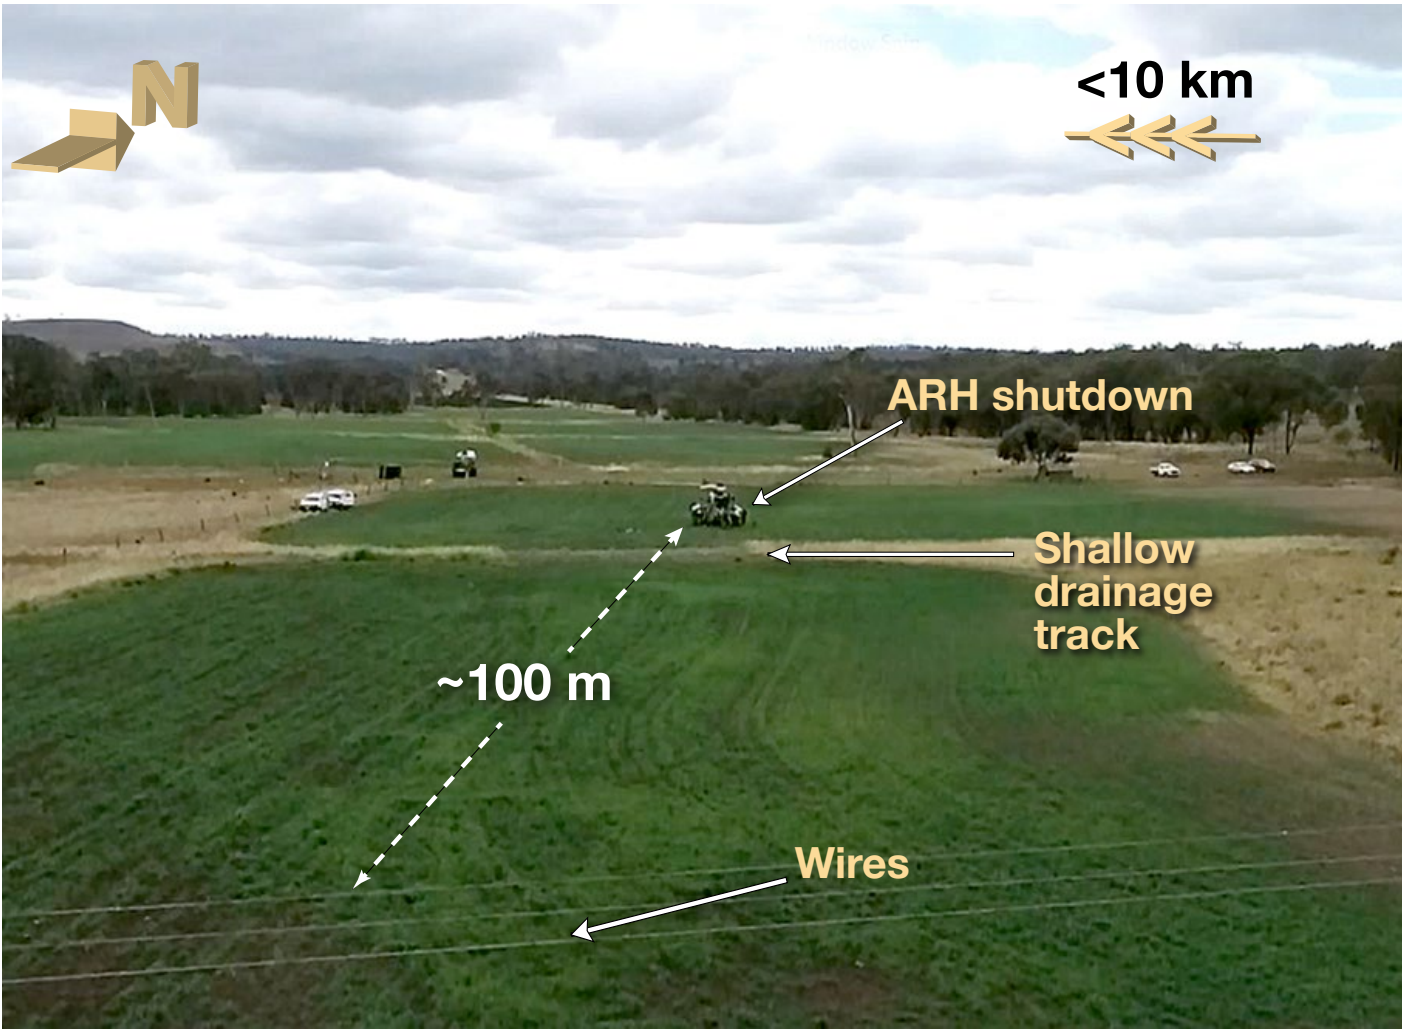
Wirestrike event – landing area

The second upper wire appeared to break under the increasing strain while snagged on the pilot’s windscreen wiper stop and impacted the side of the aircraft causing superficial damage. The gun successfully deflected the third wire from impacting the underneath section of the aircraft, but resulted in the scoring marks on the lower gun mount.

- the event was almost identical to the 2012 ARH wirestrike
- Army had not implemented actions specified by the 2012 Implementation Directive which likely would have prevented recurrence
- Army has no documented hazard analysis for wirestrike
- the ARH training syllabus was in conflict with Army OIP designed to reduce risk
- AAvnTC has not adequately conducted junior QFI mentoring and supervision
- Had these organisational issues been rectified after the 2012 wirestrike event, it is highly likely that this wirestrike would not have occurred.

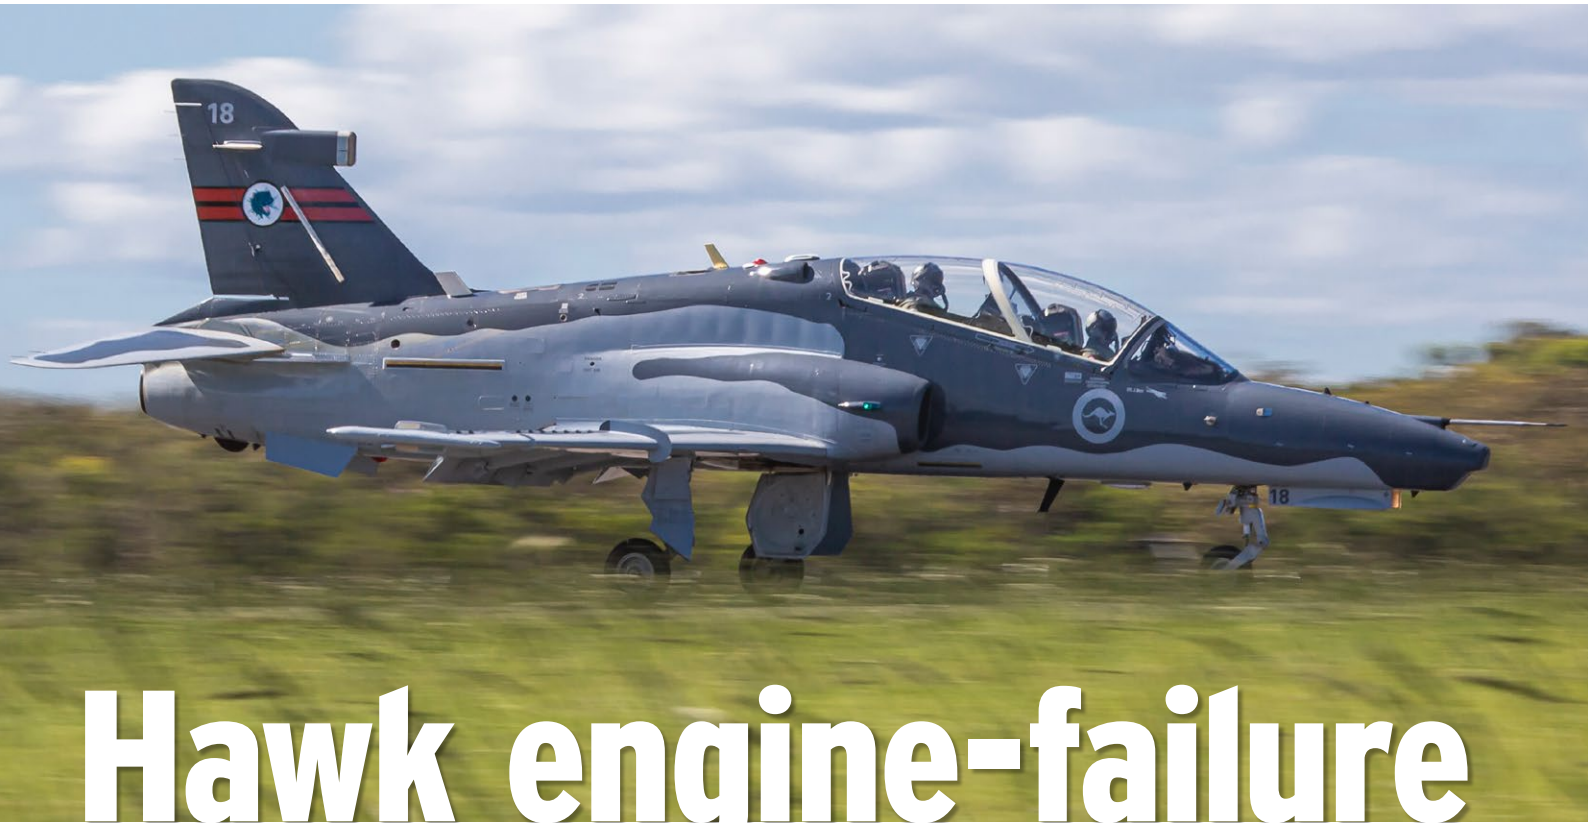
Hawk engine-failure

BAES maintenance staff attended the aircraft and noticed several perforations in the port side of the fuselage adjacent to the low-pressure turbine section of the engine. A visual inspection by maintenance staff confirmed that there was discernible damage to the low-pressure turbine/airframe where several blades appeared to have been sheared/released. After taking all the necessary precautions to render the aircraft safe, it was towed back to the BAES maintenance facility and quarantined.

As a result of the uncontained engine failure¹², the aircraft damage level was categorised as substantial,¹³ requiring significant time and resources to rectify, including an engine change, multiple component changes, wiring rectification and repairs to the aircraft’s structure. After removal of the engine, damage was also evident in the engine bay.

The onsite visual inspection by BAE identified damage to the LPT where a number of the blades appeared to have been released, damaging (non-penetrative) and puncturing the fuselage. The engine was removed from the airframe and air-freighted to the UK for an investigative strip by the OEM.

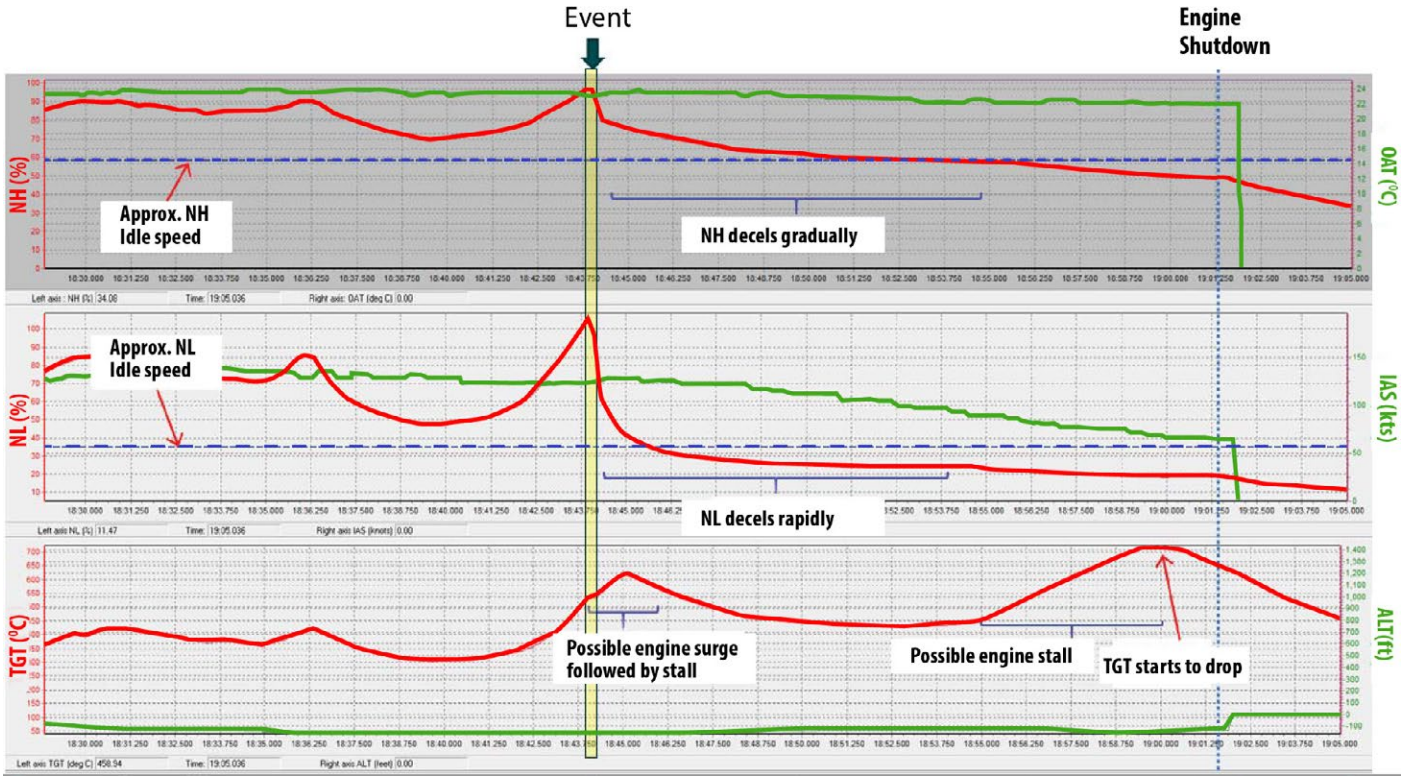
HUMS data portraying event sequence

severe damage to a number of the LPT blades, some of which had aerofoil loss down to the blade platform. BAE’s borescope identified a fractured blade that had separated in the firtree below the platform.

There was also damage to the outer (sixth) serration of the mating disc post to the right of the fractured blade.¹⁵

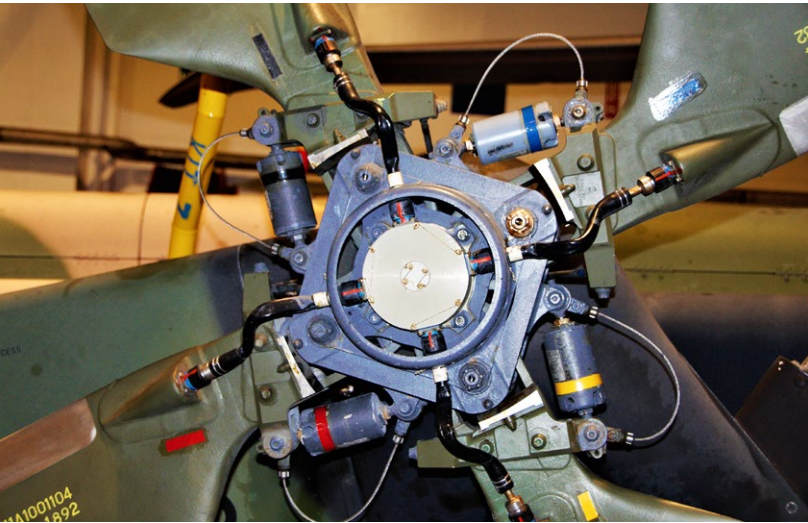
On final approach to the ship the vibrations increased significantly – an alarming contrast to the normally smooth operation of the aircraft – necessitating a PAN call by the aircraft captain and an immediate shutdown. Inspection of the tail rotor identified that the red blade had sustained significant damage. There were no injuries to personnel.
