Foreword

DF
/ 11131	
4	Growler unconta engine failure
9	Black Hawk rotor
16	PC-9 near miss
24	Bell 429 loss of c
30	C-17 load shift
34	Bell 429 cockpit f

the aviation safety magazine of the Australian Defence Force

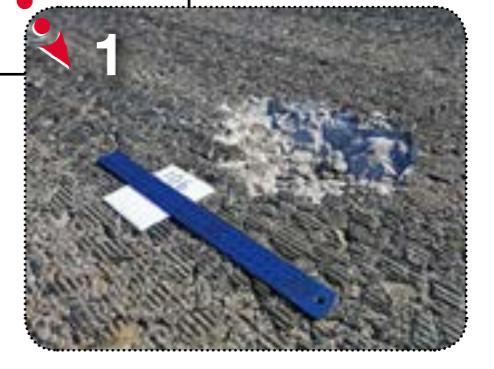
Shallow hole on Runway 03L caused by segment 1.

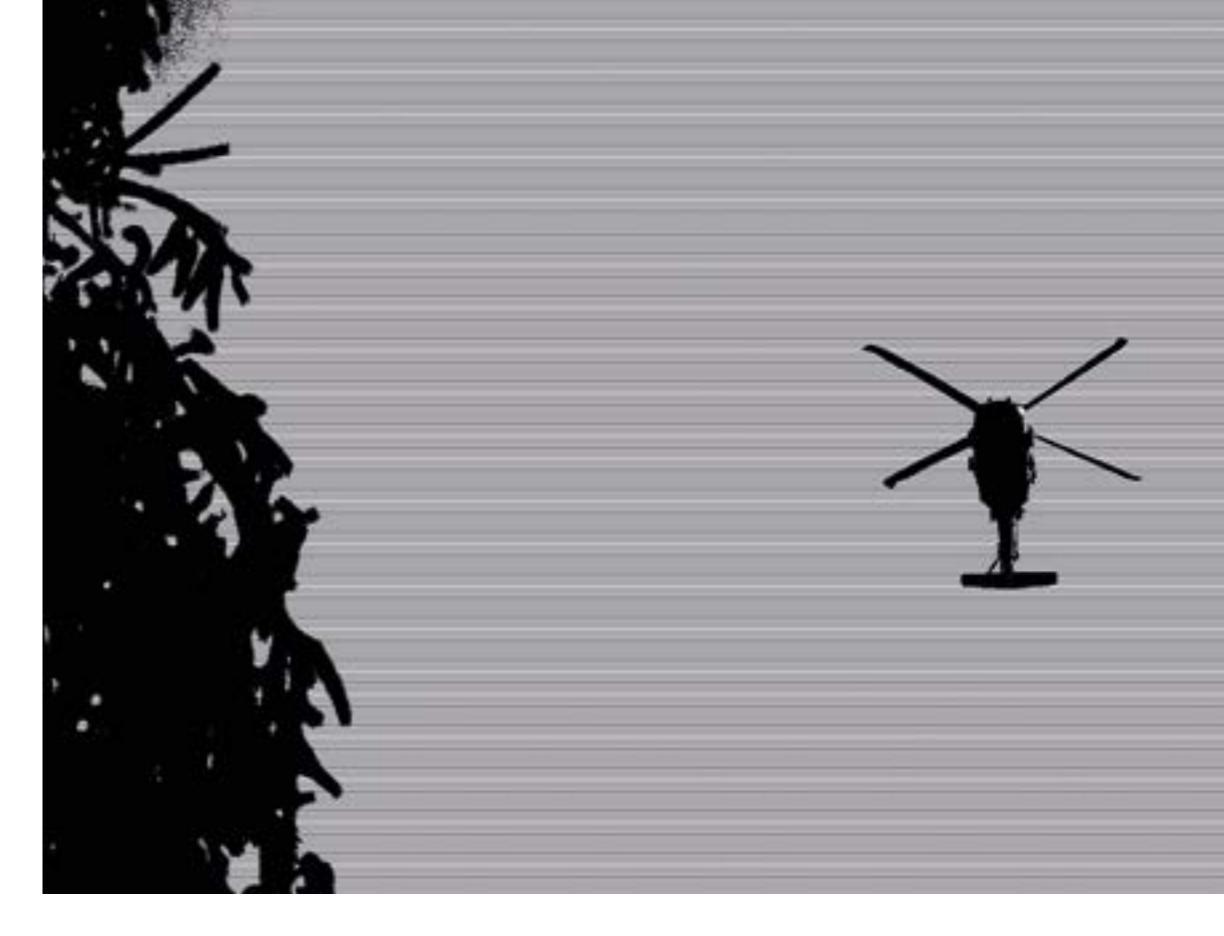
All four main rotor blades were damaged as a result of contact with a tree line on the southern boundary. The damage sustained during the contact required all blades be removed for repair, and was consistent with a descent onto a sheoak. Brush marks extending 1200 mm from the blade tip were evident on all four blades.

Visual assessment focussed on the rotor tip caps as a similar sized sapling had caused extensive damage in an incident three weeks earlier.

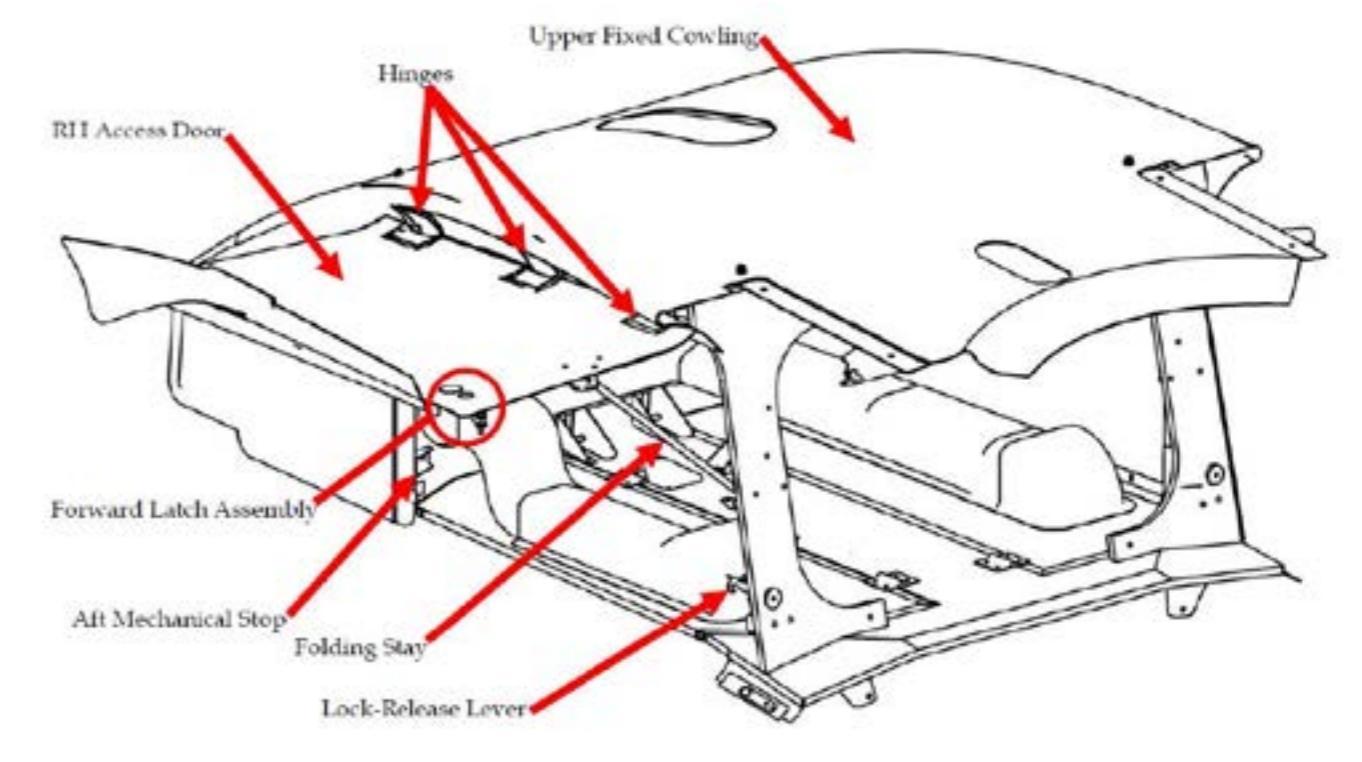
STI-ARH-273 Recurring Inspection of Upper Fixed Cowling Access Doors was released on 7 September 2018 to determine the development rate of unserviceability in upper fixed cowl access door locks and lock stops.

Diagram of the upper fixed cowling right-hand access door and associated hardware.

amendment to the servicing schedule will enable an enduring serviceability check for locks and lock stops.

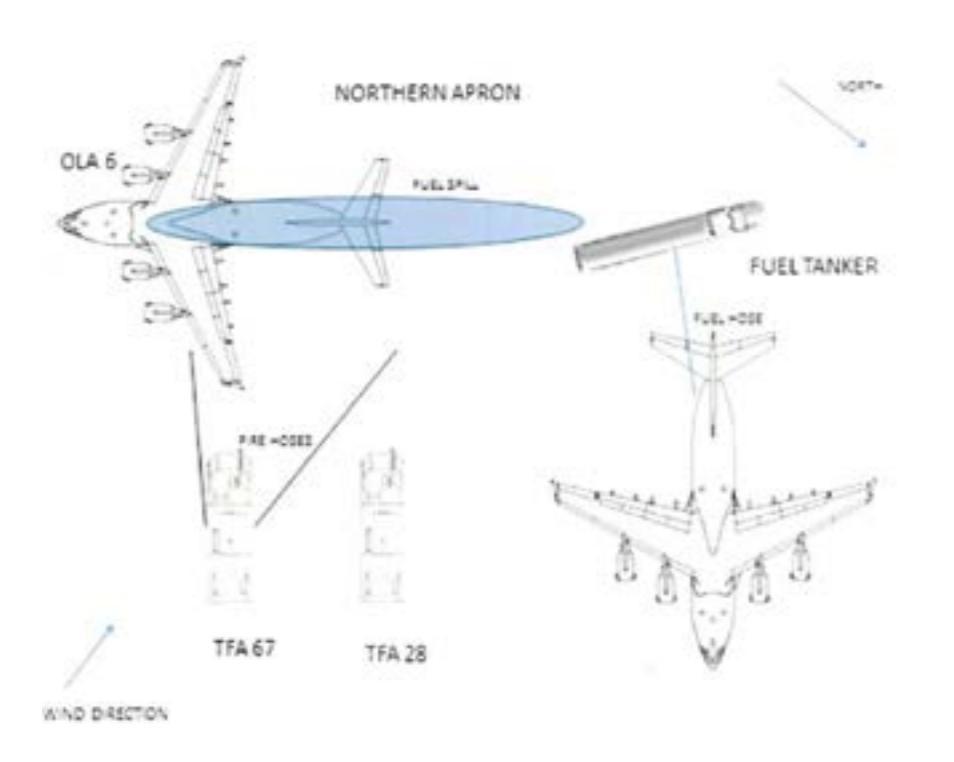
Absorbent materials (soaker pads and Sphag Sorb2) from the spill-kits were placed on top and around the edges of the spill. However, the soaker

pads were ineffective as they were too light and moved in the prevailing wind.

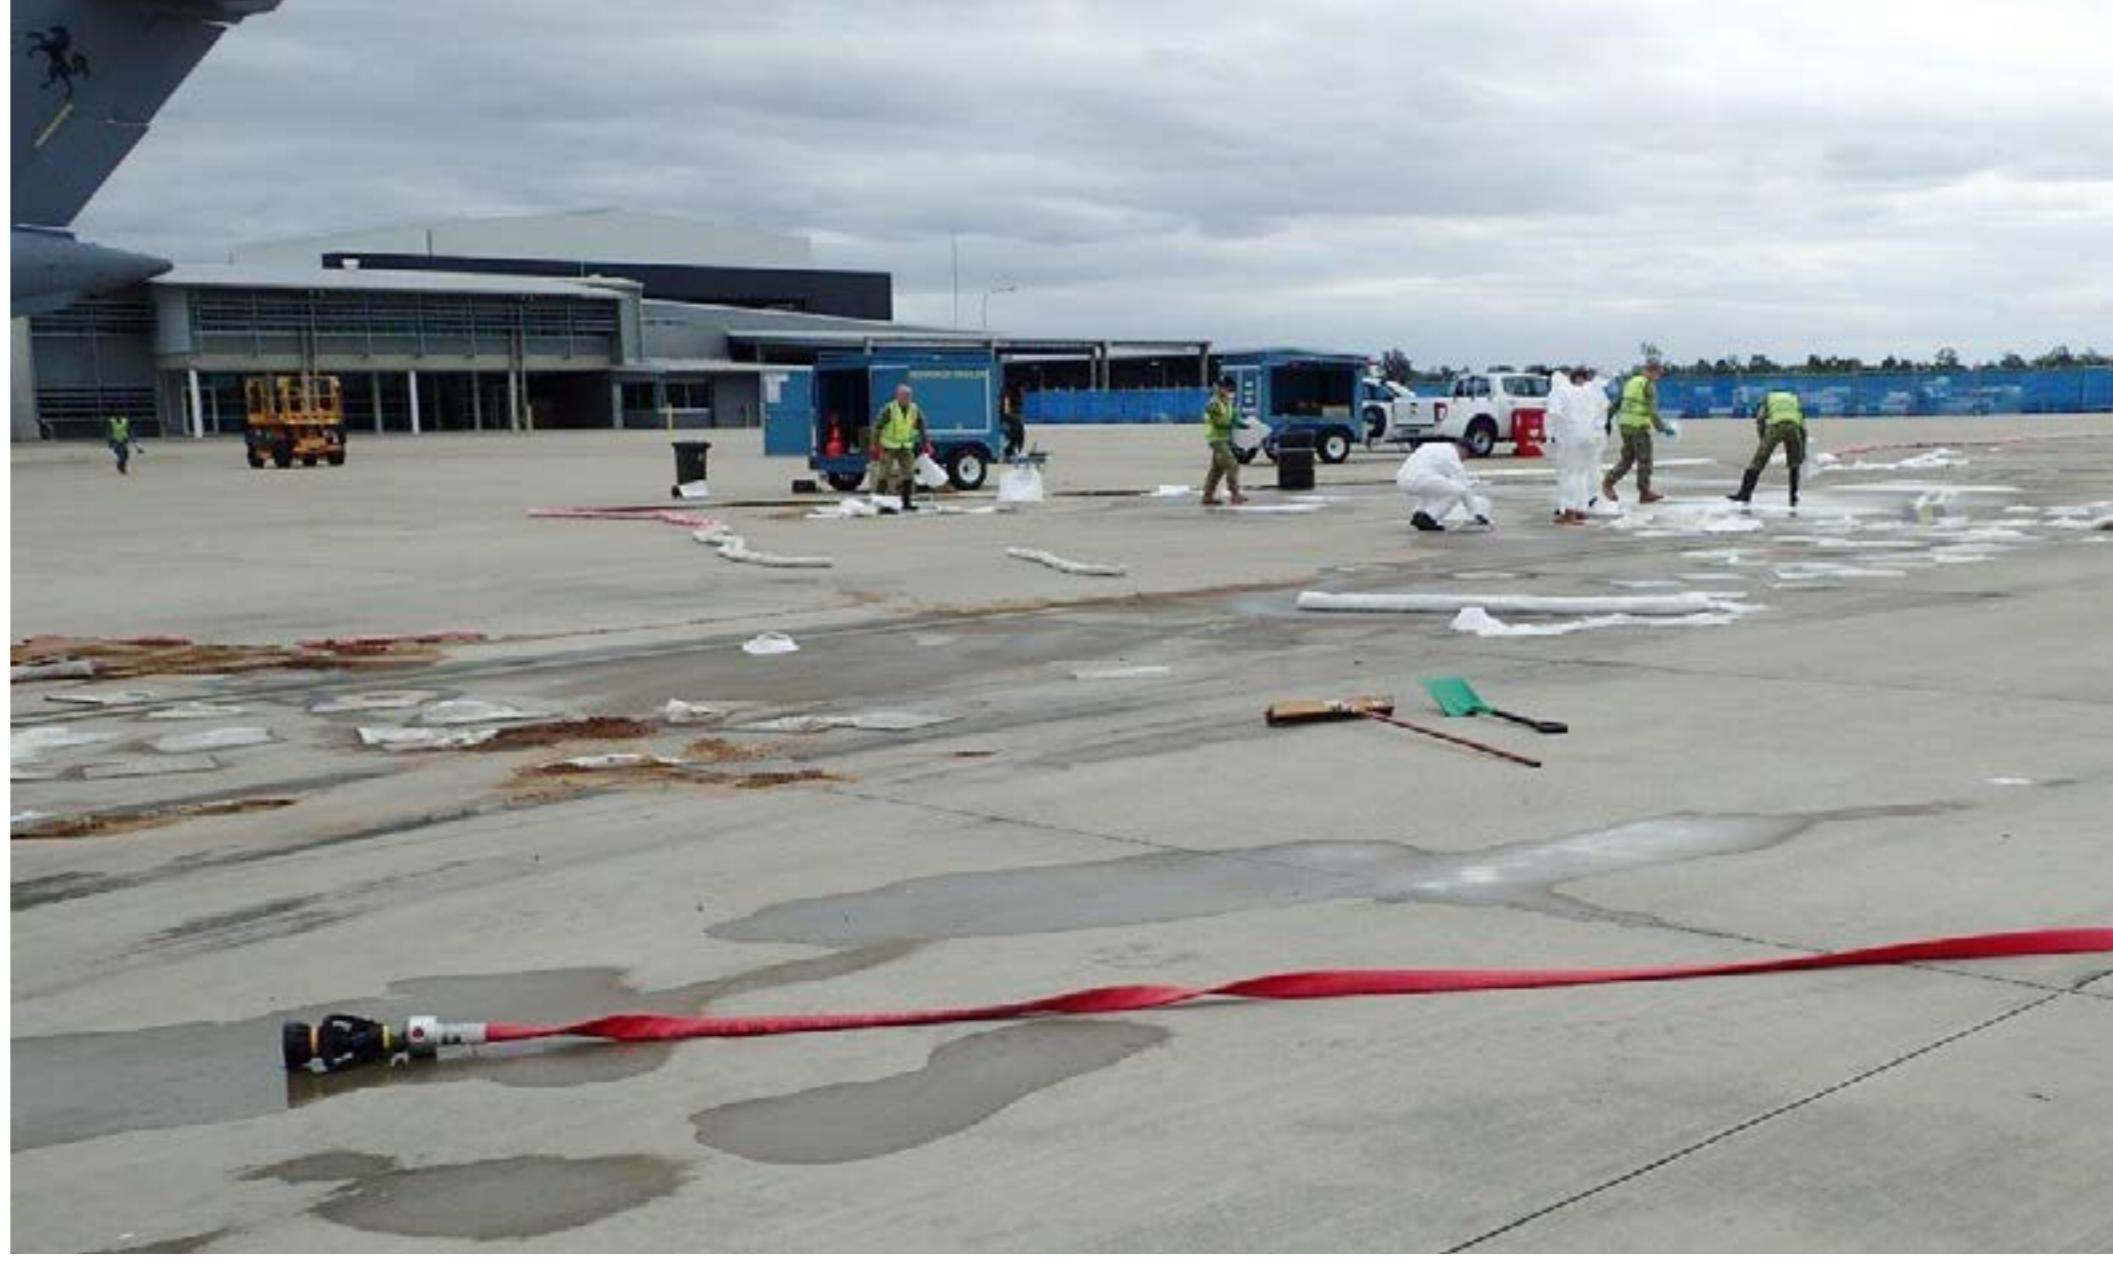
Squadron personnel absorbed the remaining fuel with soaker pads and placed the contaminated material in drums for disposal. An airfield sweeper attended the site to pick up any residual absorbent material. Fire crews packed up all firefighting

equipment and returned to fire section.

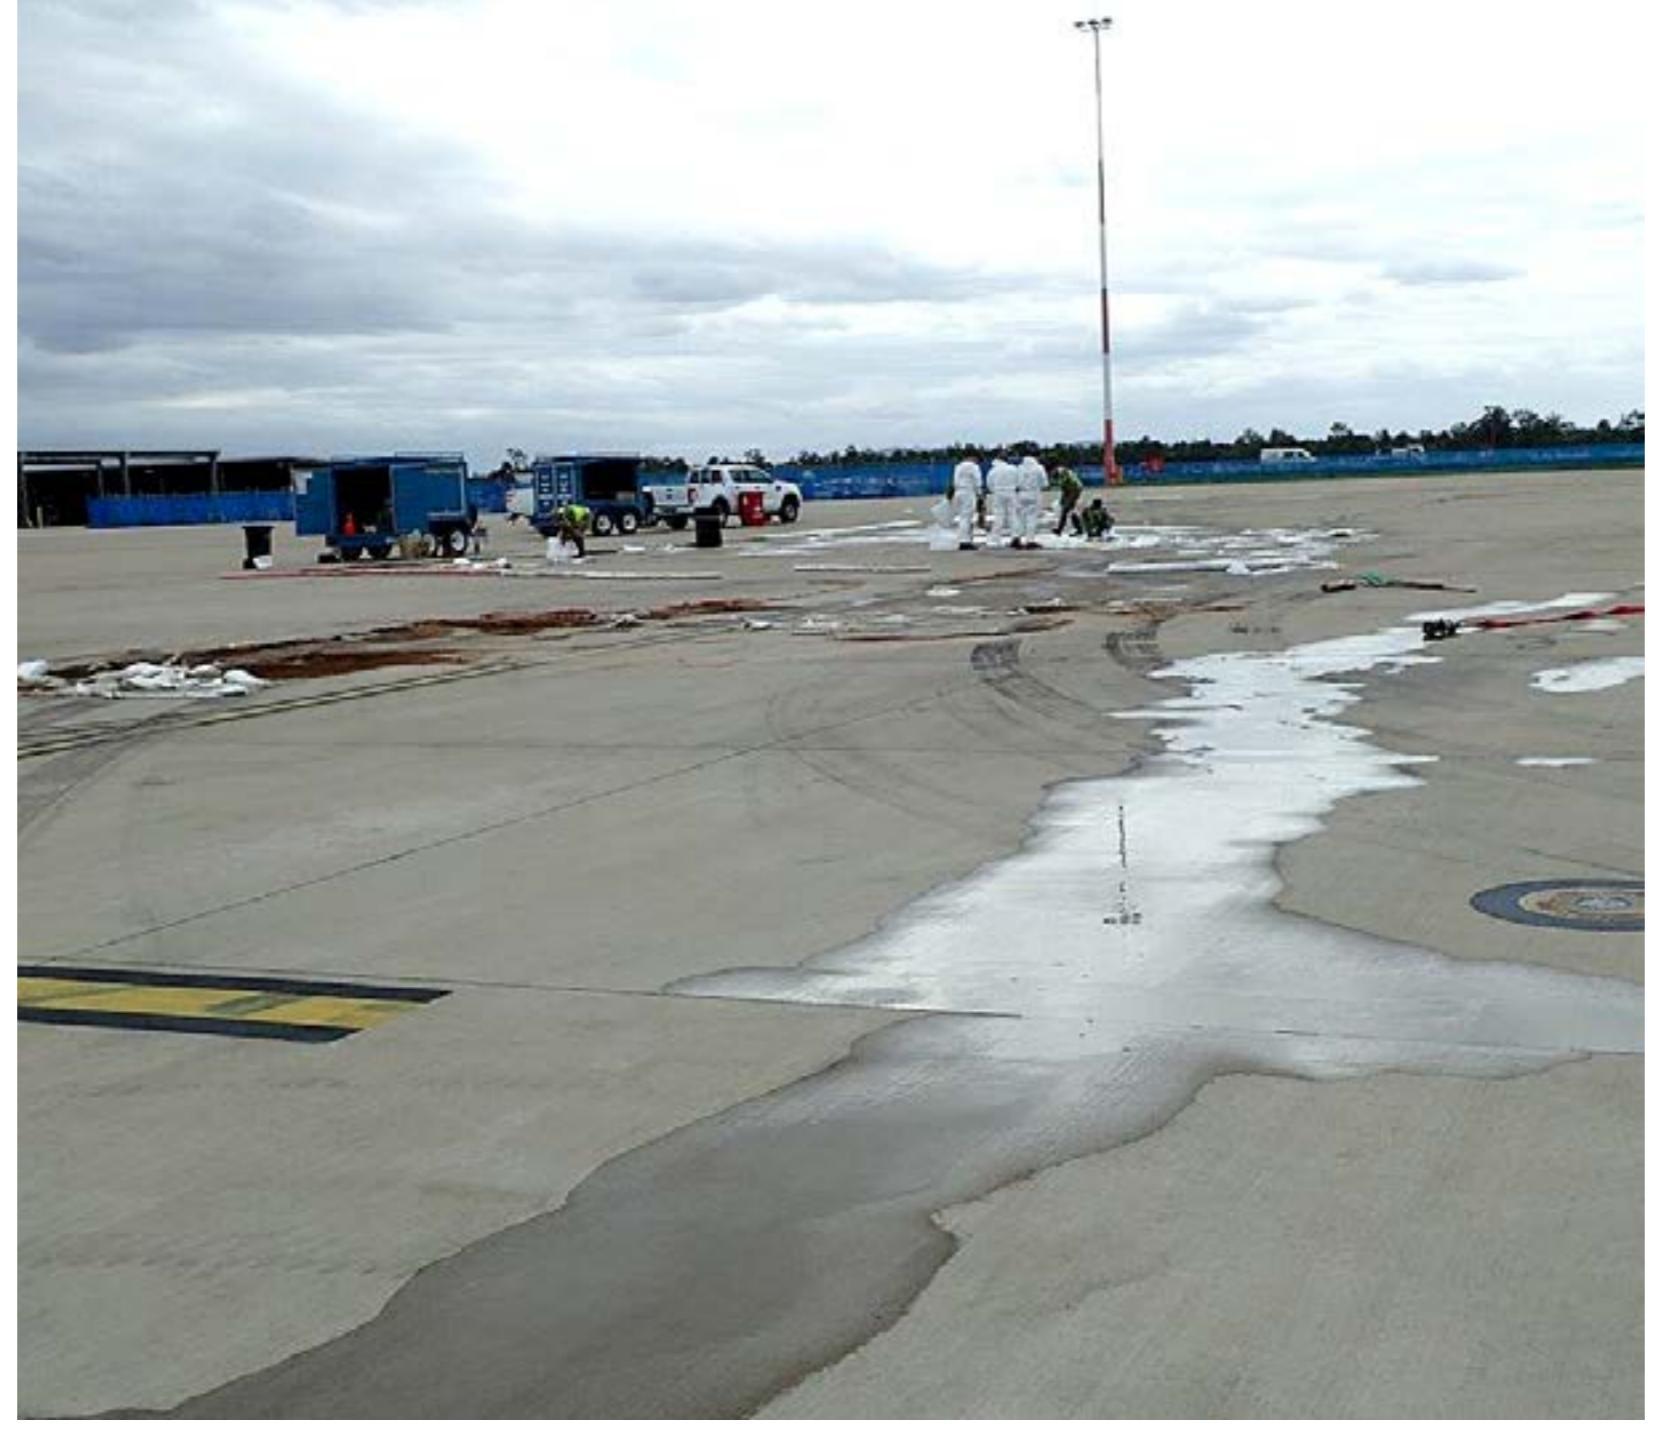
Although initial investigation found the compartment 4 outlet foot valve to be stuck in the open position, OEM found the same valve to be serviceable. The most likely explanation is that the valve had an intermittent fault, which had been detected in similar occurrences.

During a normal defuel process, fuel will flow into the selected compartments via the defuel manifold to the inlet foot valves. When the compartment 4 foot valve failed in the open position, fuel was able to enter compartment 4 via the refuel manifold without going through the bulk meter.

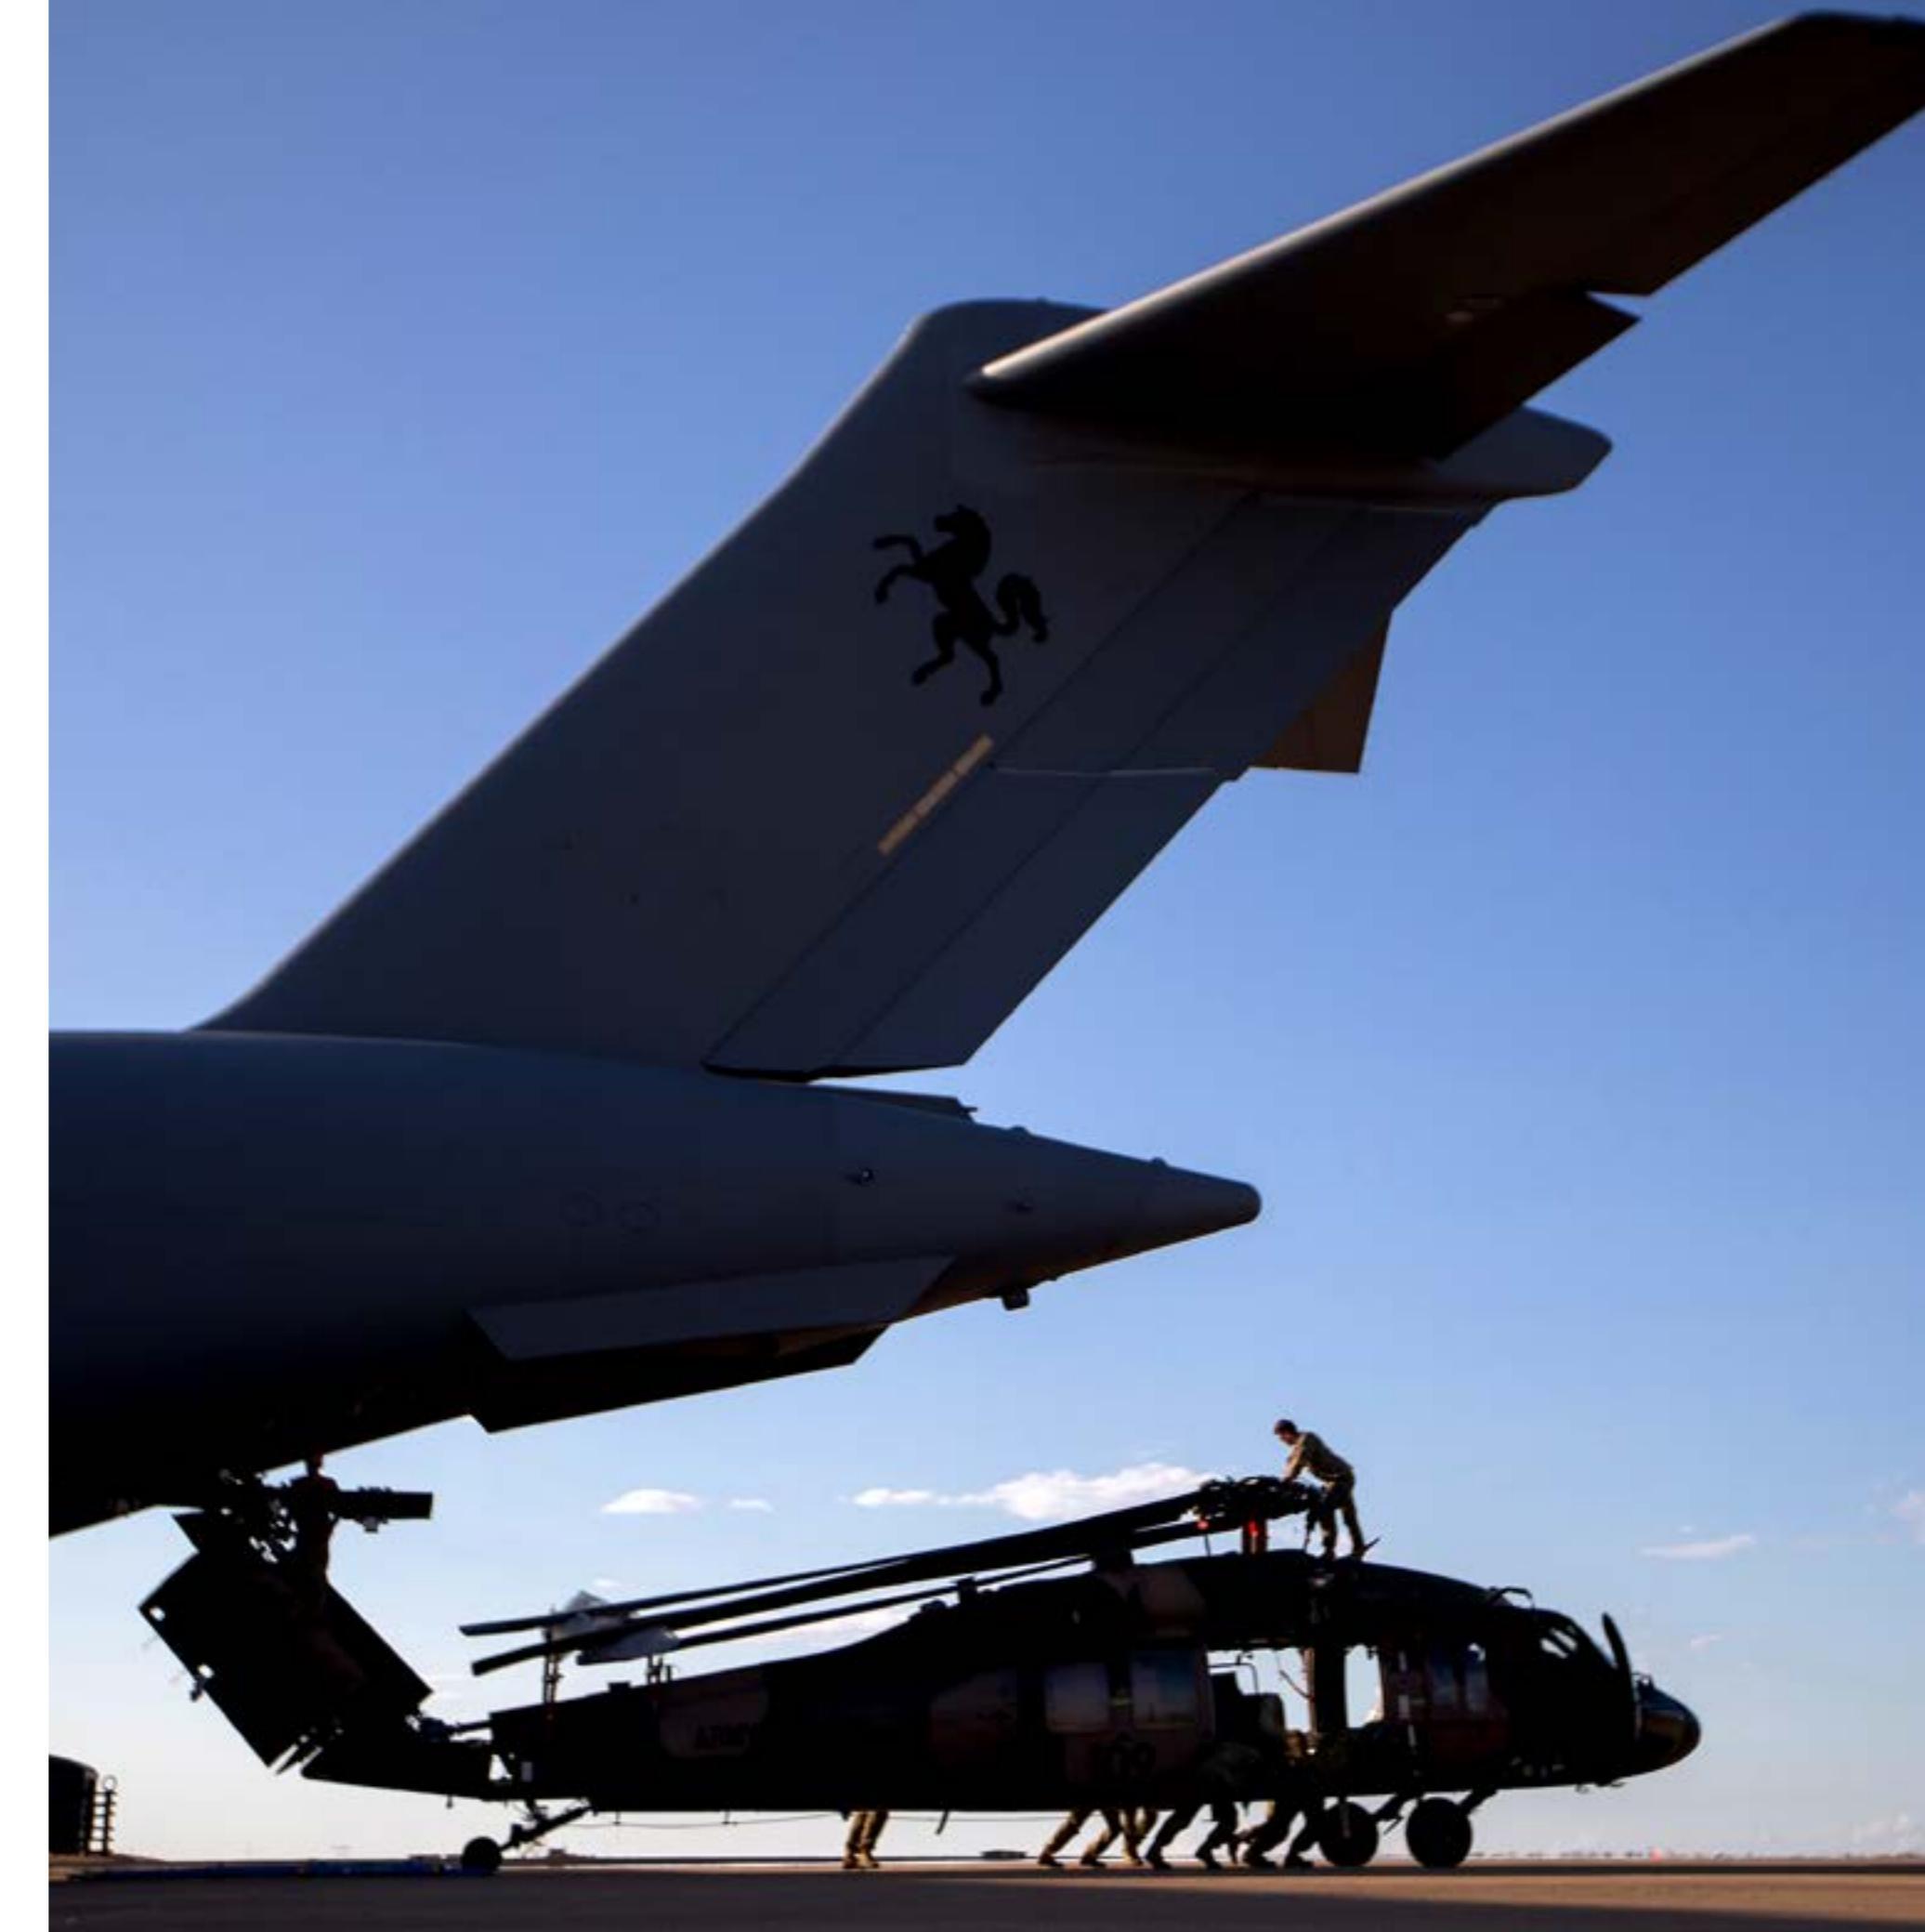
The failure caused a significant volume of hydraulic fluid to be expelled under pressure inside the C-17; spraying the Black Hawk and members of the maintenance team. This was subsequently documented in accordance with WHS policy. Fortunately, there were no injuries sustained and the C-17 was not damaged.

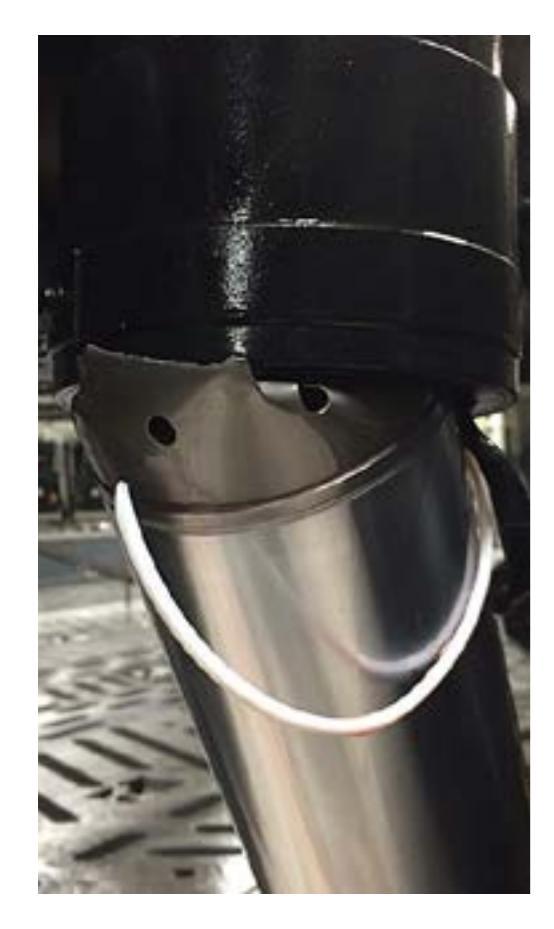
Upper and lower strut sections post separation.

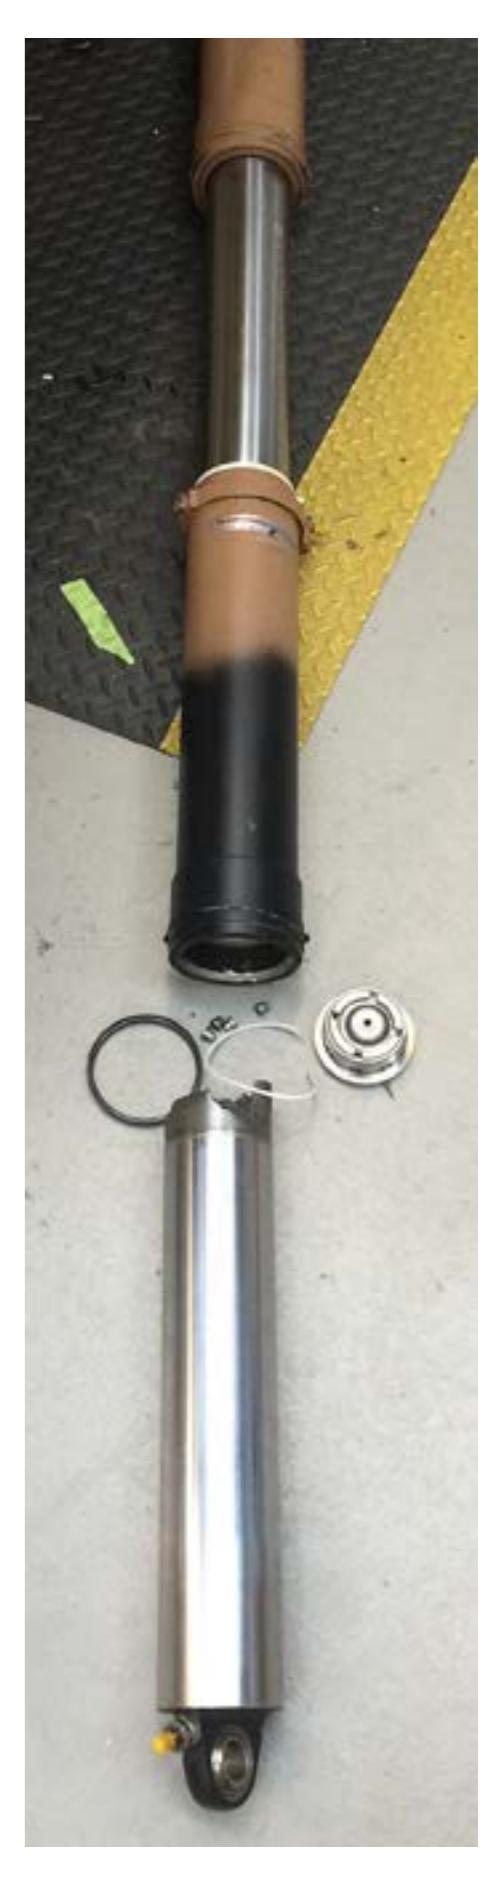
- 6. During the process of testing and confirming interim maintenance procedures and establishing operating limits, it became clear that certain legacy maintenance actions were not suitable for continued practice. An example of this was the established practice of de-activating the HKG pump only once a change in pitch noise was identified, which would traditionally indicate a strut has achieved full extension. It was identified that with the replacement HKR, no pitch change was evident, likely due to a higher performing with greater capability. As a result, it was identified that there were no other means of confirming maximum strut extension had been

achieved, which was identified as the

primary cause of this particular failure event. AASPO in conjunction with DSTG testing established and defined clear operational parameters to confirm maximum extension is achieved.
