**SPECIAL EDITION: THE HOW AND WHY**  
AVIATION SAFETY INVESTIGATIONS

# *Spotlight*

### **Investigation Special 2026**

Nine expert articles exploring flight-safety incidents,  
contributing factors, and their lessons for Defence aviators

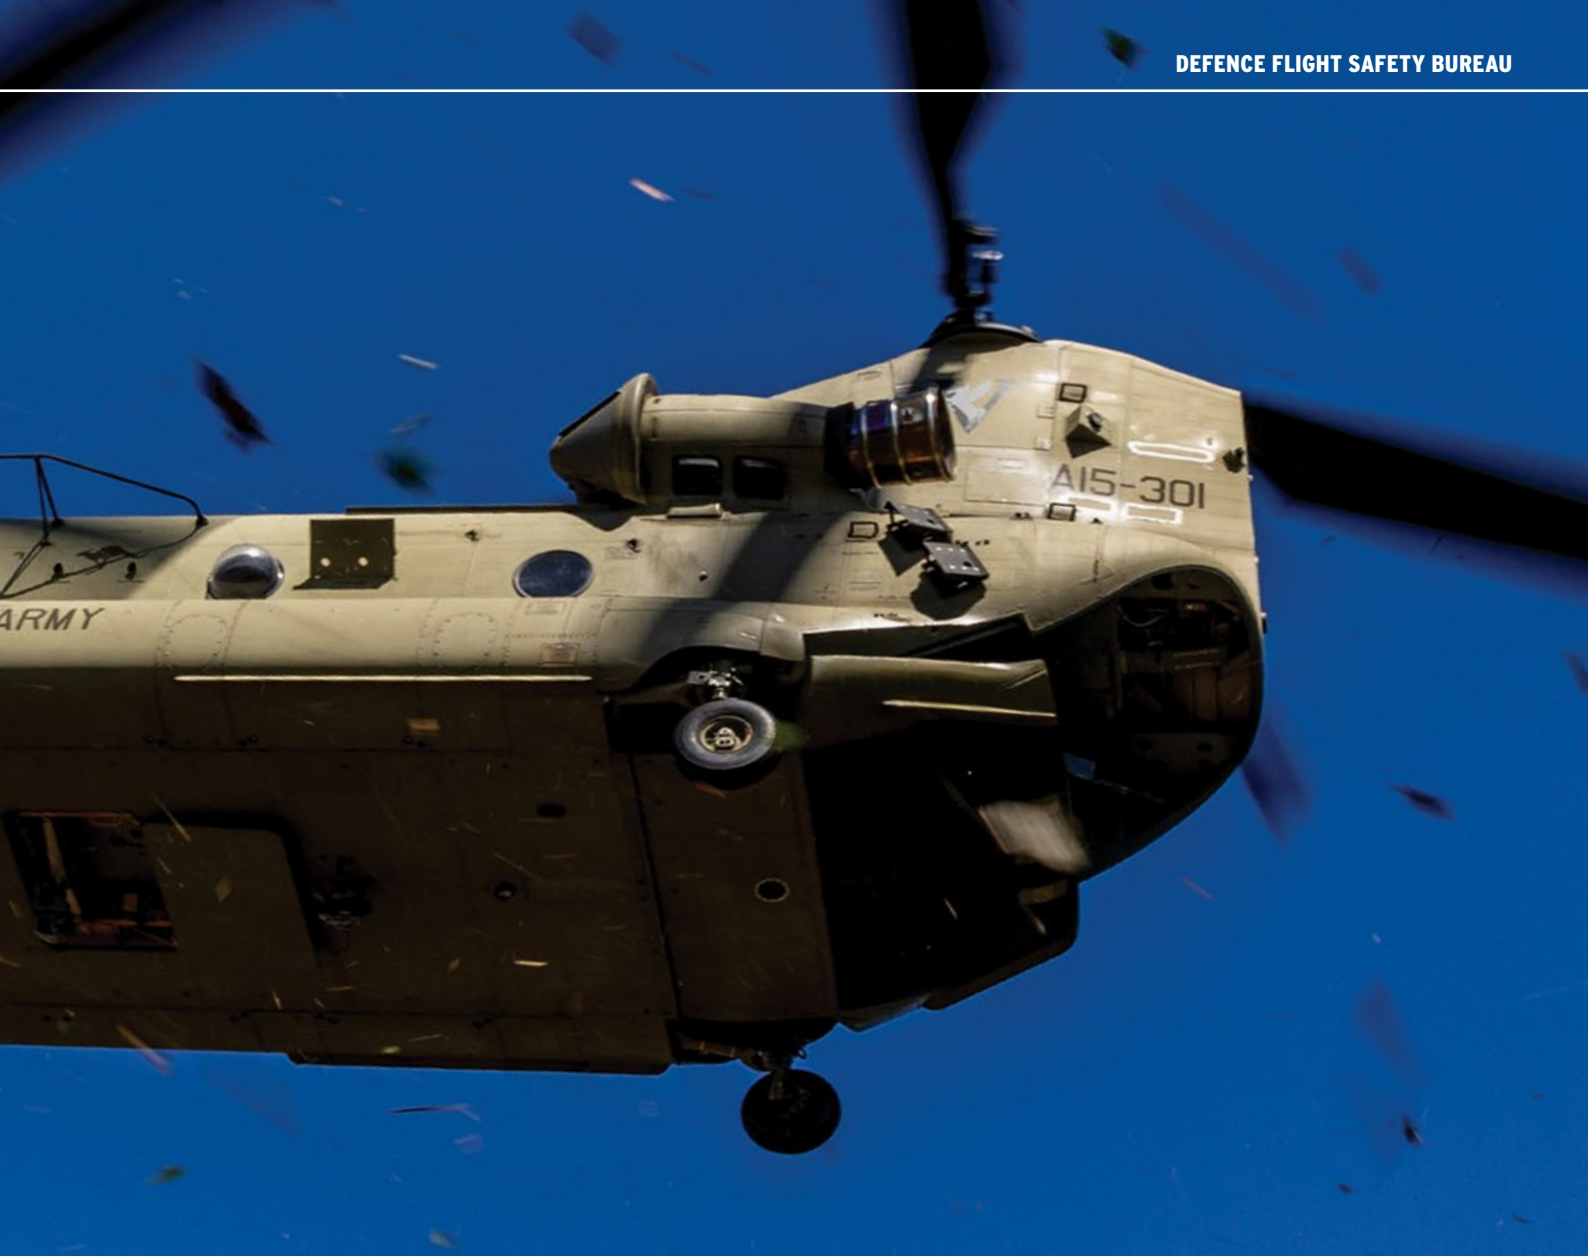
The formation then flew to Gold Coast Airport to refuel. While conducting an inspection on the helicopter, the AT discovered that the wheel-brake accumulator gauge cover was cracked. It quickly became apparent to the AT that the accumulator itself had dislodged from its mounting brackets

and was sitting freely on the flight-control rods in the upper-forward pylon of the Chinook. The crew assessed that the accumulator had significant potential to interfere with or jam the flight controls, potentially setting the conditions for a catastrophic outcome. The crew raised a Class B aviation

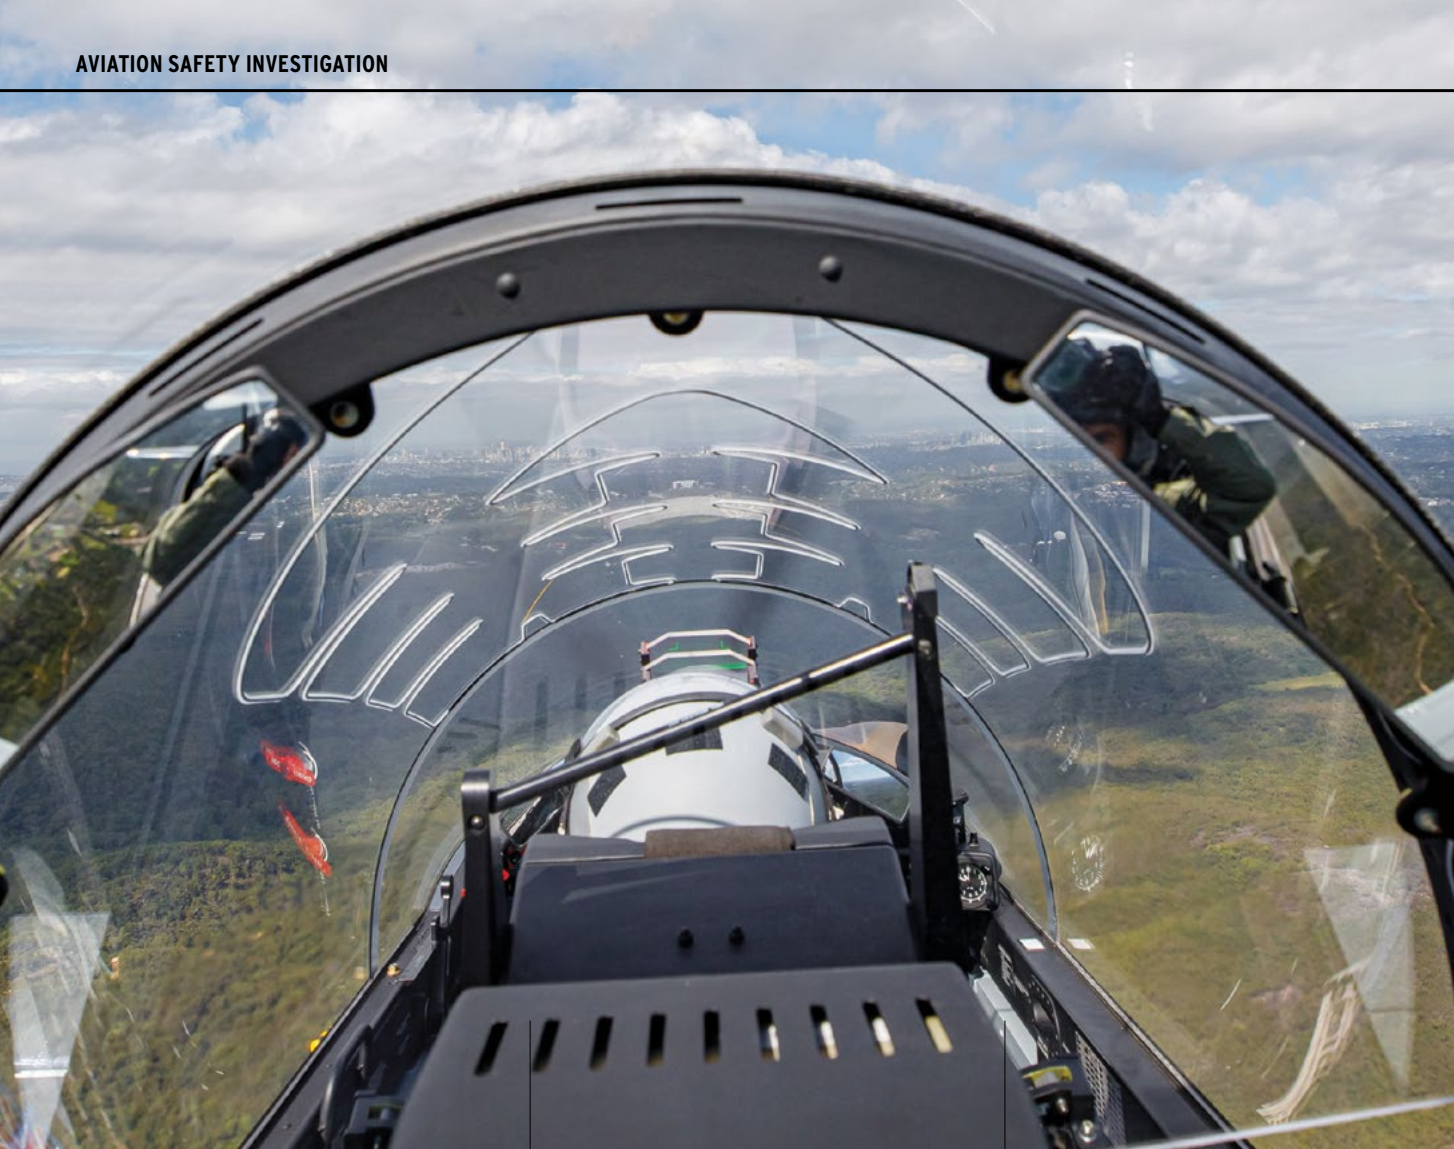
What began as a routine instrument approach developed into a high-stress sequence.

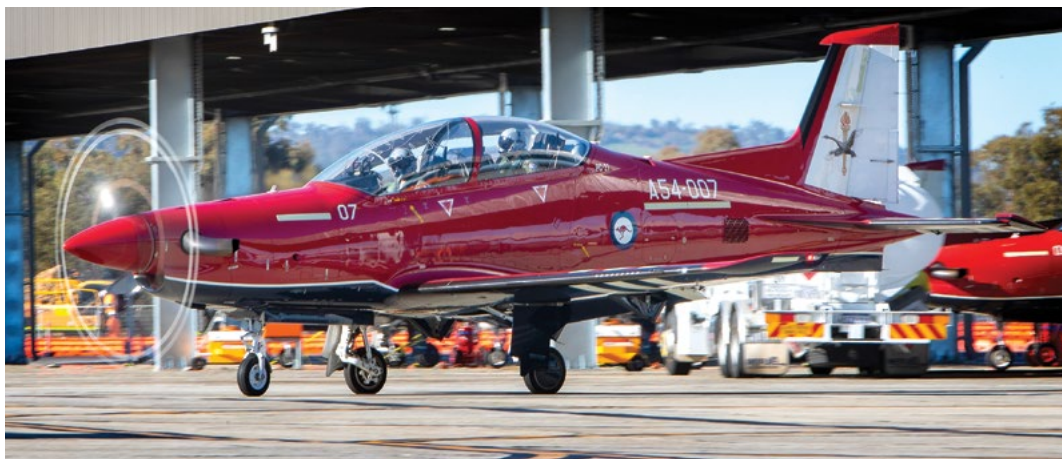
Flying level at the 360 ft AMSL Decision Altitude (DA) for nearly one minute, scanning for visual cues, the pilot eventually sighted the runway and landed safely. However, by descending prematurely to the DA, the aircraft had been well below the intended profile: up to 125 ft below the protected obstacle-clearance surface. Fortunately, the terrain east of East Sale is relatively flat.
